A Study of Indoor Air Quality in Refurbished Museum Building

Syahrun Neizam Mohd Dzulkifli ^{a*}, Abd Halid Abdullah ^a, Lee Yee Yong ^b,
Abdul Mutalib Leman ^c, Samiullah Sohu ^a

Keywords: Indoor Air Quality; Museum Building; Refurbished.

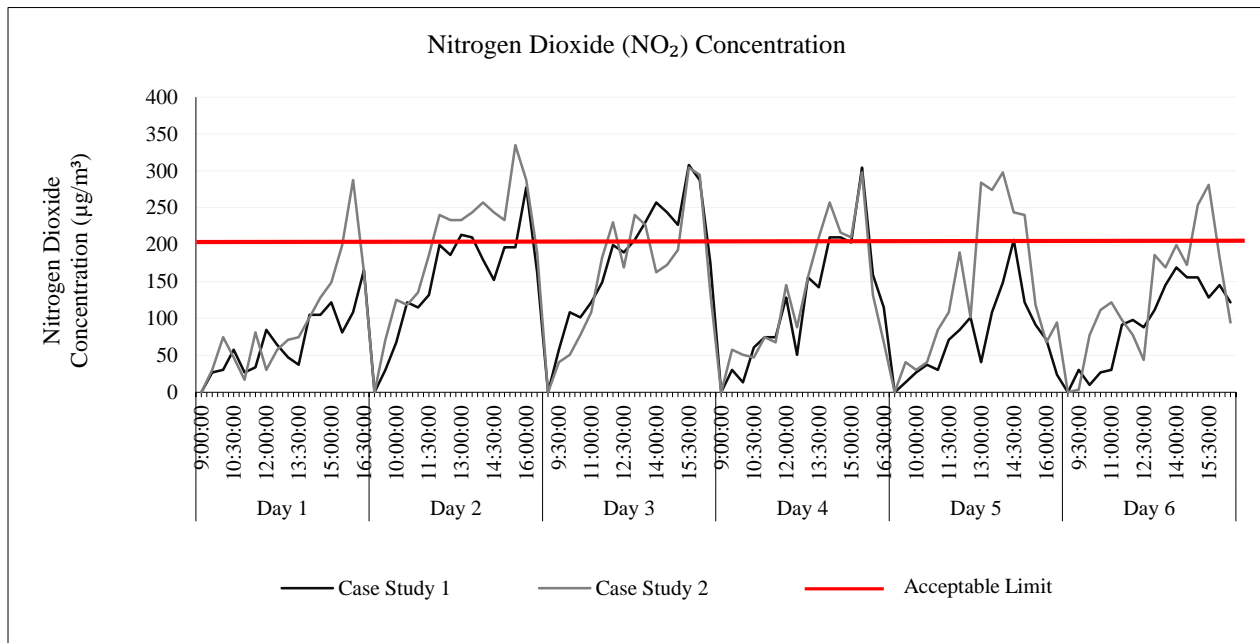
Figure 6. Nitrogen dioxide concentration for Case Study 1 and Case Study 2

Based on Figure 6, according to WHO, for a short term NO_2 exposure within one hour, the acceptable Threshold Limit Value (TLV) for NO_2 concentration is $200 \mu\text{g}/\text{m}^3$ [31]. It is found that both case studies had exceeded the acceptable TLV for the NO_2 concentration in the evening daily. Case Study 1 and Case Study 2 are located at urban area and based on Figure 6, it shown that NO_2 concentration for Case Study 2 are higher and more pollute compared to indoor levels of NO_2 for Case Study 1, because there was heavy traffic occurred, especially on weekends (Day 1, Day 2 and Day 3). It was discovered thatm, the distance of building from roadway can influence the indoor levels of NO_2 [32, 33]. And based on this fact, Case Study 2 recorded higher NO_2 concentration compared to Case Study 1 because Case Study 2 are much closer to the roadway with a distance of 60 meter while Case Study 1 are located 500 meter from the roadway.

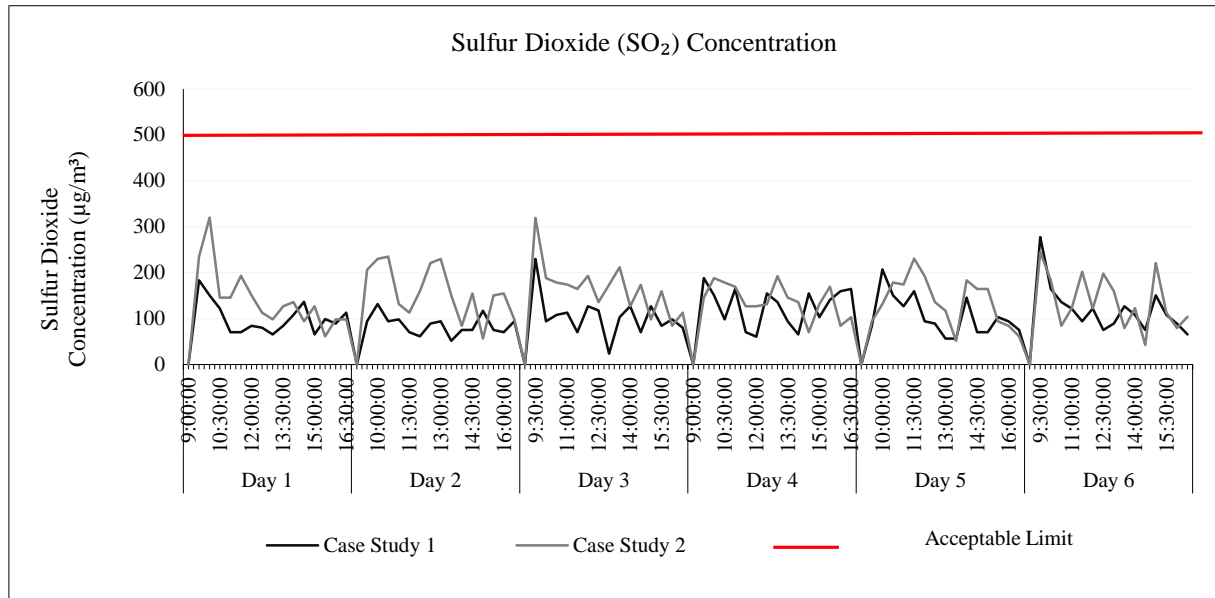
Figure 7. Sulfur dioxide concentration for Case Study 1 and Case Study 2

Based on Figure 7, according to WHO, for a short term SO_2 exposure within 10 minutes, the acceptable TLV for SO_2 concentration is $500 \mu\text{g}/\text{m}^3$ [31]. It is found that both case studies are still safe and provide a healthy indoor environment because SO_2 concentration for both case studies had not exceeding the acceptable TLV. It is because, even though Case

Study 1 and Case Study 2 are located at urban area, there was no power stations and industries are located nearby to both case studies, which according to WHO [3], the use of sulfur-containing fossil fuels for domestic heating, stationary power generation and motor vehicles contribute to environmental levels of SO_2 . However, there still has a presence of SO_2 pollutant in indoor environment due to the motor vehicles factor as reported by Clean Air Initiative Asia [34], showing that although the power sector and industries accounted for the majority of SO_2 emissions, with 60% and 20% respectively, motor vehicles or transport sector still contribute to indoor levels of SO_2 pollutant, represent with 8%. Due to this factor, with also consider the distance of building from roadway, it shown that SO_2 concentration at Case Study 2 are higher and more pollute compared to indoor levels of SO_2 at Case Study 1, because there was heavy traffic occurred, especially on weekends (Day 1, Day 2 and Day 3).

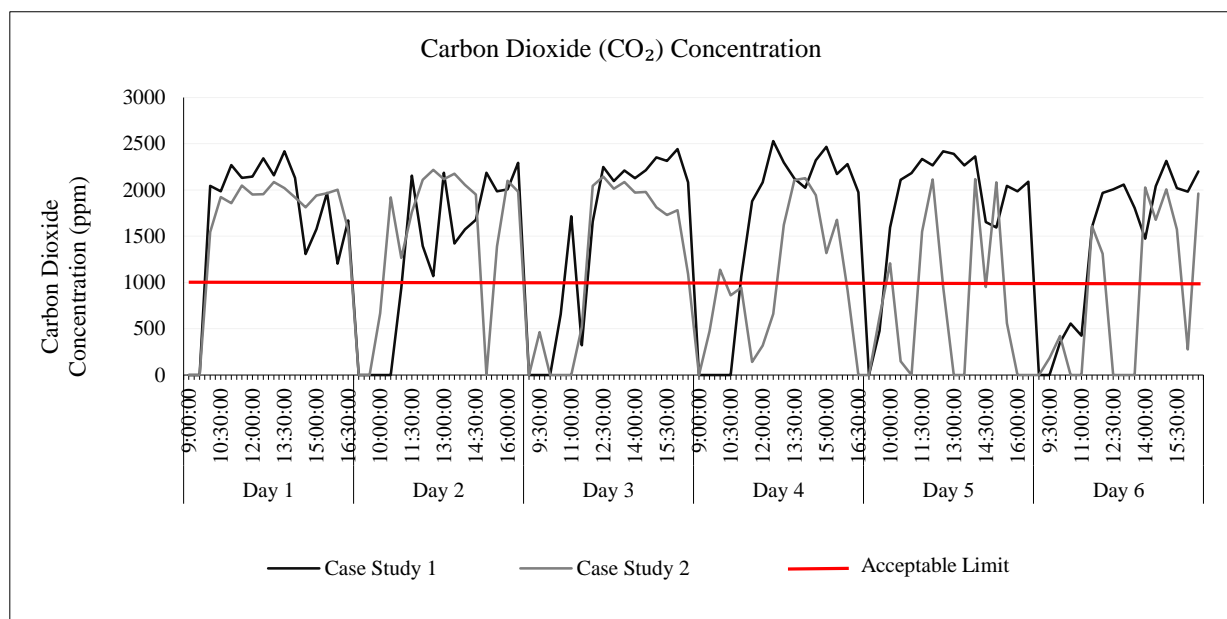
Figure 8. Carbon dioxide concentration for Case Study 1 and Case Study 2

Based on Figure 8, according to DOSH, for a short term CO_2 exposure, the acceptable TLV for CO_2 concentration is 1,000 ppm [15]. It was discovered that on weekends (Day 1, Day 2 and Day 3), both case studies were constantly exceeding the acceptable TLV from morning until the end of the museum's operating hour. However on weekdays (Day 4, 5 and 6), the CO_2 concentration for Case Study 1 have constantly exceeded the acceptable TLV starting from morning (mostly after 10 am) until the end of the museum's operation hour, while for Case Study 2, there have a mixed trends of CO_2 concentration profile that exceeds the acceptable TLV, except on Monday (Day 4) showing that the CO_2 concentration are constantly exceeding the acceptable TLV starting from afternoon (12.00 pm) until evening (4.00 pm).

For CO₂ pollutant, combustion and human respiration are common sources of CO₂ levels. In Melaka, tourism is a popular destination among tourist and as a state which is associated with history, museum such as the Melaka Sultanate Palace Museum and the History and Ethnography Museum are among the most popular museums that received quite a huge number of visitors annually [35]. Due to this factor, it shown that CO₂ concentration for Case Study 1 are higher and more pollute compared to indoor levels of CO₂ for Case Study 2, because Case Study 1 received higher visitors compared to Case Study 2.

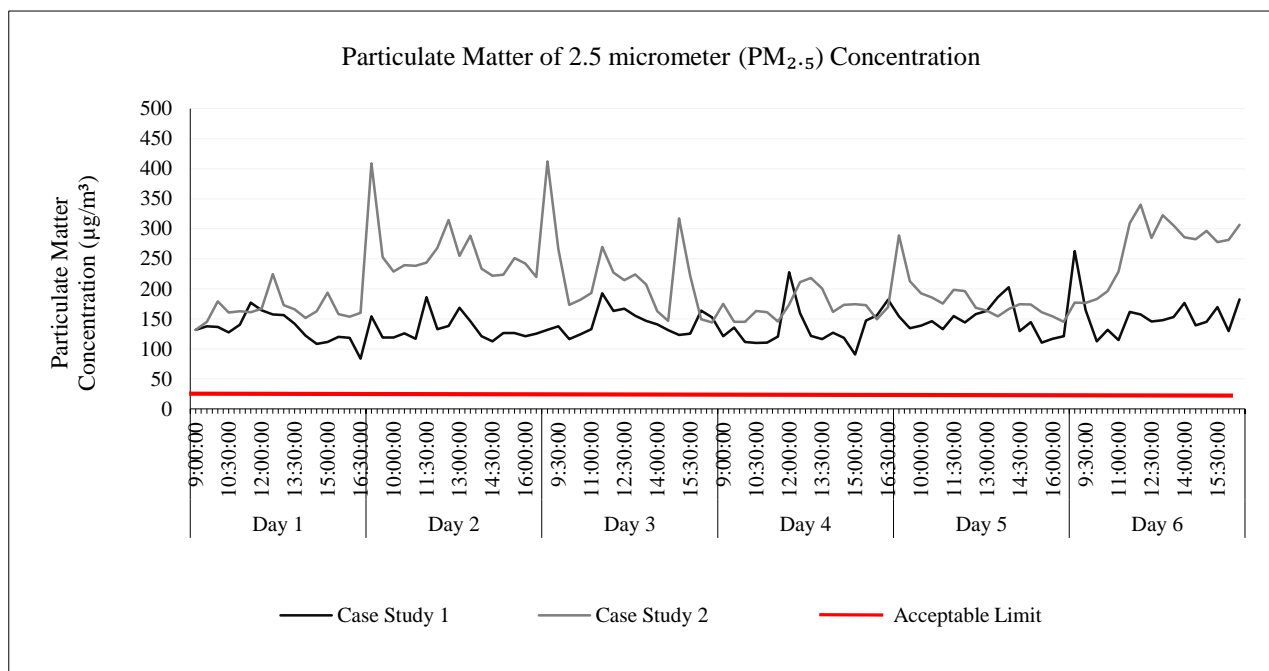
Figure 9. Fine particle concentration for Case Study 1 and Case Study 2

Based on Figure 9, according to WHO, for a short term PM_{2.5} exposure within 24 hours, the acceptable TLV for PM_{2.5} concentration is 25 µg/m³ [31]. It is shown that the PM_{2.5} concentration profile for both case studies are constantly exceeding the acceptable TLV starting from the opening of the museum's operation hour until the end of the museum's operation hour. According to WHO [3], there are numerous sources of particles related to natural sources as well as human activities, such as source obtain from infrastructure, manufacturing, landfills, construction sites, agricultural fields and vehicle use. WHO stated that indoor levels of environmental pollutant are a function of indoor and outdoor sources, where high outdoor levels originating from local traffic or other combustion sources influence indoor levels [31]. Due to this factor, with also consider the distance of building from roadway, it shown that PM_{2.5} concentration for Case Study 2 are higher and more pollute compared to indoor levels of PM_{2.5} for Case Study 1, because there was heavy traffic occurred, especially on weekends.

Nevertheless, there was a possibilities that indoor levels of PM pollutant could also originated from indoor sources, which generate source from visitors itself. There has a role of visitors' clothing as a source of fibres and dust which contributed to indoor levels of PM pollutant in museums [36]. During the field study measurement, it was discovered that Case Study 1 received a huge number of visitors with a total of 536 visitors whereas Case Study 2 received 508 visitors, recorded for six days.
