## Strengthening and Repair of a Precast Reinforced Concrete Residential Building

M. Jamal Shannag<sup>a\*</sup>, Mahmoud Higazey<sup>a</sup>

### Abstract

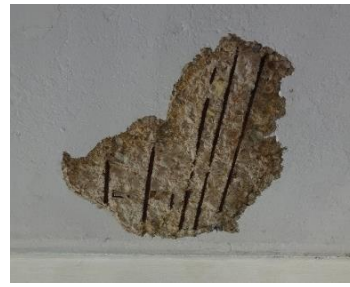
f) P02-S12

**Slabs**                      Severe spalling of concrete and corrosion                      crack spalling area of 0.2 m<sup>2</sup>

The maximum chloride concentrations reported in this investigation for some members, (1.8%) by mass of cement, corresponding to 4.86 kg/m<sup>3</sup>, exceeded the maximum chloride content reported in the literature on a reinforced concrete building, (1.07 kg/m<sup>3</sup>), by four times [12]. This indicates that chloride corrosion was the most serious problem causing the severe damage observed in some members of the precast structure. Moreover, the PH values reported in the present investigation (11.8-12.3) were larger than those reported in the literature for the same building (9.6-11.52), [12]. This shows that carbonation was mainly responsible for initiating the corrosion observed in the reinforced concrete building.

### 5.2. Structural Repair of Columns, Beams and Slabs against Corrosion Damage

The repair method proposed in this study to prevent the concrete damage induced by chloride corrosion and moisture in some structural elements consists of: removing the concrete cover including cracked and delaminated concrete to about 25 mm behind the bar using mechanical means; cleaning the corroded steel bar by sandblasting or wire brush; at areas where the corroded bars have lost more than 20% of their diameter, additional bars were used and spliced in to guarantee structural integrity; removing dust by air blowing and washing with clean water to achieve a saturated surface dry substrate; coating the exposed steel bars with a zinc rich product (such as Sika Zinc Rich® or similar material) to protect it against corrosion and to delay the attack of aggressive elements; cathodic protection of the corroded steel bars was conducted using either a mesh or ribbon anode system, covered by a cementitious overlay such as gunite, or a discrete anode system where anodes are individually placed on, or in the concrete surface [23-25]; applying a high strength cementitious repair mortar or concrete to restore the removed concrete cover [26]; in case the required thickness is less than 100 mm, repair material such as SikaRep® or similar can be used; in case the required thickness is higher than 100 mm, shotcrete must be used; and curing the applied repair mortar or concrete for a minimum of 7 days. Bonding agents should not be used where electrochemical treatment is required as it could create an insulating layer. Some of the beams and columns having corrosion, and severe cracks or a compressive strength less than 25 MPa, were strengthened further using carbon fiber reinforced polymer sheets (CFRP), or steel jackets as shown in the subsequent sections.

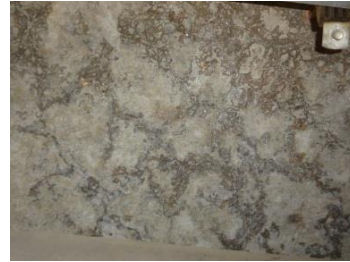
g) F14-S12

**Slabs**                      Fine to moderate cracks, salt scaling and leaching                      2 m<sup>2</sup> Area

The chemical analysis tests of the core samples taken from some locations in the structure have also shown that the sulfate content of the concrete tested exceeded the limits specified in SBC304-18 and BS1881, [5, 21] codes by 3 and 7 times respectively. Such a severe concentration of sulfates, magnesium sulfate in particular had an aggressive decomposing action on concrete in a humid environment, [21], and caused an increase in permeability of concrete, leaching and salt scaling as shown in Table 1 (c and g).

### 5.3. Structural Repair of Slabs against ASR, and Salt Scaling Damage

The repair method implemented in this study to counteract the moderate concrete damage caused by alkali silica reaction, ASR, and salt scaling included the following steps: the area of damaged concrete was bordered using a marker pen; breaking the concrete beyond the bordered area until reaching a sound concrete, using a jack hammer for saw-cutting the perimeter of the broken area to avoid feathered edges; damaged and easily removable concrete was chipped away; the dust was removed by air blowing and washed with clean water to achieve saturated surface dry substrata; bonding low viscosity material such as epoxy resin on the surface of old concrete to ensure full bond with the new concrete overlay; covering the broken concrete area with a suitable wooden forms; injecting a high strength cementitious grout at specific locations through holes in the forms using an injection pump [27]; the cementitious grout should be flowable, and contains silica fume and fly ash and had a water to cementitious materials ratio not exceeding 0.4 by weight of cement [28]; and curing the water tight overlay for a period of one week. For the structural members which suffered severe damage of more than 30% of their surface area, external strengthening of the defects injected with high strength cementitious grouts, using CFRP strips and or jackets would be a better choice for enhancing their flexural capacity and maximizing their service life. The high strength cementitious grout implemented provides a water-tight overlay on the damaged spot, and could be an ideal solution for improving the imperviousness of the concrete.

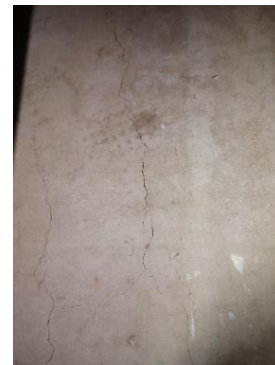
i) F08-C09

**Columns**                      fine to moderate cracks                      drying shrinkage

#### 5.4. Repair against Drying Shrinkage Cracks and Other Types of Structural Cracks

For fine shrinkage cracks narrower than 1 mm in width, polymer sealant such as low viscosity epoxy resin is a better choice for filling the crack. Moreover, polymer injection could be used to ensure full penetration of the epoxy into the crack. For larger crack width, more than 1 mm; make sure that the cracks are dormant and not growing with time. Crack injection using low viscosity epoxy resin was carried out as follows: using power driven wire brushes or grinder to remove surface laitance and any deposits along the line of the crack; using oil free compressed air to blow the dust off from the crack; chasing out along the line of the crack; cleaning the dust and apply the resin to seal the crack at the surface using scraper; fixing the injection nipples/packers; marking out positions of holes staggered on either side of the crack at 300 mm intervals, positioned so that they will intersect the line of the crack approximately half way in the concrete, when drilled at an angle of 45°; a percussion drill of 10 mm diameter was used to drill the holes marked on either side of crack by making sure that the drill passes the plane of the crack; removing the dust from the drilled holes; fixing injection packers made of steel, 10 mm dia., 50 to 60 mm long, in the drilled holes using the resin; and connecting the hose from the injection pump to the nipples, [28].

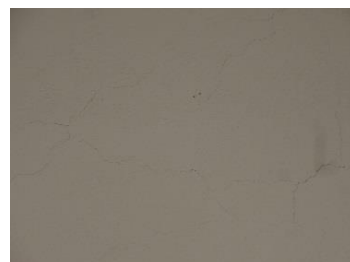
j) F07-S11

**Slabs**                      drying shrinkage                      fine cracks

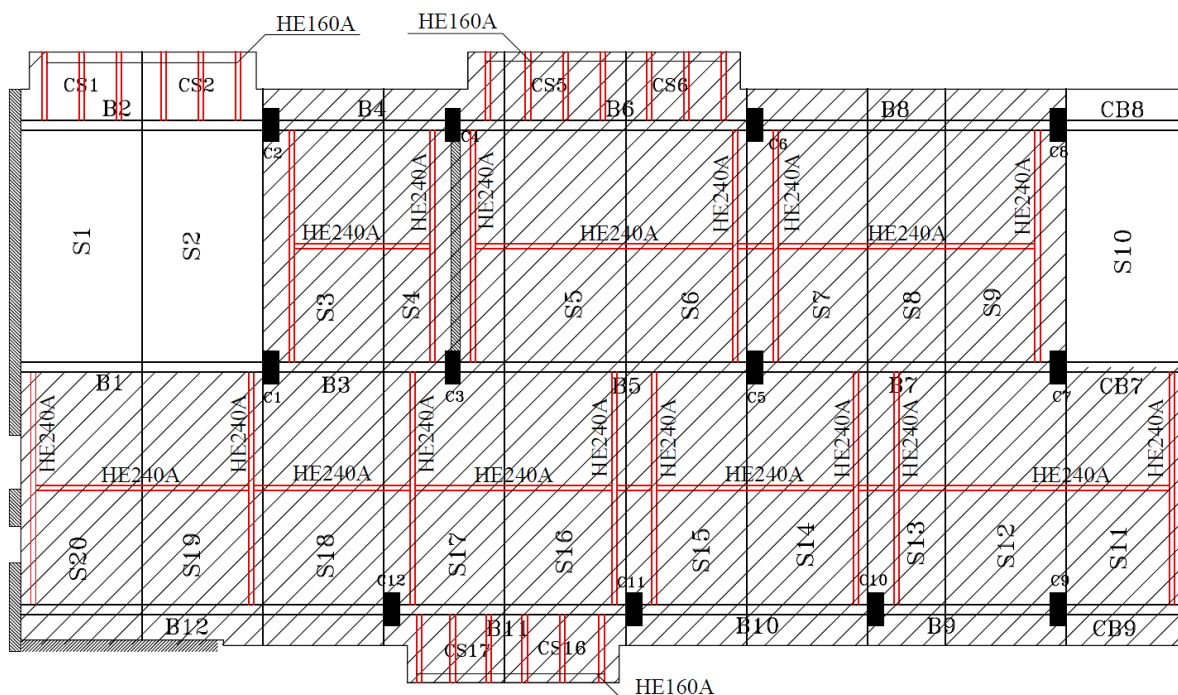
Figure 8. A layout of supported slabs for a single apartment

The field tests presented in Table 2 indicated that the measured deflections for 82% of the slabs in the building exceeded the deflection limit specified in SBC304-18/ACI 318-14 [5, 17] for the existing slabs. This is in conformity with the analytical test results obtained using SAFE and ETABS softwares. The main reason for the excessive deflection was an error in estimating the thickness of the designed slabs. A thickness of 160 mm for the existing slabs was not sufficient to control the increase in long term deflections due to sustained loads, during the service life of the structure.

The slabs whose measured deflections exceeded the deflection limit specified in the ACI/SBC codes, were strengthened by installing I-section steel beams of size HE240A on the tension side at the middle of the span as shown in Figures 8 and 9. Moreover, the deflections of the cantilever slabs were reduced by installing I-section steel beams of size HE1600A on the tension side at equal distances as shown in the same figures.
