Evaluation and Restoration of Corrosion-Damaged Post-Tensioned Concrete Structures

The adopted case study herein examines a two-story building due to notable signs of structural deterioration. The building has provided over 24 years of service, comprising halls and offices across its ground and first floors. Recent inspections have revealed concerning signs of delamination and spalling observed on the roof slab soffits. These conditions suggest a probable degradation of the structure's PT tendons, evidenced by the exposure and corrosion of the tendons, alongside cracking. Such deterioration is frequently attributed to the critical issue of reinforcement corrosion. The implications of this case study are significant, highlighting the structural challenges aging structures face in corrosive environments. The findings underscore the importance of practical maintenance and the strategic implementation of repair methodologies to ensure the ongoing safety and functionality of the building users. This study used multiple techniques for nondestructive and semi-destructive tests. For decades, those techniques have shown effectiveness and reliability in assessing concrete structures' durabi

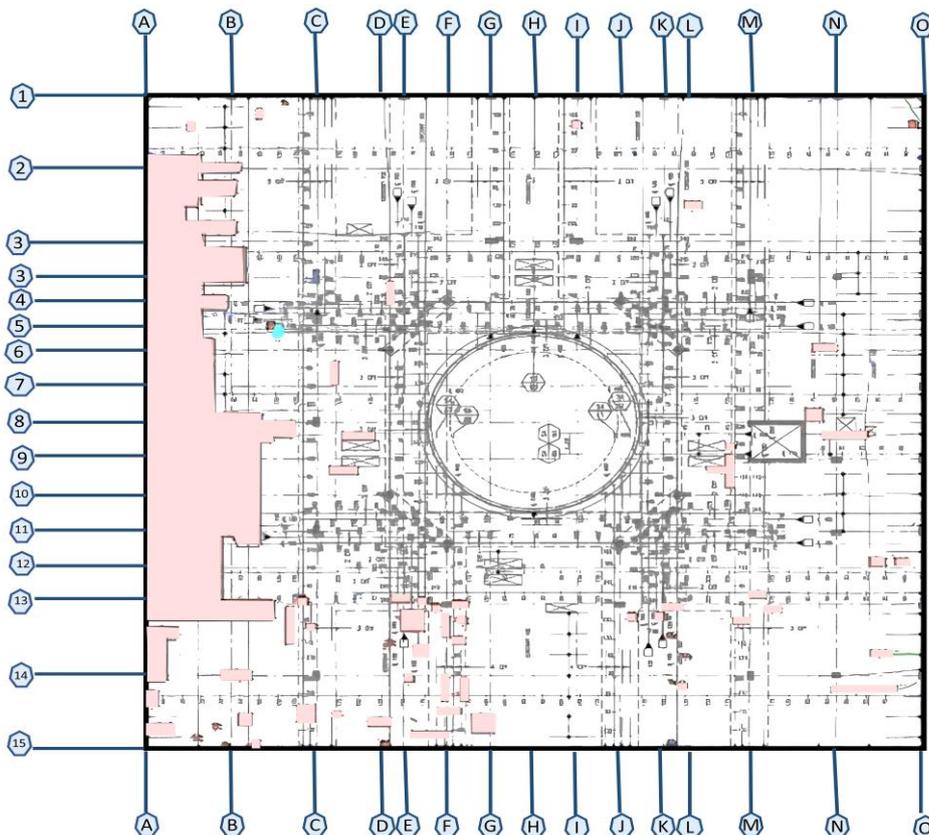
Figure 2. Condition survey of roof slab soffit (Red areas show the affected slab areas)

Based on the visual inspection, it has been noticed that the soffit of the roof slab has spalling, delamination of concrete, exposed corroded PT ducts, and broken PT strands due to corrosion (Figures 3 and 4). During the acoustic survey, hammer tapping in several locations identified Roof slabs as hollow sounds. Dampness and leakage stains were observed in the soffit slab at most of the area (Figure 5). On the other hand, the first-floor slab was in good condition. The locations identified for the testing program were based on the visual inspection findings.

- Roof soffit slabs exhibited widespread delamination, especially from grid locations A-O/11-17, where spalling and delamination were concentrated.
- Significant moisture penetration and water staining were detected across numerous sections of the roof soffit slab.

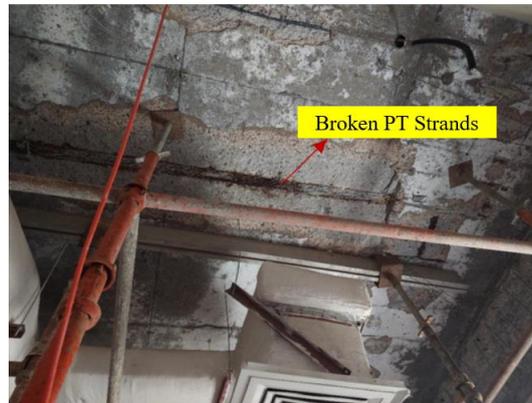
Figure 3. Exposed and corroded broken PT strands at roof slab soffit

- At gridline A-B/5-8, several instances of PT strand exposure and breakage were identified within the roof soffit slab.
- Ground floor columns at gridline A/2 showed concrete delamination and cracking, attributable to rebar corrosion.

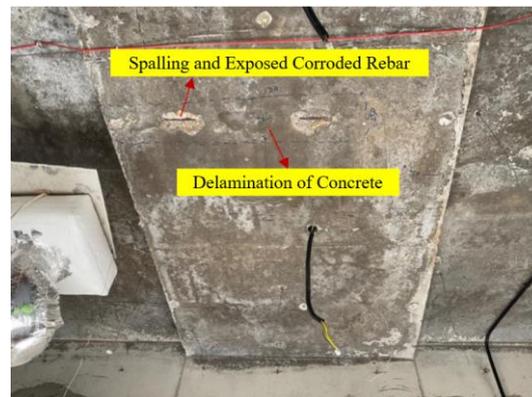
Figure 4. Delamination and spalling of exposed corroded rebar in the roof beam

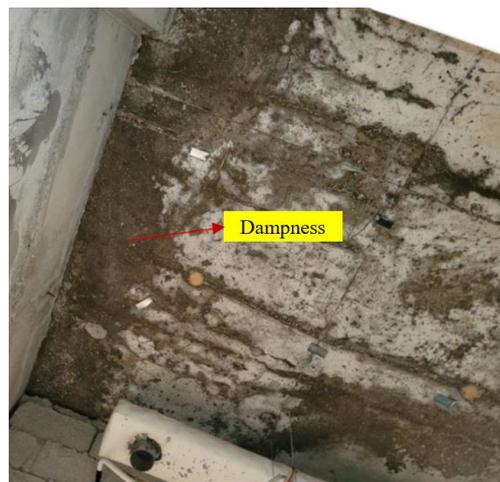
Figure 5. Leakage stain and dampness in the roof beam

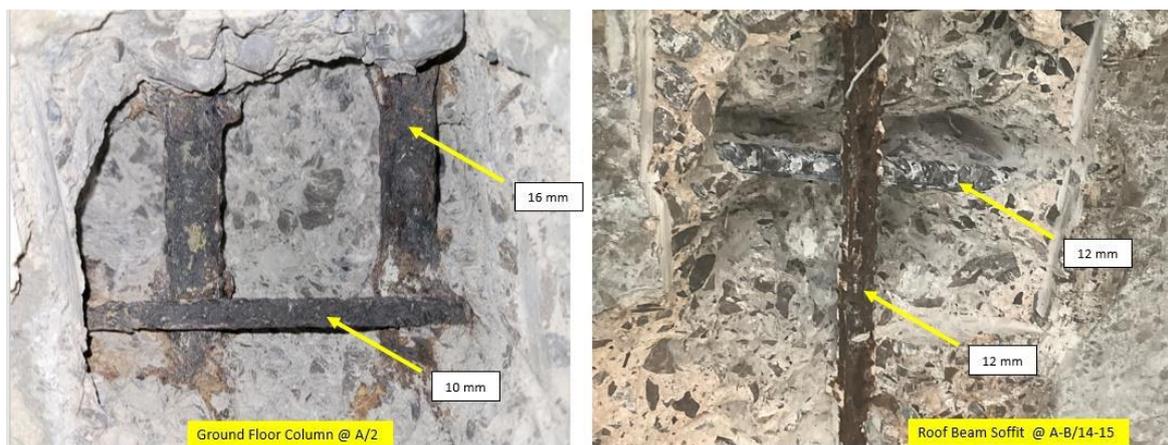
Figure 7. Typical breakout window at column and roof beam soffit

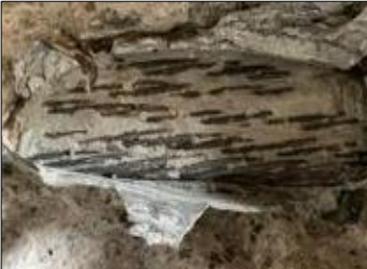
Sl. No.	Grid Ref.	Opened by:	Duct Condition	General Strand Condition	Detailed Strand Condition and Notes	Photograph
1	Grid: B-C/5-4 First floor Slab	Drill	Good	Clean	1. Duct Top surface corroded

Chip	Poor	Light Rust	2. Mild rust present in strand	
		Spall	Corroded	Medium Rust	3. Grout in good condition	
		Broken	Severe Rust	4. Chloride content below the threshold		
		Non-grouted	Broken Strand			
		Water Inside				
2	Grid: A-B/14-15 Roof Slab Soffit	Drill	Good	Clean	1. Duct Top surface fully corroded

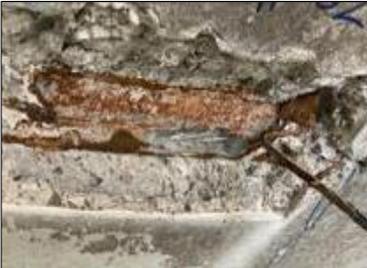
Chip	Poor	Light Rust	2. Strand in good condition	
		Spall	Corroded	Medium Rust	3. Grout in good condition	
		Broken	Severe Rust	4. Chloride content below the threshold		
		Non-grouted	Broken Strand			
		Water Inside				
3	Grid: O-N/12-13 Roof Slab Soffit	Drill	Good	Clean	1. Duct Top surface corroded

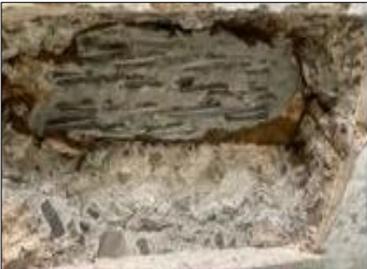
Chip	Poor	Light Rust	2. Strands in good condition	
		Spall	Corroded	Medium Rust	3. Delaminated concrete up to 20 mm

Broken	Severe Rust	4. Chloride content below the threshold		
		Non-grouted	Broken Strand			
		Water Inside

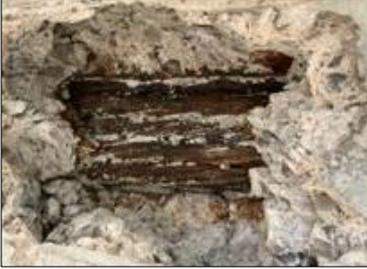
4	Grid: A-B/1-2 Roof Slab Soffit	Drill	Good	Clean	1. Duct were corroded and broken

Chip	Poor	Light Rust	2. Strands were broken due to corrosion	
		Spall	Corroded	Medium Rust	3. Delaminated concrete up to 70 mm	
			Broken	Severe Rust	4. Grout were damaged	
			Non-grouted	Broken Strand	5. Grout sample taken 1.5 m away from damaged PT	
			Water Inside		6. Grout sample chloride content below the threshold
