Rehabilitation of Partially Corrosion-Damaged Post-Tensioned Concrete Structures Using Carbon Fiber Reinforced Polymer

Hadif Alsuwaidi ¹, Ahed Habib ^{2*}, Zaid A. Al-Sadoon ¹, Mohamed Maalej ¹,
Salah Altoubat ¹, Samer Barakat ¹, M. Talha Junaid ¹

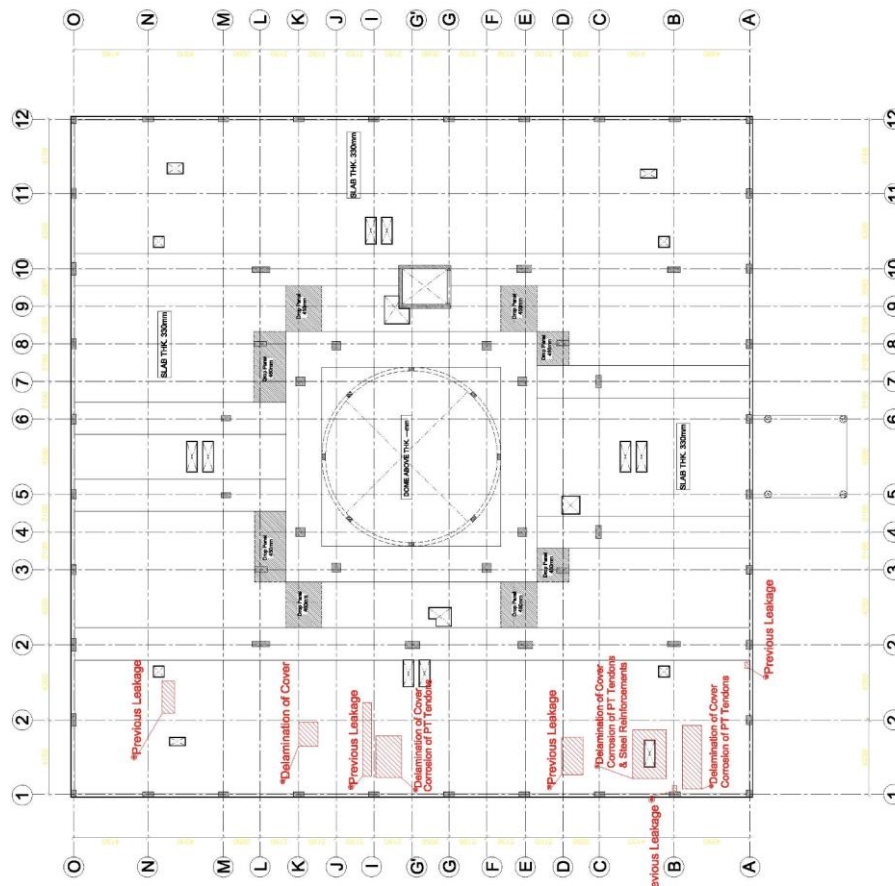
Figure 7. Condition survey of roof slab soffit (red areas show the affected slab areas)

The structural damage was widespread, with the roof slab soffit experiencing the most severe deterioration. Observations showed that 25% of the inspected roof slab soffit areas exhibited delamination or spalling, as illustrated in Figure 7. Additionally, all PT ducts and strands in this region displayed visible signs of corrosion. In contrast, the ground, first, and second-floor slabs remained relatively good. Several factors contributed to this pattern of damage. The roof slab, more exposed to environmental conditions, suffered more significant deterioration than interior structural elements. Failures in the waterproofing system facilitated water infiltration, accelerating slab degradation. Concrete quality also played an important role, as compressive strength tests indicated that none of the samples met the design strength of 30 MPa.

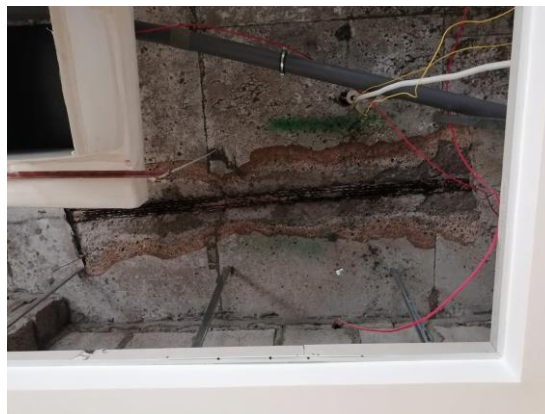
The visual inspection identified spalling and delamination of the roof slab soffit, exposed and corroded PT ducts, and broken PT strands (Figures 8 and 9). Additionally, multiple locations showed signs of past roof leakage, parapet openings, and damaged expansion joints (Figures 10 to 12). In contrast, the first-floor slab was found to be in good condition. The findings from the visual assessment guided the selection of locations for testing.

Figure 8. Exposed and corroded PT strands at roof slab soffit

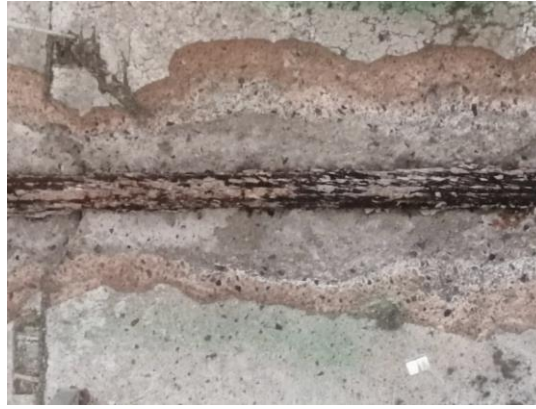
Figure 9. Delamination and spalling of exposed corroded rebar in the roof beam

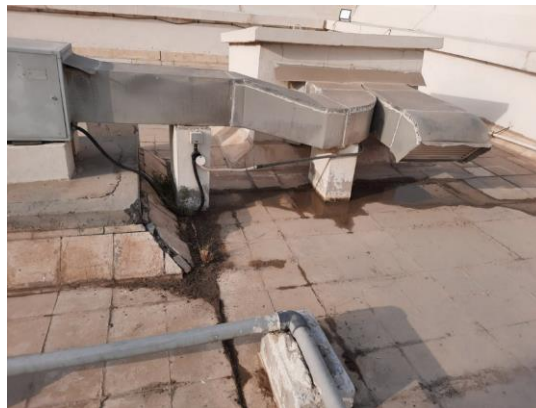
Figure 10. Leakage in the roof slab

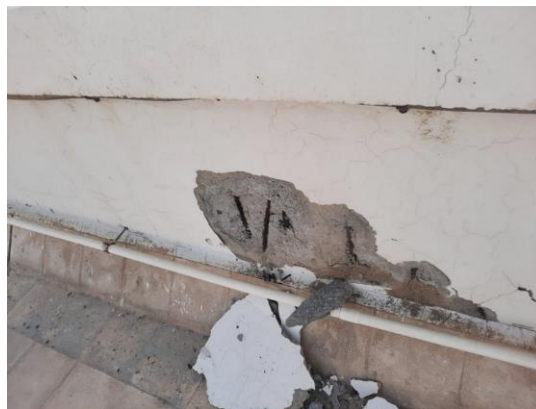
Figure 11. Delamination/spalling of the concrete in the parapet

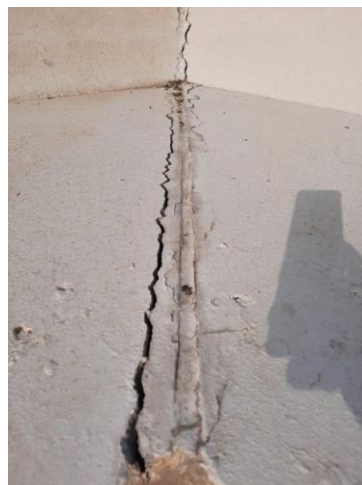
Figure 12. Damaged expansion joint

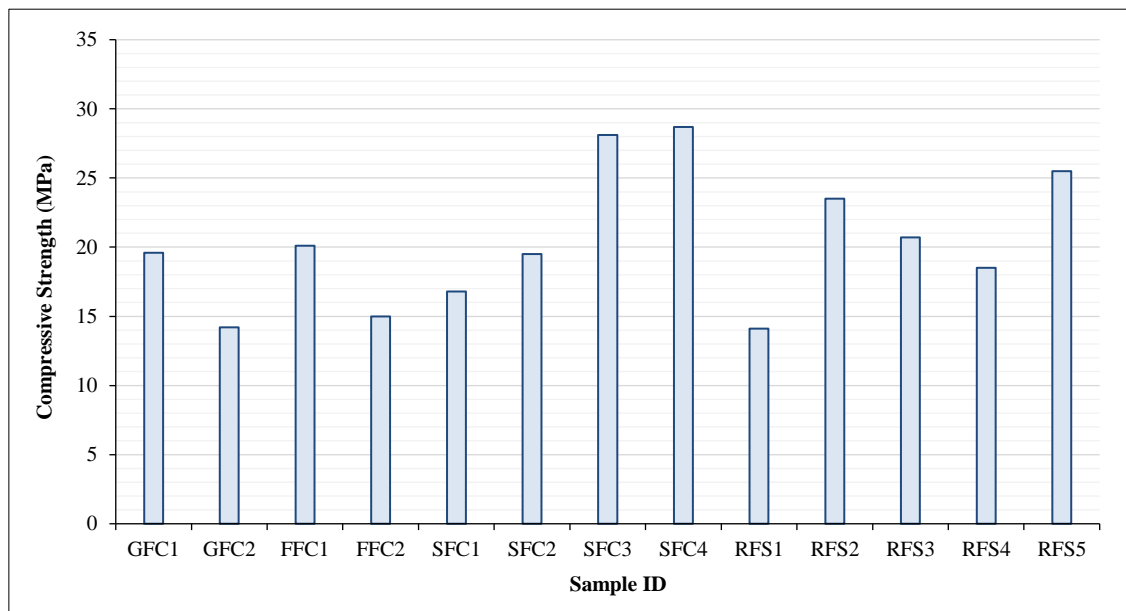
The majority of the cores exhibited medium grading with well-distributed aggregate composition. Test results, illustrated in Figure 19, show that the bulk density of the concrete cores before testing ranged from 2110 to 2230 kg/m³, with an average of 2163 kg/m³. The estimated in-situ cube strength varied between 14.1 and 28.7 N/mm², with an average strength of 20 N/mm².

Figure 19. Summary of cube compressive strength of all elements

The measured values ranged between 14.1 and 28.7 N/mm², with an average of 20 N/mm². This lower compressive strength likely increased permeability and reduced protection against corrosion. These findings highlight the necessity of repair strategies that address visible structural damage and restore concrete's structural capacity and protective properties to prevent further deterioration.
