## Classification of Precast Concrete Segments Damages during Production and Transportation in Mechanized Shield Tunnels of Iran

### Abstract

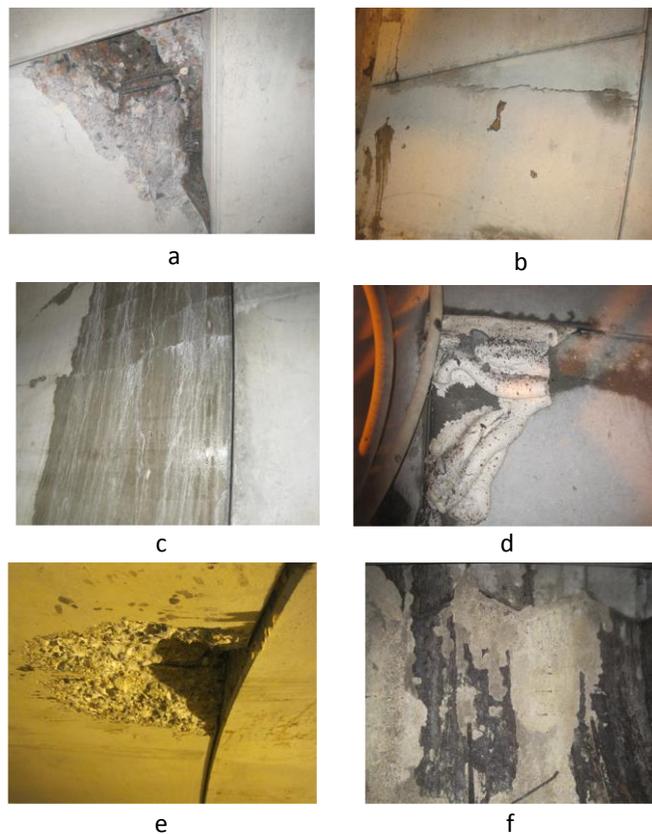
accordingly. Figure 5. displays damages at the time of tunnel excavation and Figure (6) shows chipping of concrete segments in production plant and tunnel of Golab water conveyance tunnel.

Figure 5. Damages of segments in tunnel, a: chipping (line 7 of Tehran subway), b: crack (line 2 of Mashad subway), c: crack and flow of water into tunnel (line 7 of Tehran subway), d: damage at gasket grooves (line 1 of Tabriz subway), d: damage at dowel insertion hole (line 1 of Tabriz subway), f: corrosion of reinforcement and concrete (Nosood water conveyance tunnel)

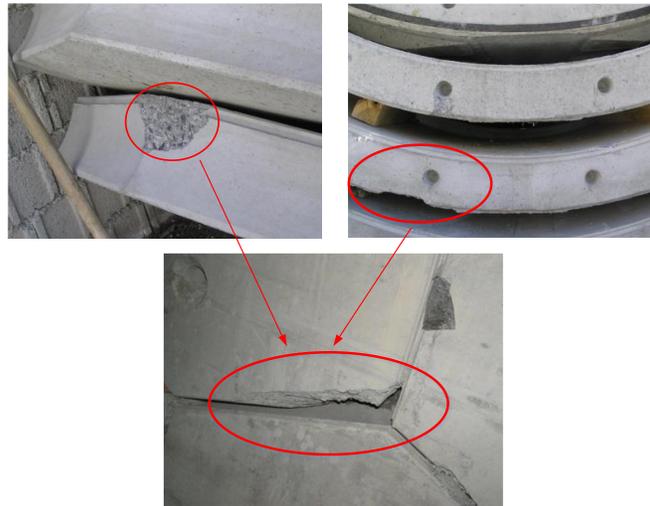
Figure 6. Chipping of concrete segments in Golab's segment production plant and tunnel

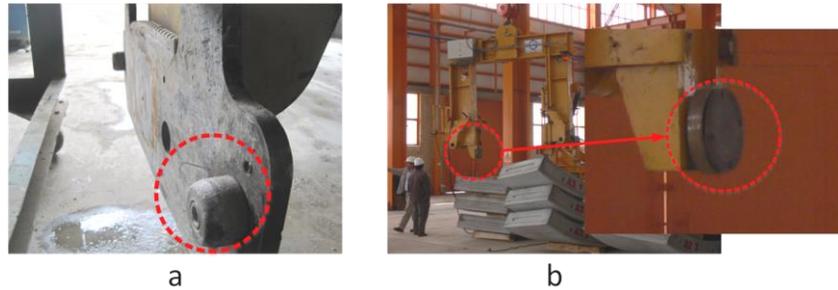
Concrete segment's chippings in zones 7, 8 and 10 are developed due to improper lifters and inadequate resistance of the segments while demolding, as well. Lifters used in segment factory of line 3 of Tehran subway, bear some protrusions that intrude into dowel holes at the time of demolding products. In case, the segments are not strong enough around the holes, chippings within the area should be expected. To prevent such harms due to above-mentioned shortcomings, frictional or vacuum lifters, like those utilized in line 1 of Tabriz subway must be used. Also, the initial resistance of the concrete in segments must be promoted. Figures 10-a and 10-b depict lifter used in segment factory of line 3 of Tehran subway and frictional lifter employed for line 1 of Tabriz subway, respectively.

Figure 10. Lifters used in: a: line 3 of Tehran subway b: line 1 of Tabriz subway
