Technical Analysis of Collapse in Tunnel Excavation and Suggestion of Preventing Appropriate Applicable Methods (Case Study: Sardasht Dam Second Diversion Tunnel)

Keywords: Sardasht Dam and Power Plant; Diversion Tunnel; Technical Analysis; Collapse; Support System.

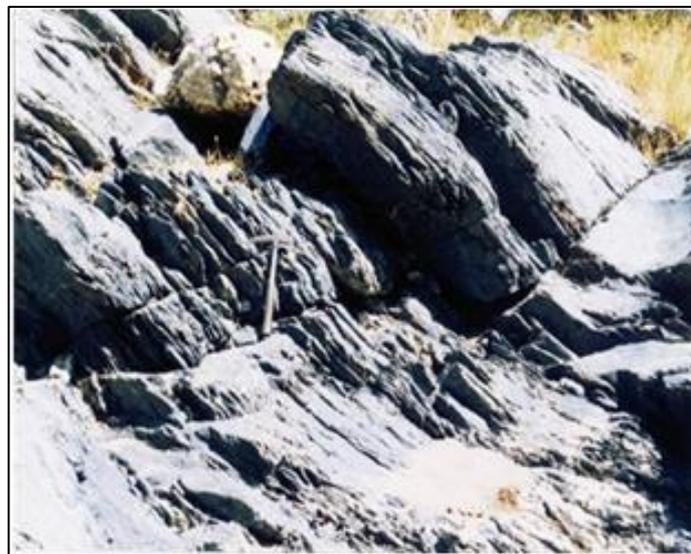
Sardasht Dam site is located among areas of a slate rock unit with inter-beds of sandstone which are metamorphosed. This area, which, in fact, is a salty belt (Figure 1), played an essential role in morphological evolution of the studied area along with major and minor faults. Regarding that almost same geological and stratigraphically conditions dominate all over the area of dam site and water conveyance tunnel to hydropower plant, same geomorphological elements are taken into account for the areas as well. However, proportion of these elements in various parts of the site shows some differences [11]. According to elevation map of Iran, the mountainous region of the studied area mainly consists of lands with elevations of 500- 2000m and areas with elevations more than 2000-3000 m are very rare. These high-rise areas are compatible with lands located in the left side of Kelas River. These areas are complied with western and southern mountains of Iran and Zagros and Makraan are considered as subdivisions of this classification [12].

**Figure 1. Slates rock mass and discontinuities [12]**

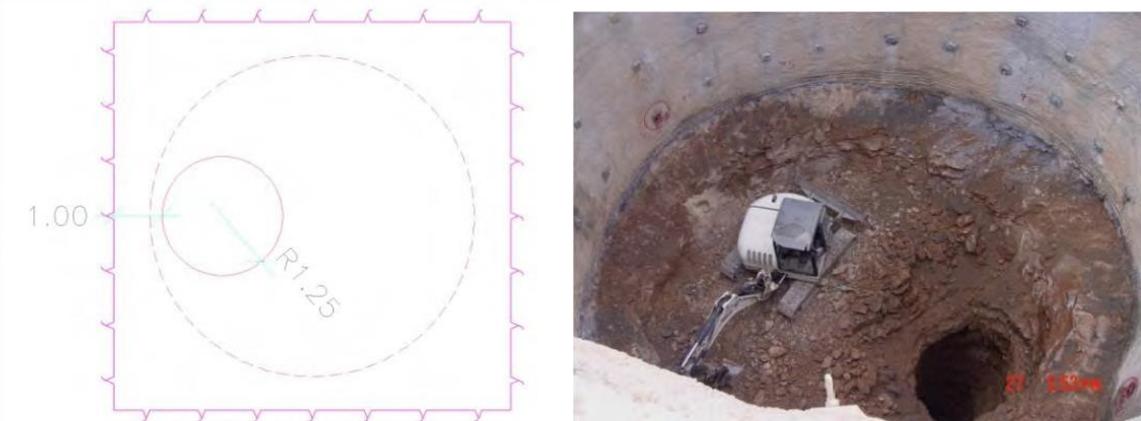
Based on what was said, first a Pilot according to Figure 4. drilled by drilling and blasting from top to the bottom. The pilot diameter is largely influenced by the main shaft diameter and pilot run method (especially the type of equipment used).

Figure 4. An illustration of the drilling depth of the drain shaft and its pilot position [14]

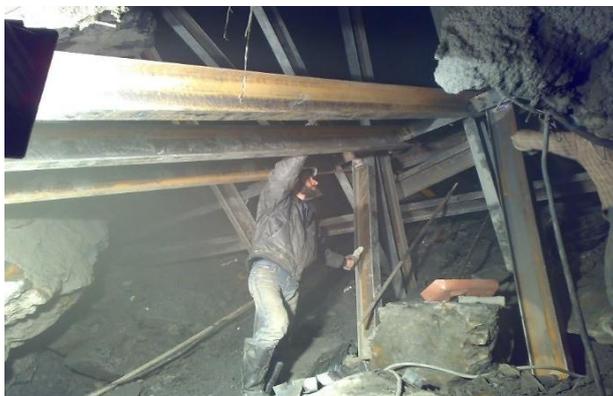
To pass through the collapsed zone, first, steel frames (rolled 18 girder) were installed and the cavity was filled with concrete, pumice and shotcrete aiming to make a safe ceiling. Due to presence of flowing water at the place of collapse, cohesion of applied shotcrete with rock surface was not significant and practically had no positive effect.

As second step, installation of beam and steel frame and filling of the cavities by pumice, concrete and shotcrete was taken into account. In spite of implementing this procedure, it was not successful in stopping the collapse and allowing passing the collapse zone, because of extension of collapse zone and occurring successive collapses from the tunnel ceiling.

Figure 5. Steel set installation for collapse prevention in occurred void [15]

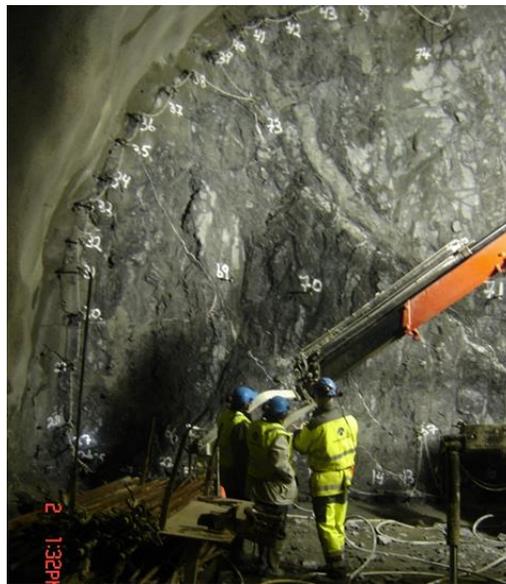
Figure 6. Steel set installation for collapse prevention in occurred void [15]

Regarding the observations during excavation operations, one may conclude that main origin of fallings and instabilities is the tunnel ceiling and fallings are going on there. Consequently, construction of a retaining ceiling at the collapsed zone is proposed as a solution for preventing materials of tunnel ceiling from falling. This retaining ceiling will be constructed by rock bolts, as well as grouting around working face of the tunnel. This technique is also used to make a grout curtain against percolated water into the tunnel area by a special procedure. Figure 3. shows a view of carrying out of this technique at a tunnel project:

To make a safe and strong shield on the ceiling, as mentioned before, first a shotcrete layer of, at least, 7cm thickness is applied on working face to stabilize surface falling blocks. Then bolt holes may be drilled in 30cm distance from each other and 4m long rock bolts of 25 or 28mm diameter will be used, as shown in Figure 6.

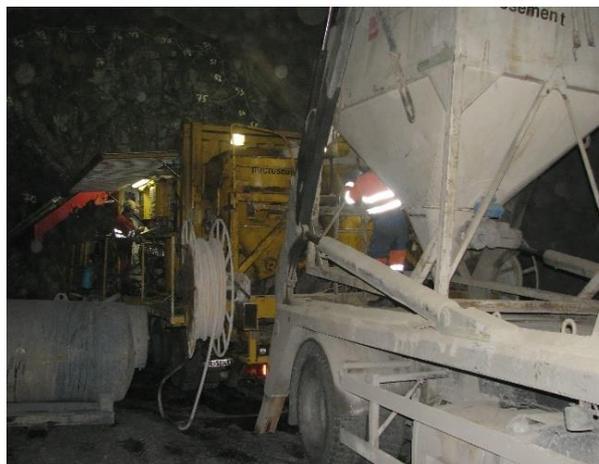
Figure 7. Steel set installation for collapse prevention in occurred void [15]

Considering the presence of water flowing in the rock surrounding the tunnel at the collapsed zone, in addition to installation of bolts which make a protective ceiling shield at collapsed zone, by grouting of peripheral holes, the developed shield will act as a water-tight curtain, as well. Figures 7 and 8. illustrate grouting system of holes around working face in a similar tunnel project.

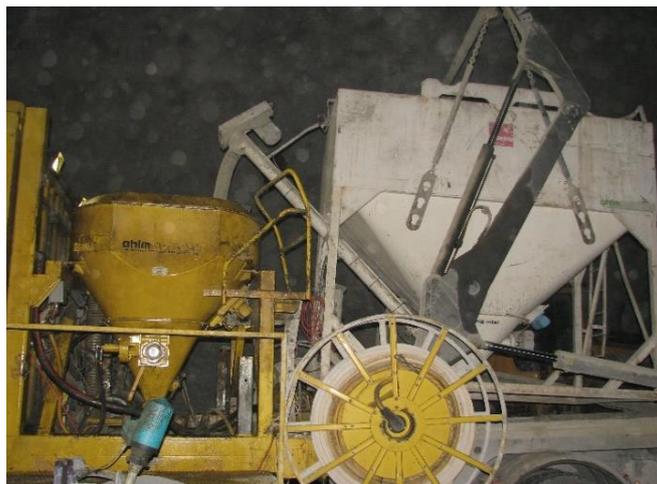
**Figure 8. Stope Peripheral boreholes grouting system to create sealing crown in tunnel [15]**
