Effect of Soil Types on the Development of Water Levels and Erosion Processes during Overtopping Test

Keywords: Dike; Horizontal Erosion Process; Vertical Erosion Process; Overtopping Failure; Spatial Breach Test.

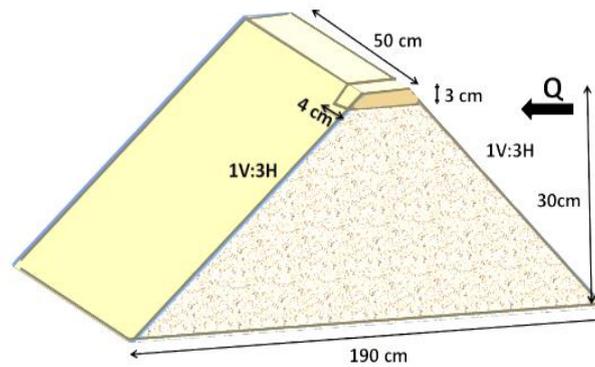
Figure 1. Geometry of dike construction with pilot channel location (shaded area)

A pilot channel was cut in the dike crest in order to initiate breach channel failure before the beginning of overtopping tests with dimensions of 3 cm depth and 4 cm wide. The construction of pilot channel was carried out along the side wall of PVC whereas the wall represents the center of initial breach channel. This is important for pure observations the evolutions of water levels and erosion processes. All other parameters are not changed during overtopping tests with identical upstream and downstream slopes of 1V:3H for both soils. A constant inflow discharge of $Q=30\text{L/min}$ is used to supply a reservoir water level in front of the upstream slope through using Flowmeter. The two digital cameras are used to record the water levels and erosion processes during the transition of water level from upstream into downstream slope through pilot channel. Tables 1 and 2 show the basic soil properties for coarse sand and very silty sand soil, respectively. In this study, the terms E4 and E6 refer to the experimental tests for coarse sand and very silty sand soils, respectively. The measurements of horizontal and vertical water levels, in seconds, are started from the toe of the upstream slope and ends at the beginning of dike crest while the measurements of erosion processes, in cm, in vertical and horizontal directions began from the water flow cross the pilot channel and ends when the erosion processes in the upstream slope are finished or the materials eroded stabilized.

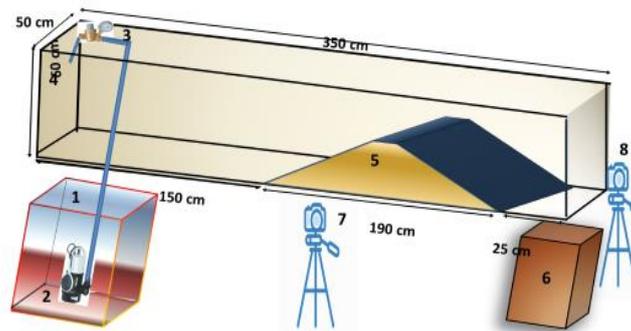
Figure 2. Component parts of flume channel: 1) Water tank, 2) Discharge pump, 3) Flowmeter, 4) Flume channel, 5) Dike construction, 6) Sediment tank, 7, 8) Camera

Total of two spatial overtopping tests was constructed in Hydraulic Geotechnical laboratories at the Universiti Sains of Malaysia to determine the evolution of both vertical and horizontal erosion processes during overtopping failure as well as the distribution of water levels inside dike. The flume channel is constructed from PVC materials with dimensions of dimensions of 450, 50, and 60 cm for length, width, and height, respectively. One digital camera is installed in front of flume channel to observe the vertical erosion process as well as the vertical and horizontal water distributions while the second one installed in front of the downstream slope to observe the horizontal erosion process inside dike embankment as shown in Figure 1. The video images, captured through digital cameras, are analyzed using GETDATA software while the figures are drawn using Origin 8 software. A maximum water pump of ($Q=70\text{l/min}$) is used to supply water inside flume channel with constant inflow discharge. Inflow discharges of 30L/min are used during the tests. A sediment box was installed at the end of flume channel to collect the eroded materials along the bed of flume channel. The dike embankments were homogeneous with dimensions of 190 and 160 cm length for coarse sand and very silty sand soils, respectively, 50 cm width, and 30 cm crest height. The sandy soil is classified as coarse sand (SP) while the other soil is classified as very silty sand (SML). Both of two the soil are oven-dry in 105°C for 24 hours to construct the dike embankment in dry condition inside flume channel. The dike was compacted every 10 cm until the height of 30 cm in the dike crest in order to conduct the dry density of 1.8 g/cm^3 for an accuracy comparisons. A pilot channel of 10cm length, 4cm width, and 3 cm depth was cut at dike crest along the side wall of PVC channel to initiate breach channel as shown in Figure 2.

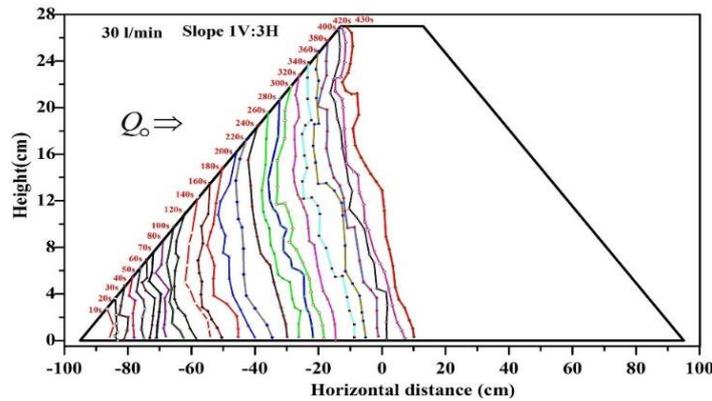
Figure 3. Water flow infiltration inside dike for E4

Figures 3 and 4 show the infiltration of water level inside dike for E4 and E6, respectively under constant inflow of $Q = 30\text{ l/min}$. The Y-axis represents the dike height while the X-axis represents the horizontal distance of dike length. One digital camera in front of the upstream slope is used to record the distribution of vertical and horizontal water levels in seconds. For both two soils, the level of infiltration water is increased gradually from the toe of upstream slope until the dike crest. It decreased the matric suction and increased volumetric water content inside particles and thus increases the easiest infiltration process. The vertical soil water pressure helps to migrate water levels from lower tension area into higher tension area in which the connection bonds, between air pressure and water pressure, within particles, are broken and gradually increases the permeability of water flow for the two soils. The rate of infiltration water is depended mainly on soils in which the presence of fine particles effects on the saturation process inside soil particles. The fine particles in E6 tend to reduce the velocity of water level higher than that in E4 in which the water saturation process is occurred faster in the toe, middle and near the crest of upstream slope for sandy soil. The water levels reached the middle of upstream slope at $t = 200$ and 350 seconds and at $t = 420$ and 630 seconds in dike crest for E4 and E6, respectively.

Majority of upstream slope's area is saturated during the transient of water level for both soils. The measurement of water levels is ended near dike crest while the initiation of breach channel failure starts to occur inside the pilot channel.

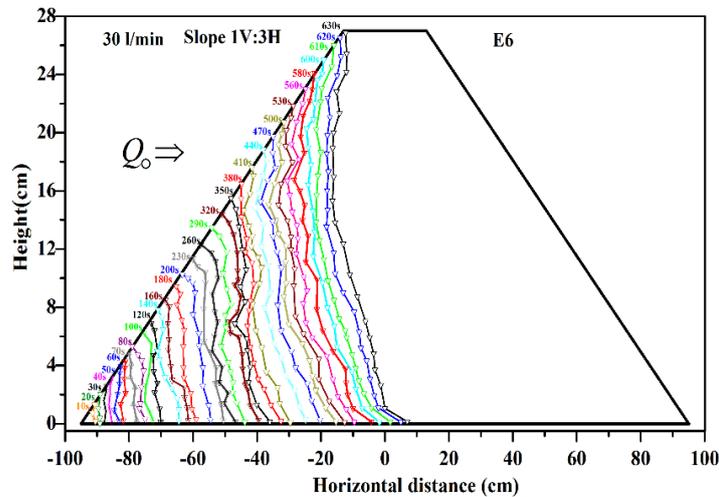
Figure 4. Water flow infiltration inside dike for E6

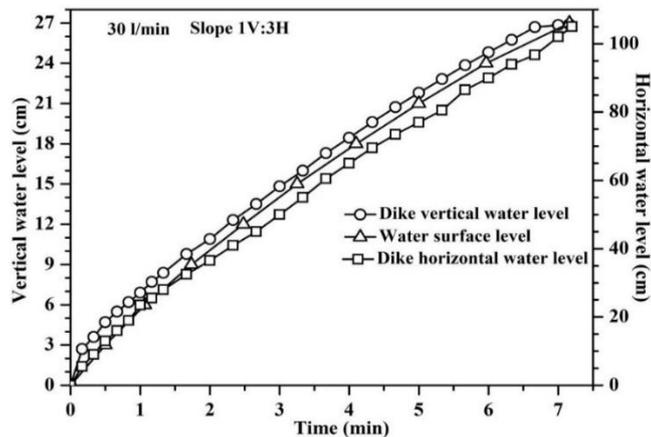
Figure 5. Distributions of vertical and horizontal water levels for E4

Figures 5 and 6 show the distribution of vertical and horizontal water inside dike embankment for E4 and E6, respectively. The values of vertical water levels are measured from the toe till the crest of the upstream slope while the horizontal water levels is measured along the horizontal distances of dike length. The differences between values of horizontal and vertical water levels at the beginning of infiltration process is convergent for both soils. For both soils, the horizontal water levels is penetrated faster inside particles compared with vertical one. This is due to the effects of soil gravity that reduce the rise of vertical water level in which the infiltration water saturated the soil particles in the horizontal distance of dike length before the elevation of water level into dike crest. The influence of gravity forces is negligible in the horizontal direction and thus the velocity of water increases. Yet, the distribution velocity of vertical water levels for both soils are reduced gradually near the dike crest. For E4, the vertical water level is 26.85 at $t = 7$ minutes, respectively while for E6, the vertical water levels is 26.8 cm at $t = 10.5$ minutes, respectively.

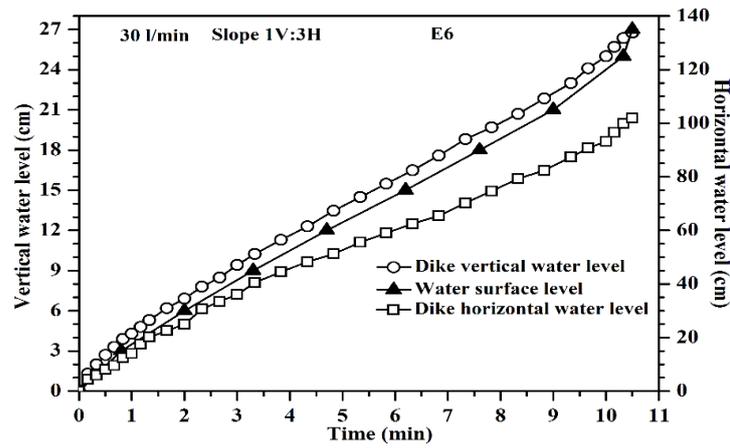
Figure 6. Distributions of vertical and horizontal water levels for E6

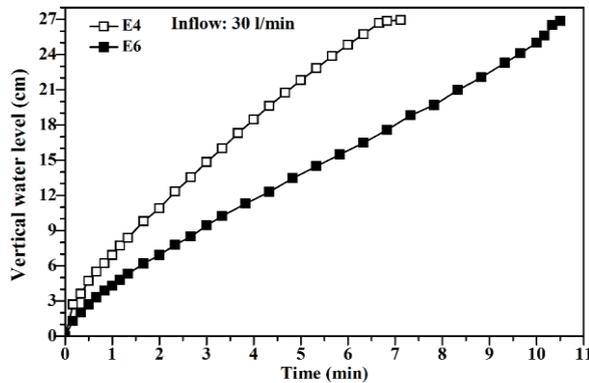
Figure 7. Comparisons between vertical water levels for E4 and E6

Figures 7 and 8 show the comparison of vertical and horizontal water levels for E4 and E6, respectively. The distribution of vertical water levels for both soils are nearly identical at $t = 0.33$ minutes with levels of 3.6 and 2.01 cm for E4 and E6, respectively. This is due to the beginning of saturation processes near the toe of upstream slope in which the soil particles are filled with a high percentage of air flow and not yet attached to the high percentage of water content. At later minutes, the vertical water level for E4 is faster than that in E6 due to the presence of fine particles (silt and clay), in which the differences between vertical water levels are increased further at $t = 5.3$ minutes with levels of 22.82 and 14.39 cm for E4 and E6, respectively. The fine particles are absorbed a huge amount of water content due to its electronic inter-particles connections within soil particles. The permeability of E6 is lower compared with E4 and the resistance for the flow of water infiltration is higher for previous soil. Similar to the distribution of vertical water levels, the penetration of horizontal water levels is difficult in the beginning of saturation process. The velocity of horizontal water level is increased significantly at later minutes for E4. The water-filled pores has blocked the path of air flow during the infiltration of water level, due to high porosity of E4, and leads to easy the penetration of water. Measurement of horizontal water levels for E6 has lasted until $t = 10.5$ with levels of 100 cm. The molecule of water is strongly attached to the surface of fine particles in E6; consequently, the channels inside the particles for the transportation of water flow will become narrow.

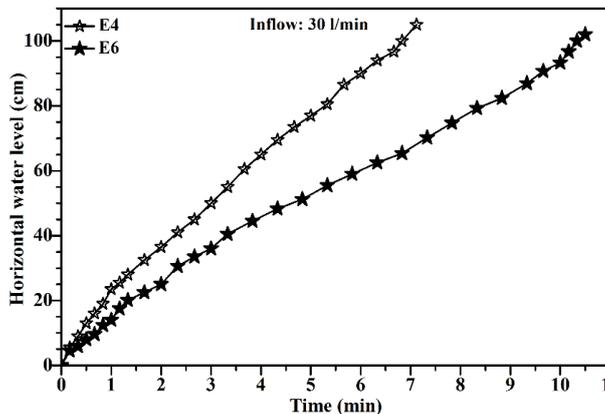
Figure 8. Comparisons between horizontal water levels for E4 and E6

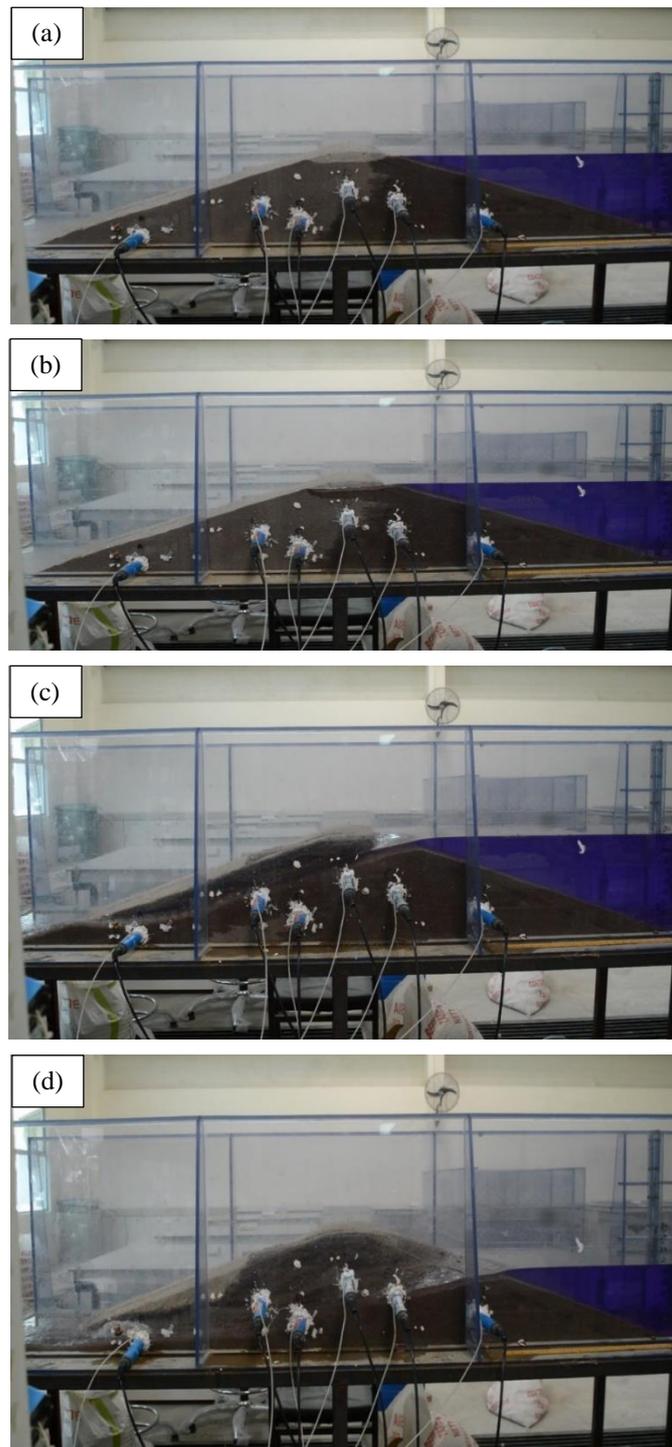
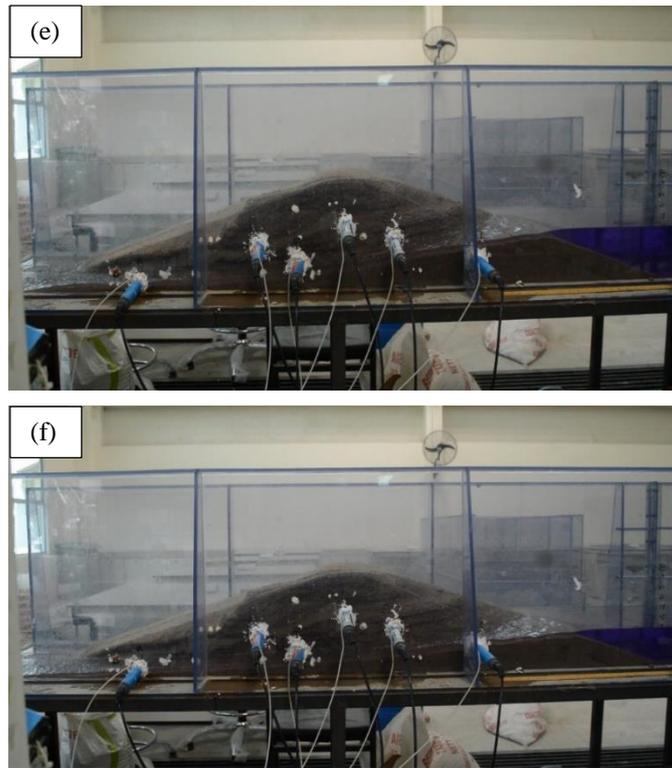
Figure 9. The development of vertical erosion process due to overtopping failure: (a) Zero seconds; (b) 10 seconds; (c) 50 seconds; (d) 100 seconds; (e) 140 seconds and (f) 190 seconds

Figure 9 shows the widening of vertical erosion process in dike embankment during overtopping failure at different times in seconds from the initiation of breach channel failure at $t = 0$ seconds in dike crest until the end of erosion process at $t = 190$ seconds. As mentioned previously, the observations of vertical erosion processes are occurred by one digital camera in front of dike embankment. Figures 10 and 11 show the vertical erosion process inside dike embankment for E4 and E6, respectively. The dashed line represents the paths of vertical erosion process during the development of breach channel. The vertical erosion process is initiated through crossing flow water inside pilot channel at $t = 0$ seconds. At $t = 10$ seconds, the vertical erosion processes for both soils is small due to high materials quantity in the dike crest, and the lack of water content percentage in the downstream slope. The development of breach channel in the downstream slope is occurred at latter minutes due to the increase of water velocity and turbulence. At $t = 120$ and 180 seconds, the majority of downstream slope materials are eroded for E4 and E6, respectively in which the breach channel failure is developed in the transition area between downstream and upstream slopes and area of the upstream slope. Soils with higher fine particles are helped to stick particles together and reduce the rate of infiltration water and time of erosion materials. The enlargement of vertical breach channel is slow down gradually and then stopped, due to the reduction of erosion velocity, while most of dike crest height is disappeared at $t = 190$ and 390 seconds for E4 and E6, respectively.

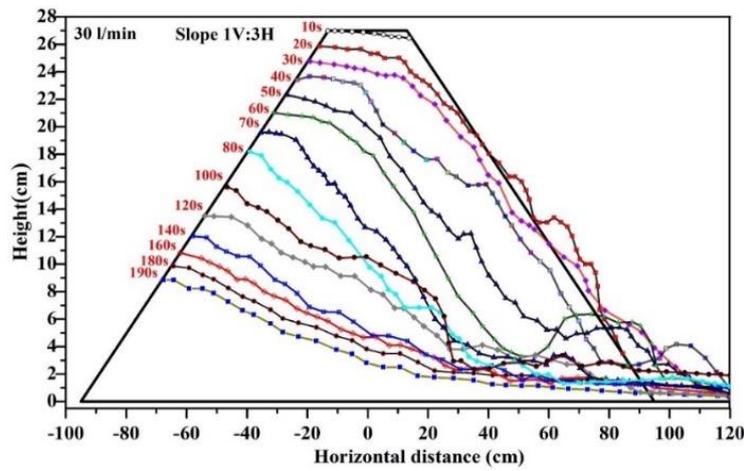
Figure 10. Dike breach profile for vertical erosion process of E4

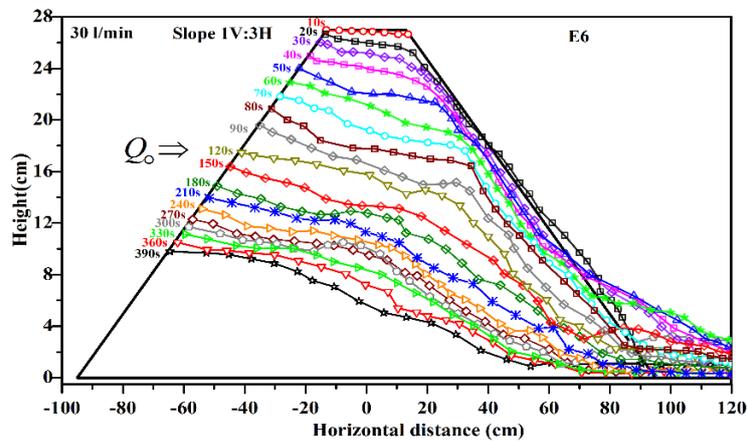
Figure 11. Dike breach profile for vertical erosion process of E6

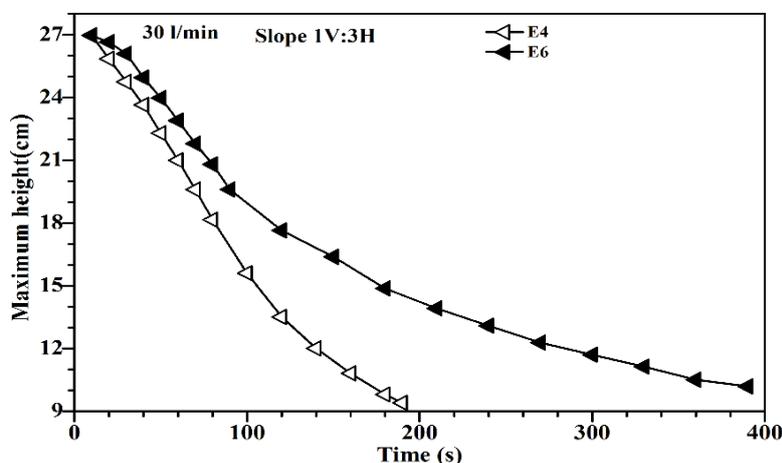
Figure 12. Comparison results of reduction dike heights inside the pilot channel

Figure 12 shows the comparison between the results of vertical erosion process for E4 and E6. The slight reduction of dike height is occurred at the beginning of breach failure initiation at $t = 20$ seconds with dike heights of 25.85 and 26.65 cm for E4 and E6, respectively. This is due to the higher matric suction in soil layers below dike crest while the velocity of infiltration water is still slow to overcome the shear strength of particles. The slope failure occurred near the dike crest in E4 while it occurred near the toe of downstream slope in E6. Increasing the water velocity above the downstream slope leads to lowering dike height into 18.16 and 20.8 cm for E4 and E6, respectively at $t = 80$ seconds. Soils with a high proportion of sands increase the materials erodibility while the rate of breach channel failure is tended to decrease with a high amount of fine sands in E6. The silt and clay particles absorb water content and thus decrease the availability of water volume to initiate gully erosion. For E6, The dike slope instability resulted in steepness slope in which the breach failure mechanism is developed into headcut failures. The latter failure imposed erosive forces on the toe of the downstream slope that increases the erodibility of dike materials along the flume channel. The noticeable failure of dike slope for E4 is observed in the upper part of the downstream slope and then developed gradually into the lower part. Steepness slope has occurred similar to that occurred in E6 in which the majority of the transition area between downstream and upstream slopes and area of the upstream slope are highly eroded. The majority of the upstream slope are eroded at $t = 160$ and 300 seconds with dikes height of 10.81 and 11.7 cm, respectively. The breach channel slope, for both soils, is becoming gentler during the progressive erosion process in upstream slope and gradually remained constant through the rest of breach failure in which the materials erodibility is no longer effect on dike construction. Comparisons between E4 and E6 show the differences between the rates of erosion process with particles. The very silty sand soil is more resistance against vertical erosion failure in which it lasted until $t = 390$ seconds.

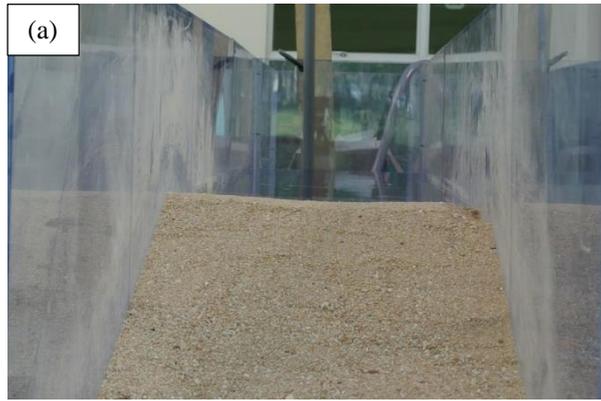
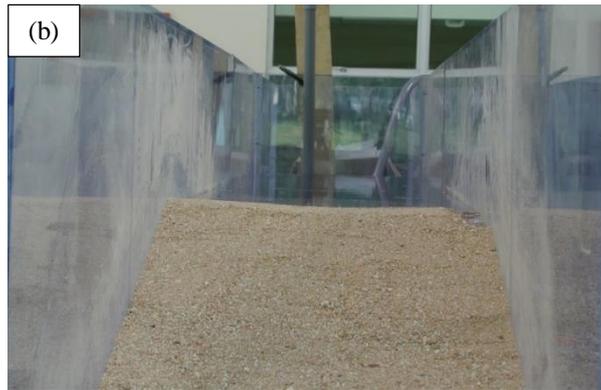
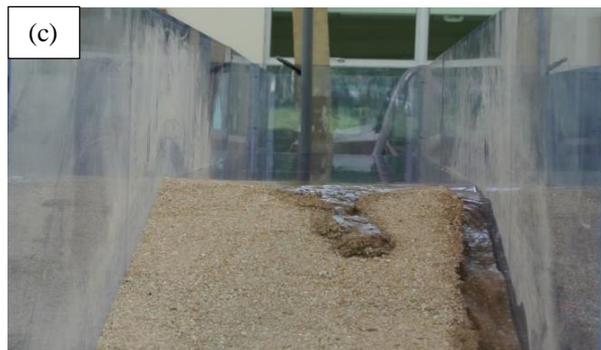
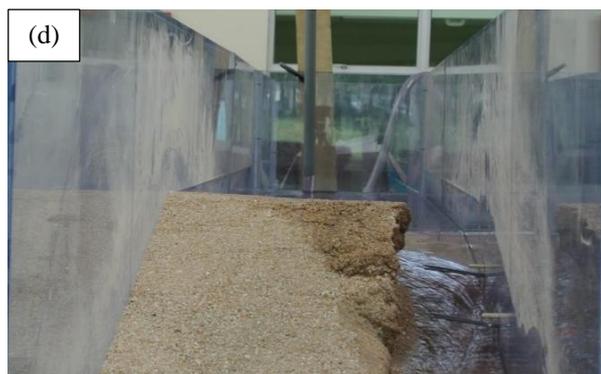
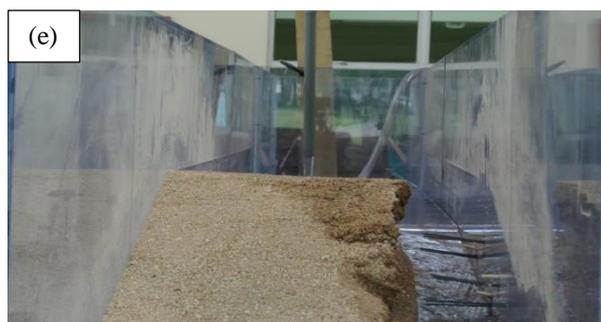
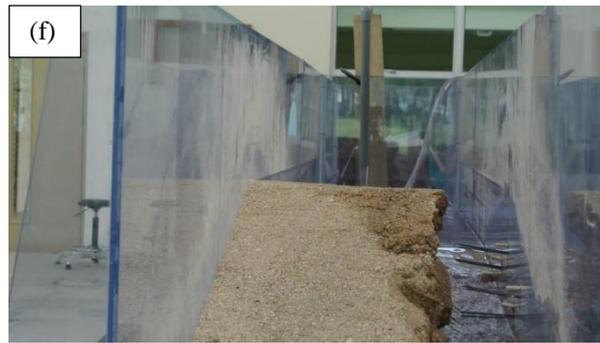
Figure 13. The development of horizontal erosion process due to overtopping failure: (a) Zero seconds; (b) 20 seconds; (c) 50 seconds; (d) 100 seconds; (e) 150 seconds and (f) 190 seconds

Figure 13 shows the development of horizontal erosion process due to overtopping failure that captured through camera-video system installed in front of downstream slope. Similar to vertical erosion process, the measurements for the horizontal erosion started from the flow cross the dike crest and ends until the erodibility process of dike materials is stabilized. Figures 14 and 15 show the horizontal erosion process for E4 and E6, respectively. The reduction of dike width is plotted against the horizontal distance of dike construction. The velocity of horizontal erosion is less compared with vertical erosion in the beginning of water cross above pilot channel until the toe of the downstream slope. For both soils, the beginning of noticeable reductions of dikes widths have occurred when the vertical erosion process started to erode the lower part of the downstream slope. This is due to the quick saturation of dike soil below dike crest that accelerates the vertical erosion process. The shear stress of flow water is increased in vertical erosion compared with horizontal erosion and increased the erodibility rate. The reduction of dikes width is small at $t = 10$ and 20 seconds for E4 and E6 due to higher suction with soil particles. The breach channel failure is started to develop laterally at $t = 30$ and 40 seconds for E4 and E6, respectively in which the top and toe sections are rapidly eroded compared with the middle of dike embankment. Nevertheless, the proportion of width reduction is higher in E4 compared with E6 because of higher water content absorption with particles in the latter. The vertical slope of breach channel is saturated in the horizontal direction and thus overcome the tensile stress of soil particles; consequently, large slope material is eroded along the bed of flume channel at $t = 50$ and 70 seconds for E4 and E6, respectively. The enlargement of breach channel is continued till the upstream slope due to the continuous saturation of vertical slopes on downstream, upstream slopes as well as the transition area between the downstream and upstream slopes at $t = 70$ and 120 seconds for E4 and E6, respectively. Most of the dikes widths are eroded at $t = 190$ and 390 seconds, for E4 and E6, respectively in which the horizontal and vertical erosion processes are no longer effect on dike stability.

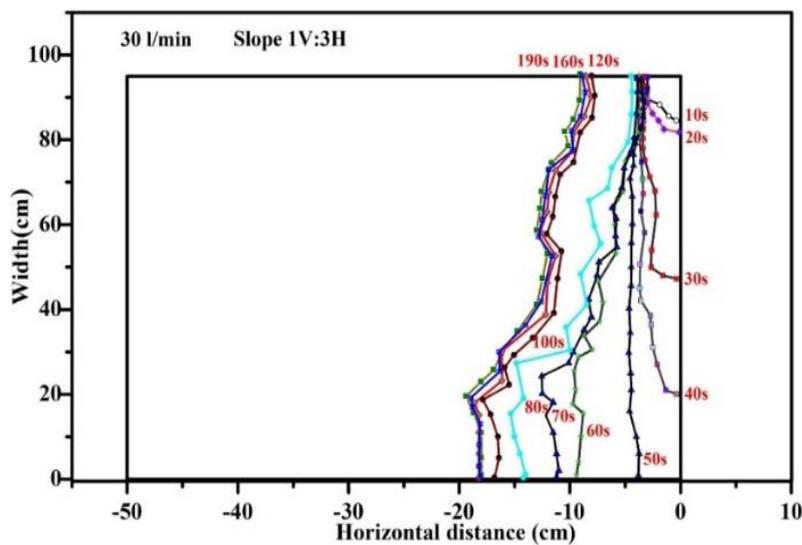
Figure 14. Reduction of dike width due to lateral erosion process for E4

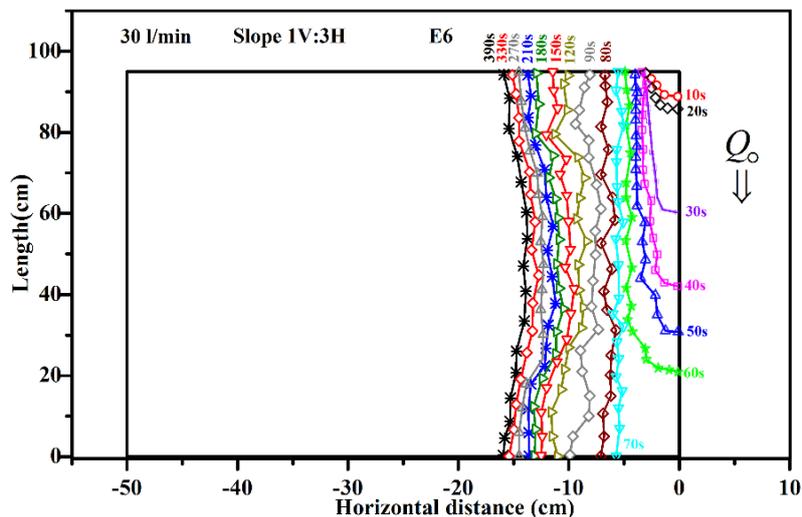
Figure 15. Reduction of dike width due to lateral erosion process for E6

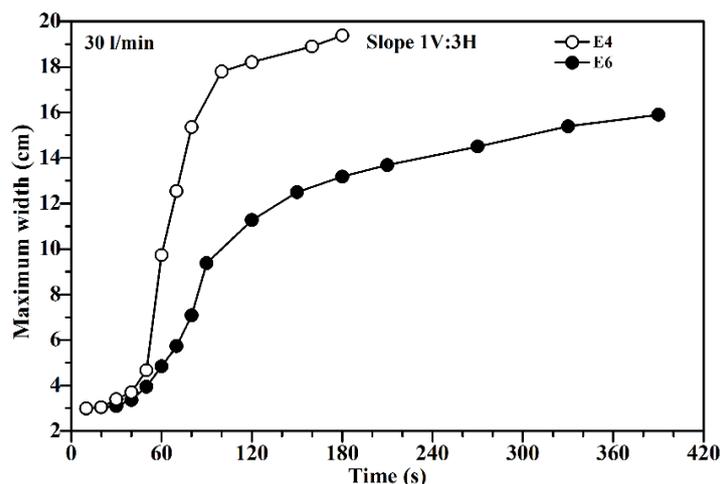
Figure 16. Comparison of widths reductions between E4 and E6

Figure 16 shows the comparison reduction of dikes widths between E4 and E6. The reductions of dikes widths is small in the beginning of flow crossover the pilot channel. The convergent results for E4 and E6 are continued until $t = 50$ and 60 seconds in which the major of dike materials erodibility is due to the vertical erosion process. The inner dike slope is largely steepness due to effects of continuous enlargement of breach channel in the downstream slope for E4 and E6. Horizontal erosion process in E6 is occurred due to the breach flow shear erosion along the top surface of dike slope. The erosion failure resulted in lowering dike heights and expanded the breach development in the horizontal direction. The dike width reduction in E6 is slower than that in E4 due to the presence of fine particles proportion. The development of breach channel failure is transferred into the outer upstream slope in which approximately half of the

dike widths are eroded along the flume channel. For E6, the erodibility rate is increased further in the lateral direction due to the discrete side-slope instability that occurs due to the increasing the velocity of falling flow near the middle of transition area of downstream and upstream slopes. For E4, the undermining of saturated dike slope is faster than that in E6 due to the high water turbulence in the porosity sand materials. At $t = 160$ and 330 seconds, the dike widths are 18.9 and 14.7 seconds for E4 and E6, respectively. The cohesive particles reduce the rate of horizontal erosion process until $t = 390$ seconds compared with $t = 190$ seconds for E4 in which the effectiveness of lateral erosion process is stabilized with dikes widths of 15.3 and 19.38 cm, respectively. Although the physical laboratory tests were conducted in specific configurations due to laboratory possibilities, for example on small – scale homogeneous dike embankment and specified flume width of 50 cm, results can help for understanding the real water level distributions and erosion processes and may be useful in scientific research, for the simulation the widening of breach channel in numerical model, for conduction different scenarios on real large scale and for suggestion design and reinforcement solutions for risk prevention.
