## An Analysis of Shoreline Changes Using Combined Multitemporal Remote Sensing and Digital Evaluation Model

*Keywords:* Cua Dai; Shoreline Evolution; Erosion; Tidal Correction; Tidal Level.

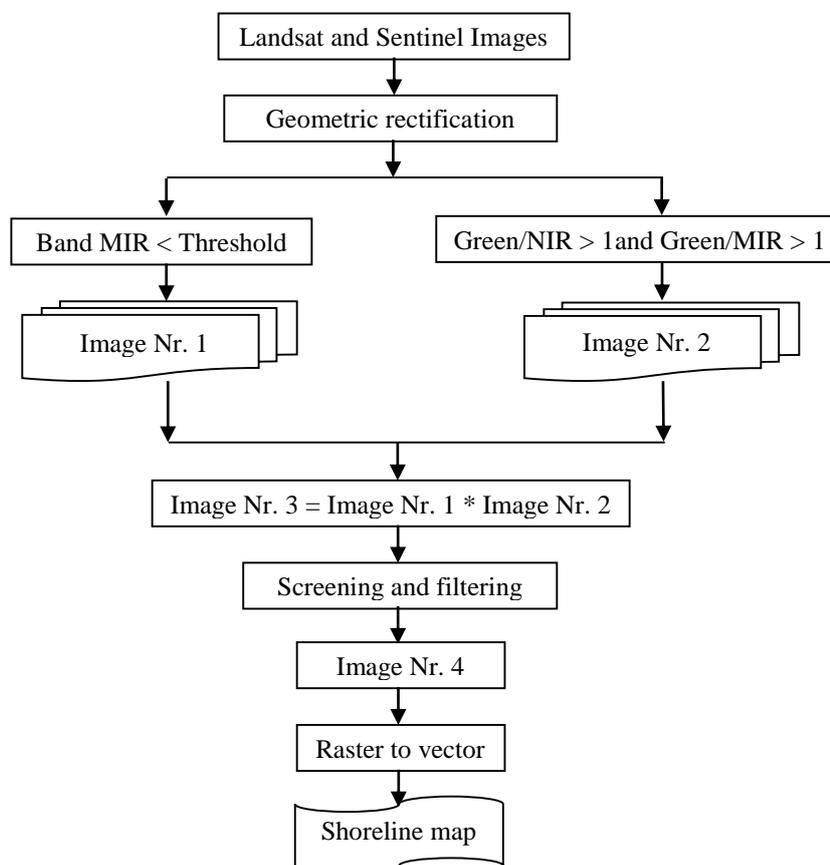
**Figure 2. Flowchart of extracting shorelines from satellite images**

Flowchart of the research methodology has been presented by the Figure 2.

Since today, various methods for shoreline extraction are introduced (i.e., numerical modeling, remote sensing or field survey) [26]. The shoreline can even be extracted based on a single band image [19]. It should be noticed that none of these approaches could provide a clear information on the evolutions of shoreline. The reason for this is because a shoreline position on horizontal or vertical could vary anywhere, depending on the beach slope, tidal range and prevailing wave/weather conditions at the snapshot [27]. In other words, in the process of the identification of shoreline evolutions, possible errors could be originated from (i) shoreline extraction process, (ii) geometric correction of Landsat images or (iii) a variation in some factors affecting shoreline change. So, it is difficult to find a universal method of extracting shoreline for the coast. In the study, a proposed technology is to improve the accuracy shoreline extraction methodology. The method is divided into two steps. As first step briefly presented in Fig. 2, in order to detect shoreline, the method of Alesheikh (2007) [19] is used to extract the waterline from the original satellite images. It is primarily based on a combination of histogram thresholding and band ratio techniques. Band of green/Near-infrared (NIR) are used to define the threshold values which all water pixels separated from the land pixels in the former technology. Meanwhile, bands of green/NIR and green/mid-infrared (MIR) are considered in the later technology. Green/NIR is useful for separating land from vegetation, whereas green/MIR is useful for separating non-vegetation land. To get the final shoreline images, then, some isolated pixels without features are discarded by screening and filtering. The shoreline extraction is transformed to vector from raster format for analyzing the next step.

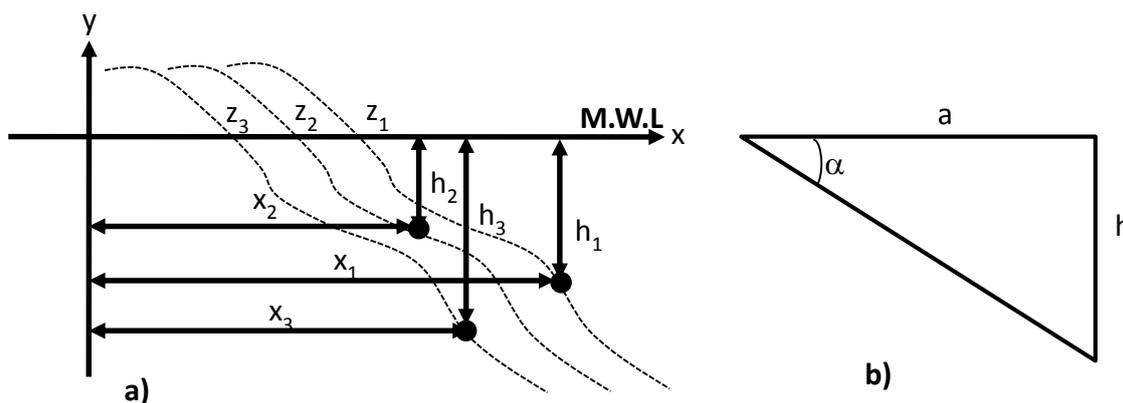
Figure 3. Beach slope for the correction of tidal level (adapted from [28])

In the second step is to discard the tidal effects. This step is shortly called as tidal correction. As mentioned in the previous paragraph, one of factors affected the accurately identification of shoreline positions is tidal. So, in this step, tidal correction is considered and clarified. The effect of tidal level variations during highs and lows is corrected with the lowest level of tidal in the long-period tides. For the Cua Dai estuary, tidal levels range from 0.79 to 1.16 during 1975 to 2018. On the basic of tidal level at the snapshot for the Cua Dai estuary, the shorelines are interpolated based on the one-line shift method or shoreline change model [28]. The method assumes that the beach moves offshore or onshore with one bottom profiles as shown in Figure 3. A brief description of this method is presented with three beach profiles at three different times:  $t_i$  ( $i = 1,2,3$ ) (Figure 3a). At time  $t_i$ , the waterline is located at  $x_i$ , away from the origin of the transformed coordinates, and the corresponding water depth is  $h_i$  above or below MSL. When the sea surface is at MSL, the MSL-datum-based shoreline is located at  $z_i$  away from the origin. Fig. 3 illustrates an example of a beach profile moving from the right to the left. If the extracted waterlines from satellite images at time  $t_2$  and  $t_3$  are located at  $x_2$  and  $x_3$ , respectively,  $x_3 > x_2$ . Extracted waterlines ( $x_2$  and  $x_3$ ) without consideration of tidal effect imply that the beach moves from the left to the right. This inference conflicts with the assumption Figure 3. Shifting the extracted waterlines to the MSL-datum-based shoreline position is necessary to accurately estimate the beach movement. Tidal correction is then analyzed by comparing the position of the shoreline corrected by tides with the shoreline that is not corrected for tides. On the basic of triangle theory (Fig. 3b), shoreline shift is calculated as expressed by the Equation 1:

$$a = h \times \cot \alpha \tag{1}$$

Where  $a$  is value of shoreline shift at the highest tidal level;  $h$  is value of water depth between the highest to lowest tidal level at the snapshot and  $\alpha$  is slope angle of the beach measured in the field.

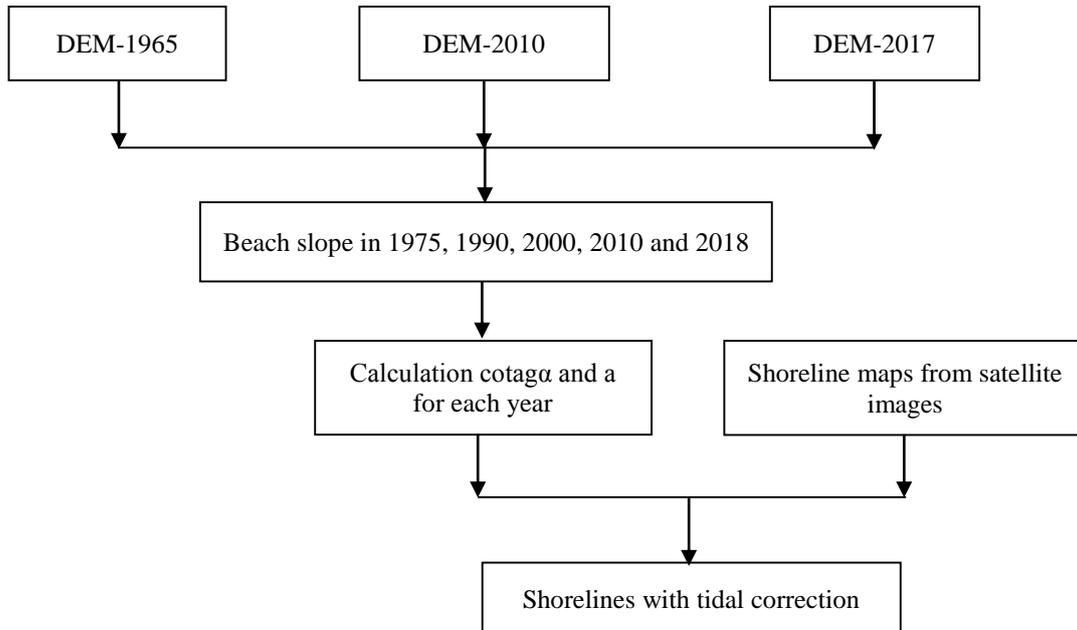
Figure 4. Flowchart of shorelines with tidal correction

In order to define  $\alpha$  and  $a$ , an assumption of beach slope made for tidal correction is continuously a linear trend during 1965 and 2010. The reason for this is that there is no measured data in this duration for the Cua Dai estuary. The flowchart as presented in Fig. 8 is implemented to reproduce the topography of Cua Dai for 1975, 1990 and 2000 based on the topographic data. In case 2018, the correction of shoreline using the lowest tidal level for Sentinel Image 2018 is calculated on the basic of topographic slope in 2017. The application of ArcGIS Tools is used to create slope maps and define the values of  $\cot \alpha$  and  $a$ .

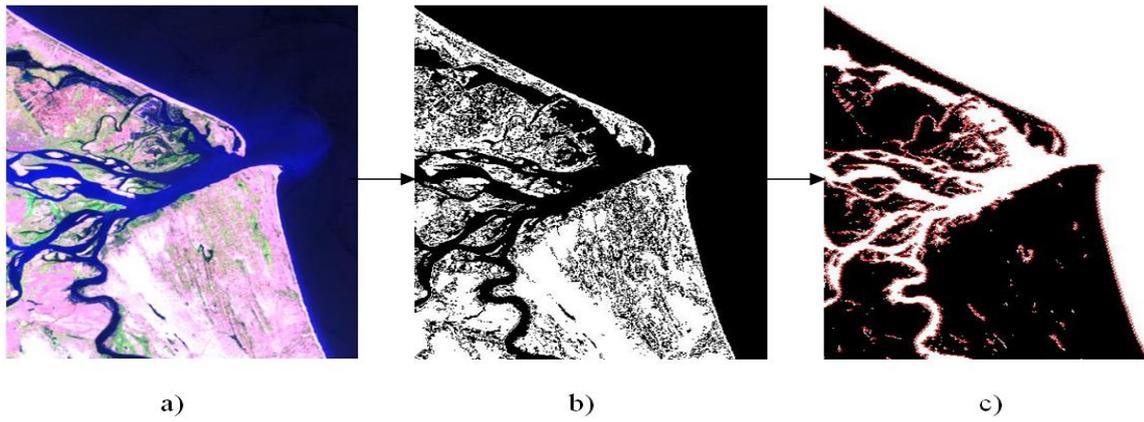
Figure 5. Landsat 7 ETM Satellite for the Cua Dai estuary, snapshotted on 07/05/2000 (a); processed shoreline (b); converted shoreline from raster to vector format (c)

As the first step of the methodology, shoreline maps in 1965, 1975, 1990, 2000, 2010 and 2018 are directly created from the satellite images without tidal correction. A typical result for step by step in 2000 is shown in Fig. 5. A series of other shoreline maps is also presented in Figure 6.

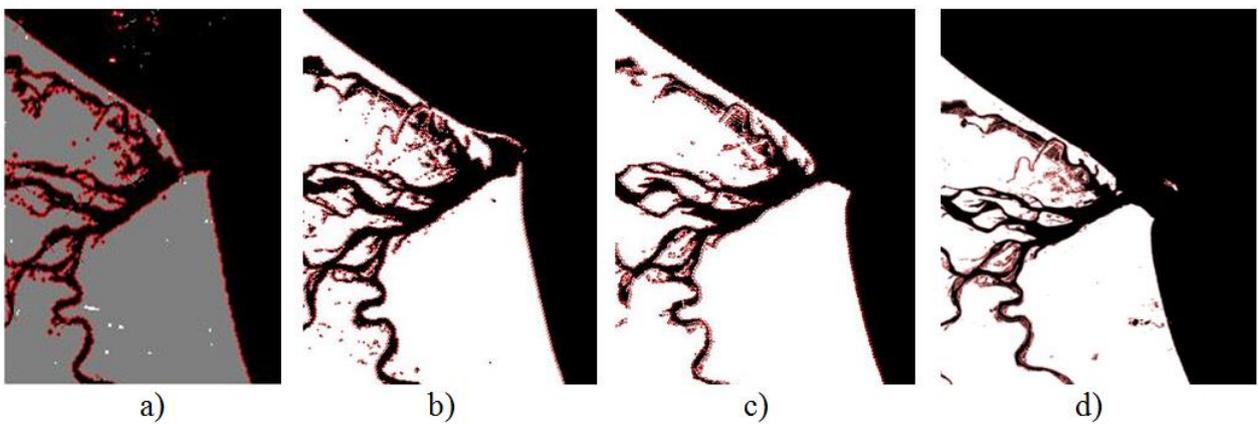
Figure 6. Shoreline maps under the vector format in 1975 (a), 1990 (b), 2010 (c) and 2018 (d)

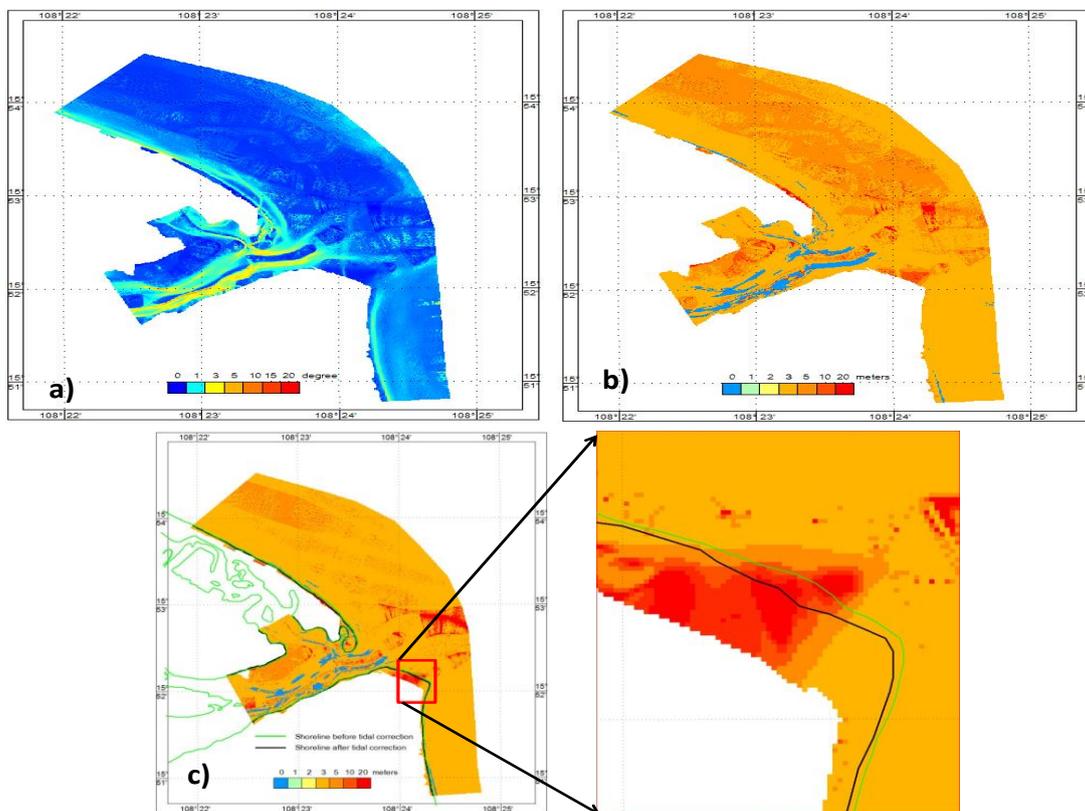
Figure 7. Tidal correction of shoreline steps with slope estimation (a), value of shoreline shift (b) and difference before and after tidal correction (c) in 2000.

As the second step of the methodology, beach slope angle is mapped based on the Equation 2 for the considered years (1965, 1975, 1990, 2000, 2010 and 2018) with tidal correction. The values of shoreline shift ( $a$ ) in the Equation 1 are relatively small ranging from 0.62 to 16.27. The reason for this is due to negligible values of beach slope and tidal level in the Cua Dai estuary. Even if small values of shoreline shift are, however, observed but this significantly makes a difference of shoreline shift between with and without tidal correction, especially in the south of Cua Dai estuary as shown in Figure 7c. During tidal correction, it should be noticed that shoreline maps from the satellite images are transformed to points with the distance of 10 m for each points. Then, values of latitude plus shoreline shift are implemented to transform the point to polyline format after getting the values of coordination and shoreline shift. From that, shorelines with tidal correction are produced as shown in Figure 8.

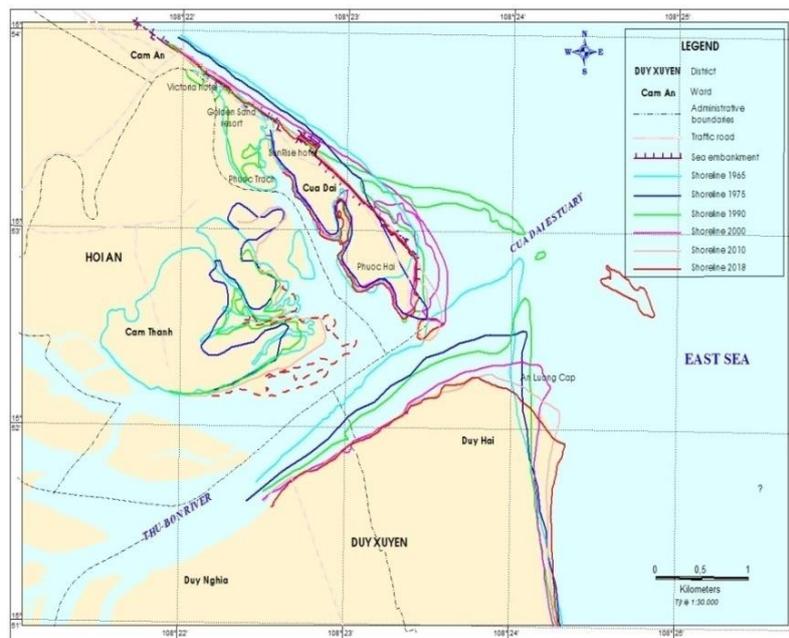
Figure 8. Shoreline maps during 1965 - 2018

Applying the proposed tidal correction, the shoreline changes are fully mapped with the processes of erosion and accretion for the Cua Dai estuary during 1965 - 2018 as shown in Table 2 and Figures 8 to 10.

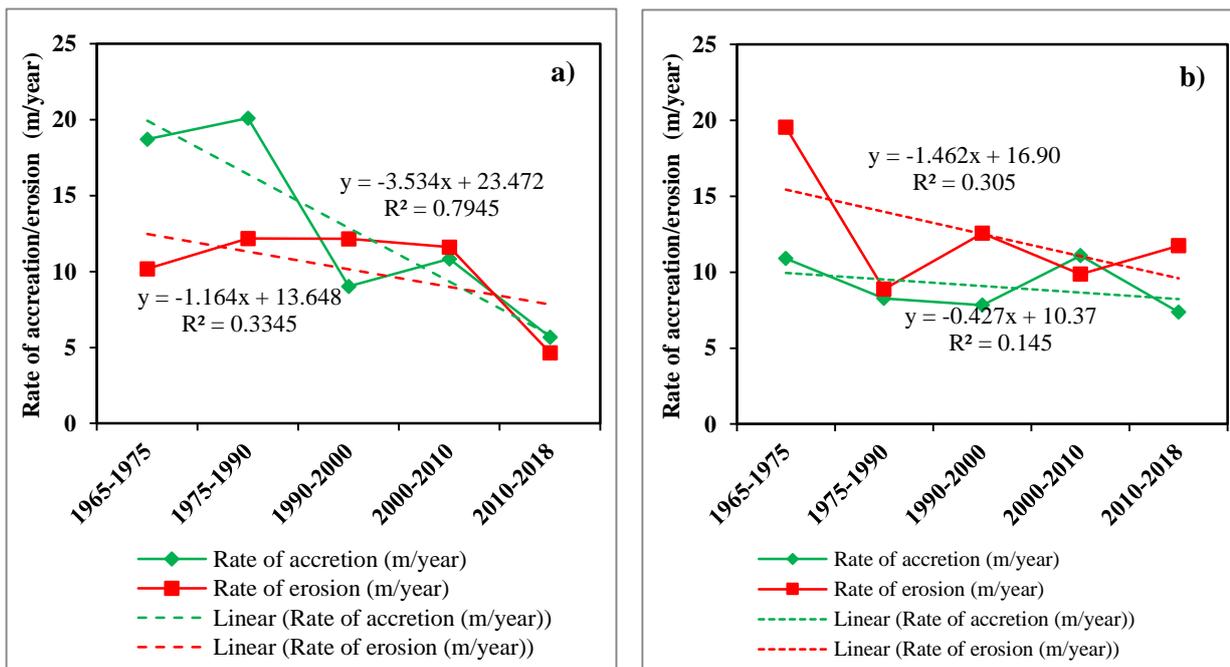
Figure 9. Rate of accretion and erosion in the north (a) and south (b) of Cua Dai estuary during 1965 - 2018

Figure 9 clearly shows the overall rate of accretion and erosion in the north and south of Cua Dai estuary. In the year of 1965 to 1975 average accretion rate is + 18.71 m/yr and erosion rate - 10.19 m/yr acquired in the north of Cua Dai (Fig. 9a). A tendency of decreasing in accretion/erosion is observed during 1965-2018 for both northern and southern Cua Dai. It should be noticed that the accretion process is relatively stable in the south of Cua Dai ranging from +10.9 (1965-1975) and + 7.36 (2010-2018). In the decade of 1975 to 2000, the accretion process is rapidly reduced in the north of Cua Dai (Fig. 9a). Plus, fig 9a reveals a decreasing trend in accretion rate with a high certainty ( $R^2 = 0.7985$ ) in the north of Cua Dai estuary in the period of 1965 to 2018. Notably, fig 9b illustrates a sharp decrease in the erosion rate in the south of Cua Dai in the decade of 1965 to 1990. As shown in fig9b, specially, a stable trend in accretion rate observed in the south of Cua Dai estuary during 1965 - 2018 likely relates to an ensemble of waves in near shore, fresh flows from the river and tides where force of components is balanced in a given period.

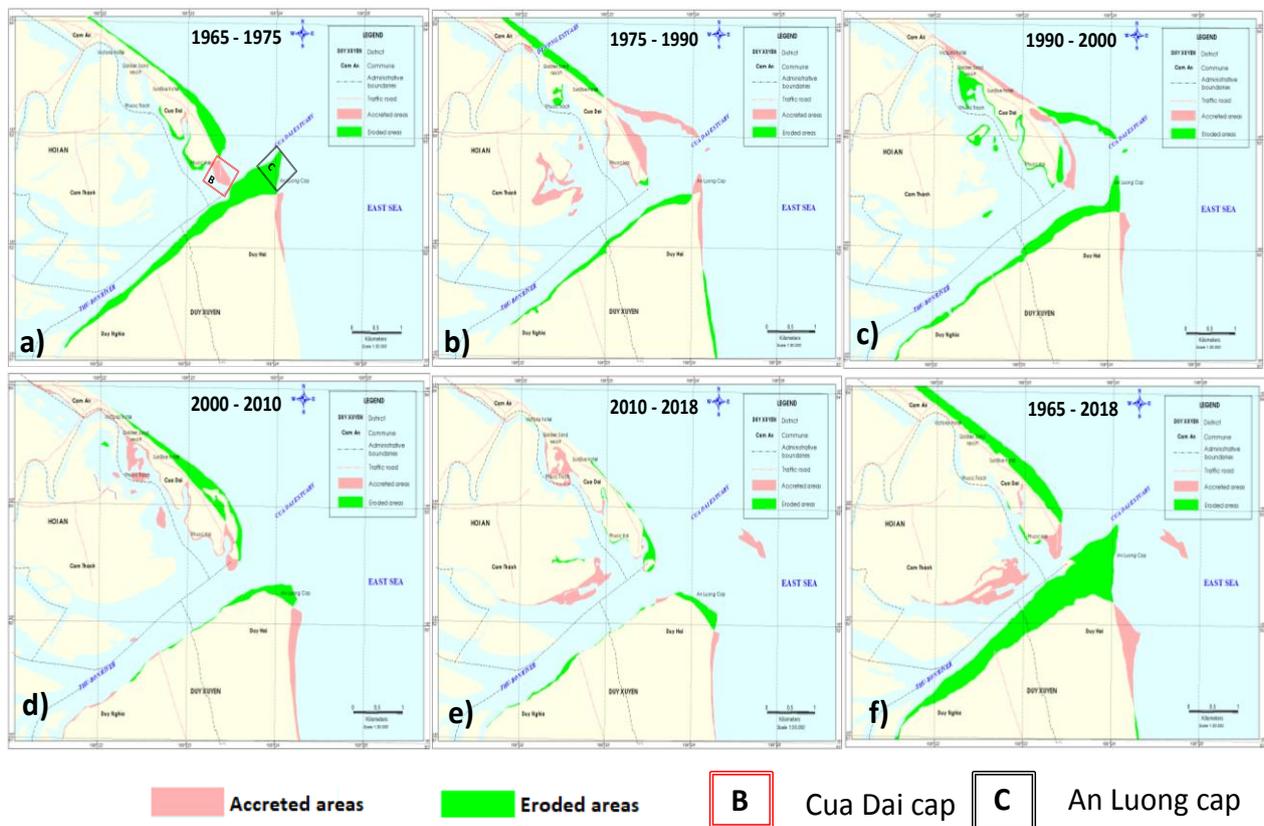
**Figure 10. Eroded and accreted areas in the Cua Dai estuary during 1965 - 1975 (a), 1975 - 2000 (b), 1990 - 2000 (c), 2000 - 2010 (d), 2010-2018 (e) and 1965-2018 (f).**

Figure 10 shows the eroded and accreted areas in the Cua Dai estuary during 1965 – 2018 with six different periods of 1965-1975 (a), 1975-1990 (b), 1990-2000 (c), 2000-2010 (d), 2010-2018 (e) and 1965-2018 (f). Obviously, in the decade of 1965 - 1975 (Fig. 10a) for both northern and southern Cua Dai, the erosion processes are strongly occurred in the estuarine areas with a total length of eroded sections of 8755 m and an area of 136.73 ha. The total length of accreted section is 1763 m with an area of 22.3 ha. The strongest eroded section is observed in the north of Cua Dai estuary belonged to Cua Dai ward and riverbanks in the south of Cua Dai estuary belonged to Duy Hai commune. Contrary to this, the most accretion section is Cua Dai cap. Consequently, the seaport is narrowed and then shifted to the southward. A point needed to be considered is that the coastal area of Quang Nam province is directly affected by a total of 11 tropical cyclones including storms and depressions during this period [29]. Especially, in the Cua Dai estuary is strongly affected by Nr. 6 typhoon namely Louise in October, 1970 traveled from east to west direction with the strongest wind speed of 130 m/s. This causes of dramatically changes in the shape of shoreline and estuarine area. As shown in Fig. 10a-e, the accreted areas for both northern and southern Cua Dai are calculated in the different decades of 1975 - 1990 (3480 m in length, 52.12 ha in area), 1990 - 2000 (4520 m in length, 38.96 ha in area), 2000 - 2010 (3610 m in length, 39.64 m in area) and 2010 - 2018 (2492 m in length, 13.99 ha in area). In addition, the eroded areas are fully interpret for 1975 - 1990 (7139 m in length, 71.71 ha in area), 1990 - 2000 (7463 m in length, 92.65 ha in area), 2000 - 2010 (5778 m in length, 63.51 ha in area) and 2010 - 2018 (3277 m in length, 28.08 ha in area). During 1975-2018, generally, the complex changes are irregularly recorded both in intensity and space scale. The processes of erosion and accretion are intertwined between the coastline sections, but erosion is still dominant. The erosion is specially recorded in the An Luong cap.

It is especially noteworthy from the Fig. 10c-d that in the decades of 1990 to 2010, An Luong cape is shifted to the southward and extended to the sea. This very likely relates to (i) the historical flood recorded in Quang Nam province in November, 1999 and (ii) the concreted embankment in Duy Hai commune in 2006 and 2007 with the length of more than 1 km. Fig. 10f shows an overview map of accreted and eroded areas for a long period of 53 years (1965-2018) in the Cua Dai estuary. In a nutshell, the tendency of erosion and accretion could be divided as the typical accreted and eroded sections. (i) Sections along the coast of Quang Nam province tend to be accreted (i.e., Cua Dai cape in the Cua Dai ward, An Luong cape in the Duy Hai commune). They tend to shift in the northwest and southeast direction during 1965-2003 with average accretion rate of approximately 10 m/yr. In comparison with the position of the An Luong cape, the Cua Dai cape is westly pulled with a length of about 1050 m. Presently, the concreted southern Cua Dai sections are very likely cause of accreted areas in front of the Cua Dai estuary. (ii) Sections tend to be eroded: the north of Cua Dai estuary, coastline of Cam An and Cua Dai wards, Hoi An. The erosion recorded in the south of Cua Dai ward are
