## Experimental Investigation of RC Exterior Beam Column Connection with Eccentric Beam Subjected to Reversible Quasi Static Loads

### Abstract

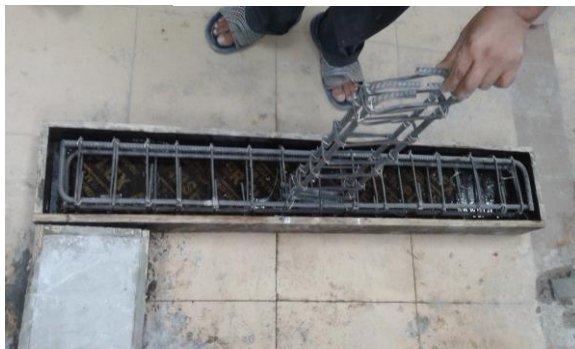
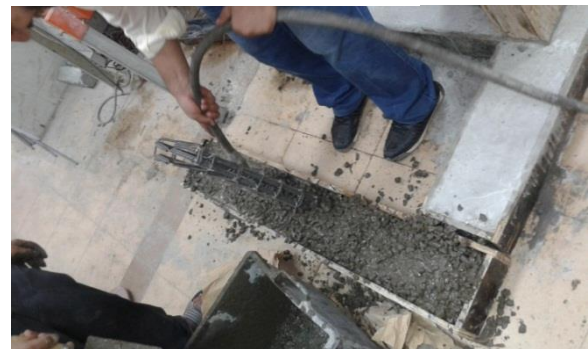
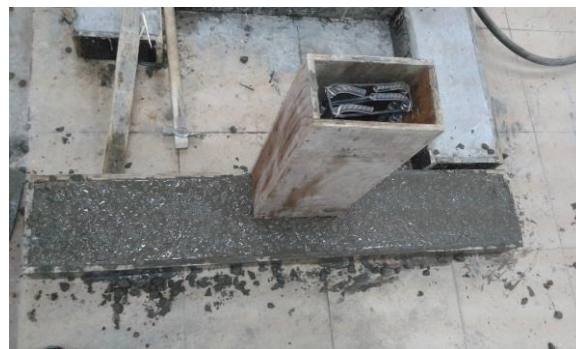
Step 1: Reinforcement shape

Step 2: Casting of the column

Step 3: Fixation and Casting of the beam

Figure 4. Steps of the specimen casting

The experimental program consisted of one reduced scale reinforced concrete (RC) beam column joint (BCJ) (1/3 scale model). In the current study, an exterior isolated beam-column joint as shown in Figure 1. was considered. It consisted of half the height of a column on each side of the joint and part of the beam up to 50% of the span, which corresponded to the points of contra-flexure in beam and column under lateral loads. Symmetric boundary conditions were maintained at both ends of the column for isolation of a single unit of beam-column connections. A typical full-scale residential building with floor to floor height ( $h_c$ ) as 3.9 m and the beam ( $L_b$ ) of 3.6 m effective span was considered. The connection was scaled down to 1/3 size for the experimental work as shown in Figure 2. The Egyptian code [9] was used in design of the specimen. The column has a cross section of  $100 \times 200$  mm (see in Figure 2.). The total height of the column was 1300 mm. The beam had 100 mm width and 200 mm depth. The column was reinforced by 4D12 mm in longitudinal direction and 12D6 mm/m in the transversal direction except the joint panel. The shear reinforcement of joint panel was 1D6 mm. For the beam, the top and bottom main longitudinal bars were 2D12 in longitudinal direction while 10D6/m were used as vertical stirrups. The stirrups were started from the column face. The embedded length of lower and upper main steel of the beam was 245 mm from the critical section of the flexure. The typical concrete dimensions for all parts of the specimen are shown in Figure 2. The reinforcement details for tested specimen are illustrated in Figure 3. The casting steps of concrete inside wood form showed in Figure 4.

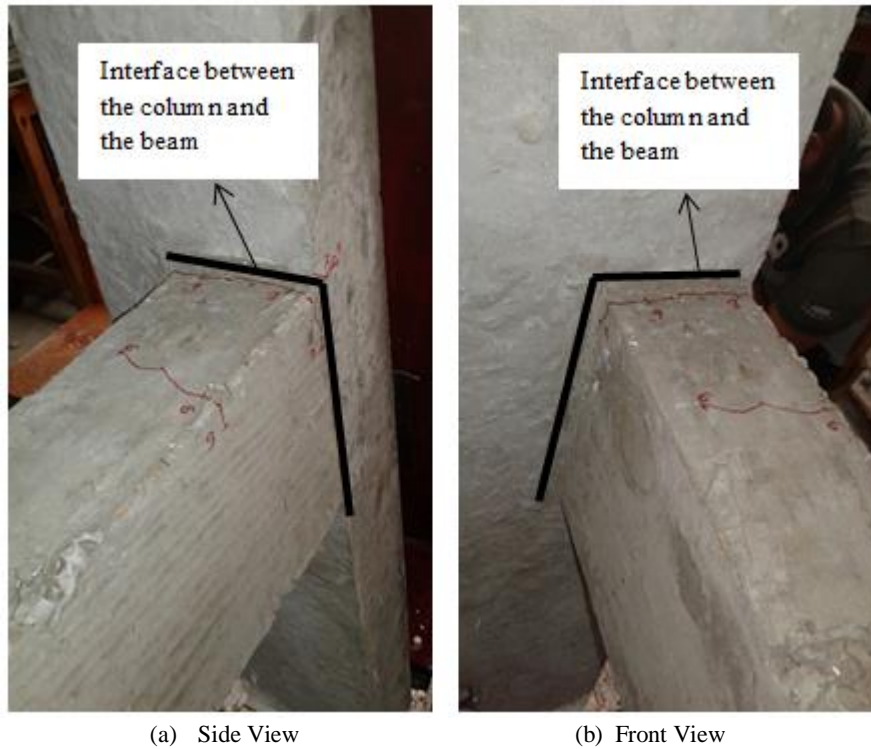
Figure 8. Crack pattern of specimen after the 1<sup>st</sup> cycle ending when the load toward down ward

The crack propagation at each cycle end due to cyclic loading is presented in Figures 8 to 19. In the early stage of cyclic loading, the first cracks in the specimen mainly developed at the beam-column joint interface as shown in Figure 8. The 1<sup>st</sup> cycle ended at the load of 9 KN down word. In this cycle, the cracks number was two cracks. The first took place at the beam-column joint interface while the second occurred at the top side of the beam due to flexural stresses. The BCJ was divided into four zones A, B, C, and D as shown in the following figures.

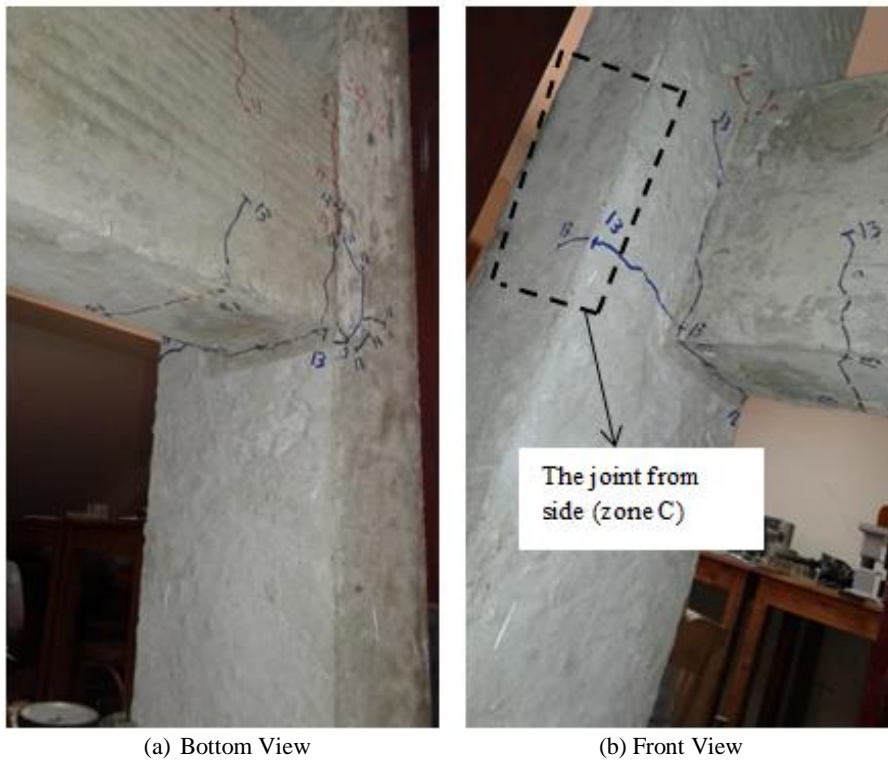
Figure 10. Crack pattern of specimen after the 2<sup>nd</sup> cycle ending when the load toward upward

With increasing of the cyclic loading rate, the cracks spread towards the weakest zone. For the second cycle, the load reached to 13 KN down ward then it was released. Same load of 13 KN affected on the beam up ward and it was removed. The previous two flexural cracks extended in this cycle. The first crack extended to the joint from the front (zone A) and it extended to the joint from the side (zone B) as shown in Figure 9 and 10. showed cracks shape when the loading direction was inverted up word. Same cracks were appeared on the opposite sides in addition to one crack in the joint from the side (zone C). It was shown that the cracks appeared on both sides of the joint (zones B and C). But the cracks on zone B were bigger than the cracks on zone C. The eccentricity of the beam toward zone B was the reason. This eccentricity transmitted more stresses on the side than other side.

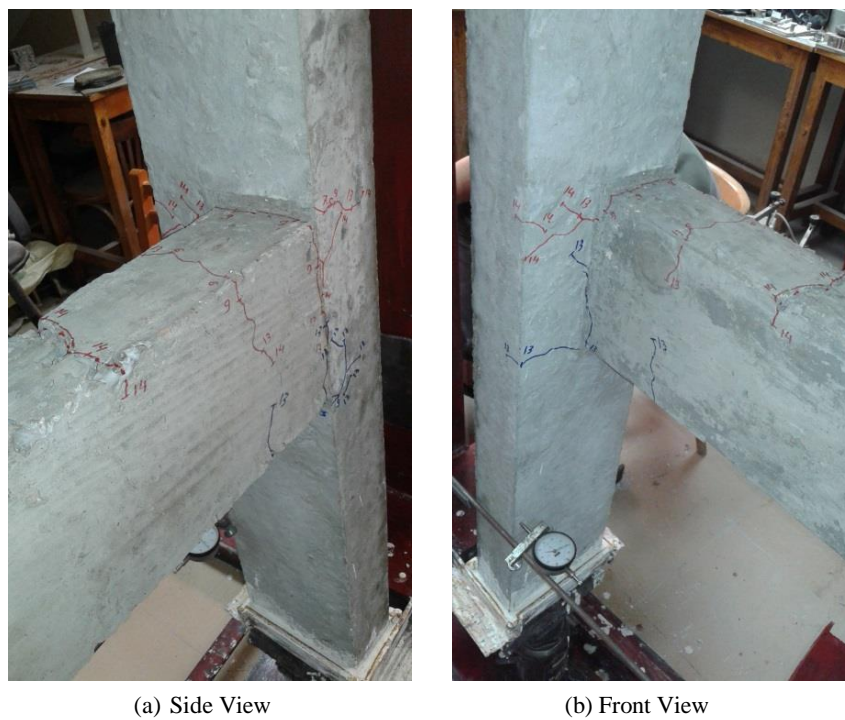
Figure 11. Crack pattern of specimen after the 3<sup>rd</sup> cycle ending when the load toward down ward

Both Figure 11 and 12. showed the added cracks of the tested specimen at the 3<sup>rd</sup> cycle ending either the load was loaded down word or up word. The flexural cracks of the beam were increased either in the depth or the number. This was because the load value increased to 14 KN at the end of this cycle. The cracks concentrated on the side of the joint (zone B) in addition to the cracks increased in the face of the joint (zone A). When the load directed up word at 14 KN, the first crack appeared at the joint from the back (zone D) as shown in Figure 12b.

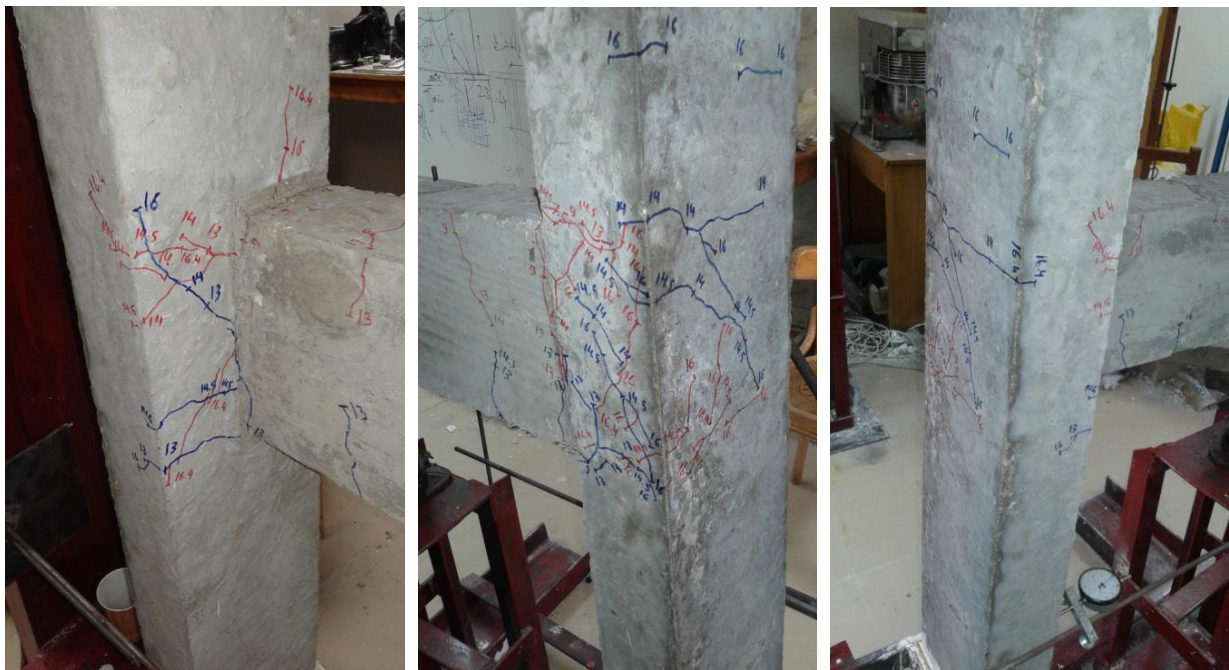
(a) The joint – front view

(b) The joint – back view

(c) The column – side view

Figure 15. Crack pattern of specimen after the 6<sup>th</sup> cycle ending

Figure 15. showed the crack pattern of the tested specimen after the 6<sup>th</sup> cycle ending. The load still at 16.4 KN with the end of the cycle. The cracks took placed at the upper part of the column as shown in Figure 15b. For the back of the joint (zone D), the horizontal cracks extended to full width of the column. The value of the load was 17.4 KN at the 7<sup>th</sup> cycle as shown in Figure 16. The maximum load was occurred at this cycle. One crack started from point 3 (see Figure 14.) toward up ward on the column. When the displacement increased to 16 mm in the 8<sup>th</sup> cycle, the load capacity decreased to 16.8 KN as shown in Figure 17. Same crack extended from point 3 increased vertically upward.

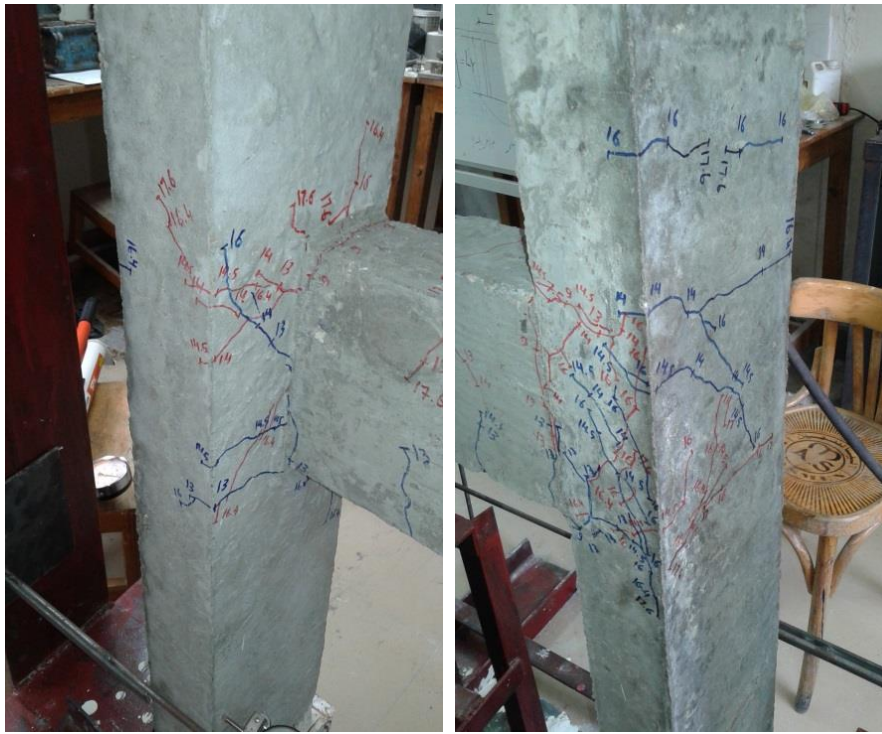
(a) The joint – front view

(b) The joint – back view

**Figure 16. Crack pattern of specimen after the 7<sup>th</sup> cycle ending**

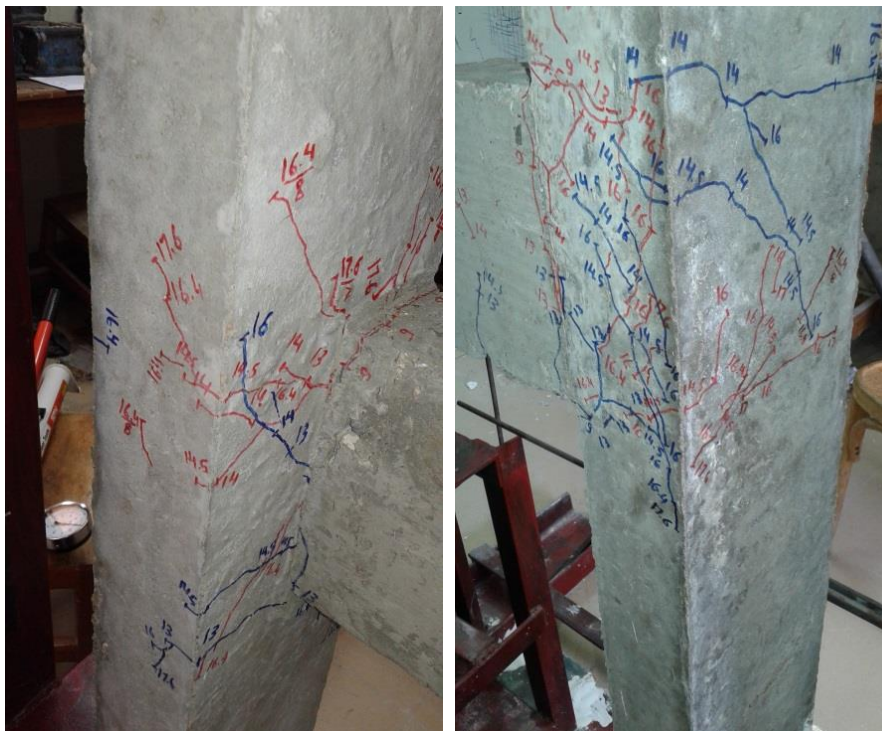
(a) The joint – front view

(b) The joint – back view

**Figure 17. Crack pattern of specimen after the 8<sup>th</sup> cycle ending**

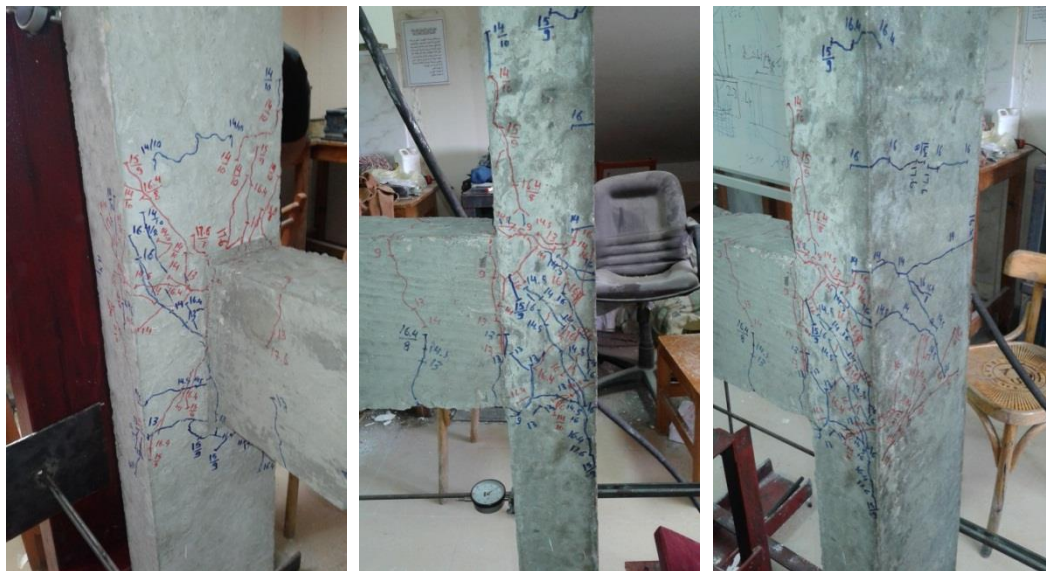
(a) The joint – front view

(b) The joint – side view

(c) The joint – back view

(d) The joint – side view

(e) The joint – bottom view

Figure 19. Crack pattern of the specimen after the 10<sup>th</sup> cycle ending

The cracks in the side and the back of the joint were developed in its numbers. In the 9<sup>th</sup> cycle (see in Figure 18.), the cracks propagated speedily in all parts of the joint. Also the cracks spread above and down the beam. The load capacity decreased to 15 KN in this cycle. Figure 19. showed the cracks pattern of the last cycle. More views were recorded for all parts of the tested specimen. The maximum load in this cycle was 14 KN. The concrete crashed in the part of the column that placed above the beam directly. The widest cracks were taken placed at the side of the joint (zone B). The failure took placed in zone B which expected position.

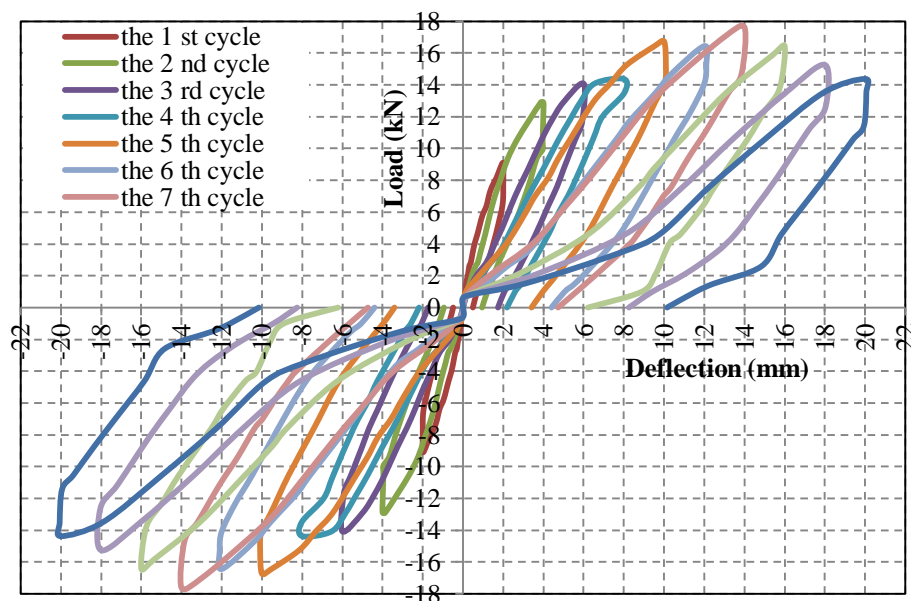
Figure 20. Load- deflection relationships of all cycles for the tested specimen- $\Delta_1$

The relationship between the load and the vertical deflection ( $\Delta_1$ ) of the beam end for all cycles was shown in Figure 20. This figure included more curves, so the curves were drawn in five figures. The load-deflection relationship consisted of positive 10 cycle plus negative 10 cycle. In order to make a comparison between two cycles, each two cycle was drawn in a single figure. Figures 21-25. are showed the curves for all cycles in details. For the first cycle, the curve begins at 0 mm deflection then increased gradually until reached to the maximum displacement (2 mm). The load was removed slowly and it was retained back to 0 KN again. It was noticed that the deflection was not retained back to 0 mm but it kept part of the displacement at cycle positive end. The values of remained displacement at each cycle end at 0 KN were illustrated in the Figures 21-25. Often, the remained displacement in any cycle was higher than the remained displacement in the previous cycle. This might be due to cracks spread in the consecutive cycles. The slope of the curve in any current cycle was less than the curve slope in the previous cycle. On the other hand, as cycle number increased, the rate of deflection increased at the same level of loading. This may be due to decreasing of the rigidity with more cycles. Other reason was that the cracks propagation in any cycle more than the previous. For all cycles, it was showed that the deflection value at a given load during increasing of loading was less than the deflection value at the same load during removing of loading. Figure 26. showed the relationship between cycle end displacement and the corresponding load for same cycle. It was found that the capacity of the tested specimen increased gradually from the 1<sup>st</sup> cycle to the 7<sup>th</sup> cycle until it reached to the peak then it was decreased.

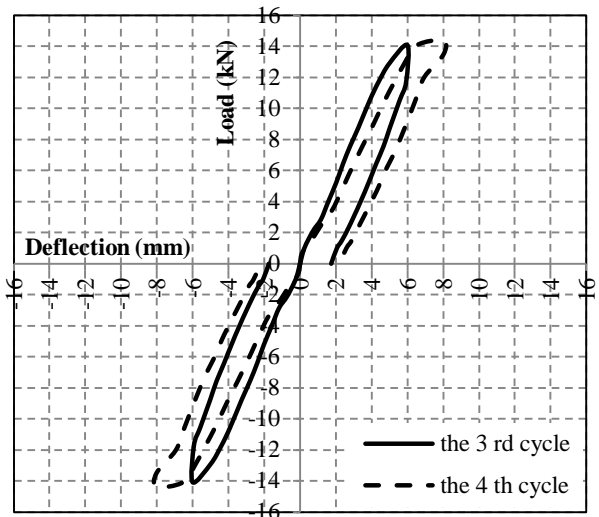
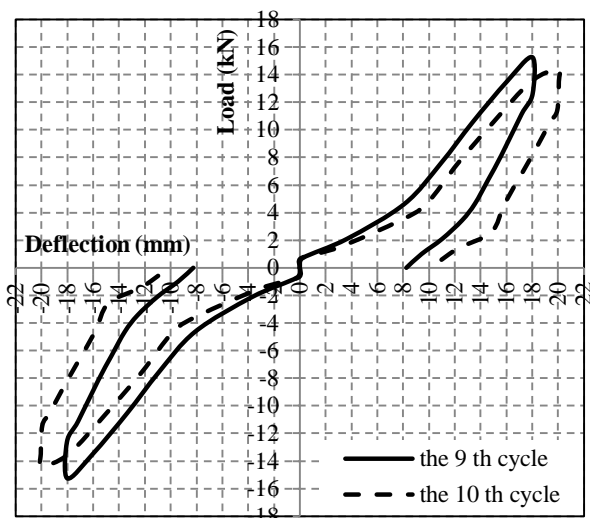
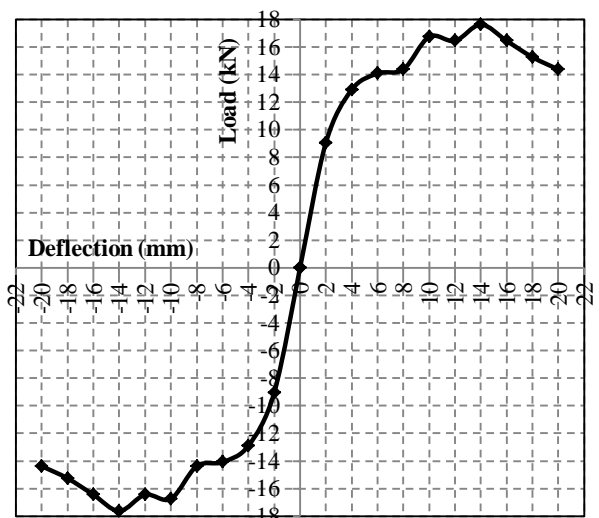
Figure 21. Load- deflection curve of the 1<sup>st</sup> and 2<sup>nd</sup> cycles -  $\Delta_1$

Figure 22. Load- deflection curve of the 3<sup>rd</sup> and 4<sup>th</sup> cycles -  $\Delta_1$

Figure 23. Load- deflection curve of the 5<sup>th</sup> and 6<sup>th</sup> cycles -  $\Delta_1$

Figure 24. Load- deflection curve of the 7<sup>th</sup> and 8<sup>th</sup> cycles -  $\Delta_1$

Figure 25. Load- deflection curve of the 9<sup>th</sup> and 10<sup>th</sup> cycles -  $\Delta_1$

Figure 26. Peaks of load- deflection curves of the tested specimen -  $\Delta_1$

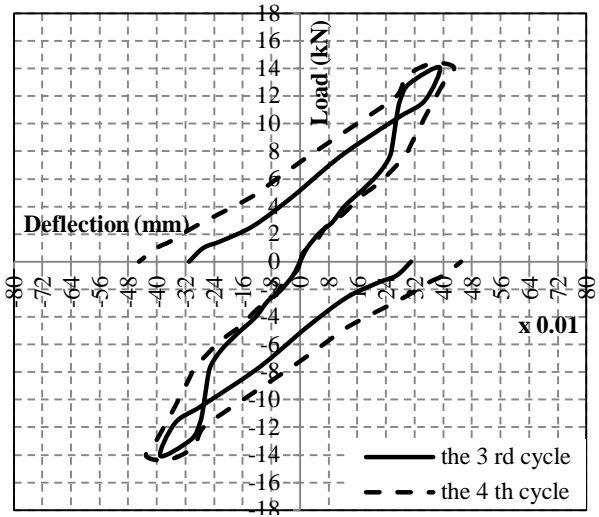
Figure 27. Load- deflection curve of the 1<sup>st</sup> and 2<sup>nd</sup> cycles-  $\Delta_2$

Figure 28. Load- deflection curve of the 3<sup>rd</sup> and 4<sup>th</sup> cycles-  $\Delta_2$

Figure 29. Load- deflection curve of the 5<sup>th</sup> and 6<sup>th</sup> cycles-  $\Delta_2$

Figure 30. Load- deflection curve of the 7<sup>th</sup> and 8<sup>th</sup> cycles-  $\Delta_2$

Figure 31. Load- deflection curve of the 9<sup>th</sup> and 10<sup>th</sup> cycles-  $\Delta_2$

Figure 32. Peaks of load- deflection curves of the tested specimen-  $\Delta_2$

The horizontal movement ( $\Delta_2$ ) of upper part of the column at height middle was recorded (see in Figure 6.). The positive value of the load was toward down ward direction. The positive value of  $\Delta_2$  means that the movement to the right (see in Figure 6.). Figure 27. showed the relationship between the load and horizontal displacement  $\Delta_2$  for the 1<sup>st</sup> cycle and the 2<sup>nd</sup> cycle. As the load increased, the  $\Delta_2$  value increased until ending of maximum displacement of cycle. When the load was removed slowly, the  $\Delta_2$  decreased. During removing of the load, the displacement retained speedily more than before the loading. At the 1<sup>st</sup> cycle end, the maximum movement of the column ( $\Delta_2$ ) reached to  $10 \times 0.01$  mm. each cycle divided into two parts of the loading; the first is displacement from 0 mm to 2 mm then removing of the load. The second is displacement from 0 to -2 mm then removing of the load. For the 2<sup>nd</sup> cycle, the maximum value of  $\Delta_2$  was  $24 \times 0.01$  mm at the cycle end. The slope of the curve of the 1<sup>st</sup> cycle was equal with the curve slope of the 2<sup>nd</sup> cycle approximately. The curves of the 3<sup>rd</sup> and the 4<sup>th</sup> cycle are drawn in Figure 28. Both of two curves have same trend and its values. For both two cycles, the maximum of  $\Delta_2$  is  $40 \times 0.01$  mm. The remained displacement at end of the first half of cycle was  $-32 \times 0.01$  mm for the 3<sup>rd</sup> cycle while it was  $-48 \times 0.01$  mm for the 4<sup>th</sup> cycle. Figure 29. showed the load versus  $\Delta_2$  for the 5<sup>th</sup> and the 6<sup>th</sup> cycles. The increasing rate of deflection of the 6<sup>th</sup> cycle was higher than deflection rate of the 5<sup>th</sup> cycle. The maximum displacement of  $\Delta_2$  of the 6<sup>th</sup> cycle was  $56 \times 0.01$  mm while it was  $40 \times 0.01$  mm for the 5<sup>th</sup> cycle. For the 7<sup>th</sup> cycle and the 8<sup>th</sup> cycle, the curves of deformation were showed in Figure 30. The maximum value of  $\Delta_2$  for the 8<sup>th</sup> cycle was higher than the  $\Delta_2$  of the 7<sup>th</sup> cycle. It was found that the linear behavior of the curve during removing of the load was showed for all cycles. Figure 31. showed load-deflection curve of the 9<sup>th</sup> and the 10<sup>th</sup> cycle. The maximum of  $\Delta_2$  for both the 9<sup>th</sup> and the 10<sup>th</sup> cycle was  $56 \times 0.01$  mm. The peaks of all cycles were drawn in Figure 32. It was showed that the peak of both the 5<sup>th</sup> cycle and the 6<sup>th</sup> cycle were the worst in all cycles. The maximum value of  $\Delta_2$  was  $64 \times 0.01$  mm during the experiment. To make a comparison between all cycles, the curves of all cycles were drawn in Figure 33. The slope of curve for any cycle was less than the curve slope for the previous cycle. For all cycles, all curves were straight lines during load removing.

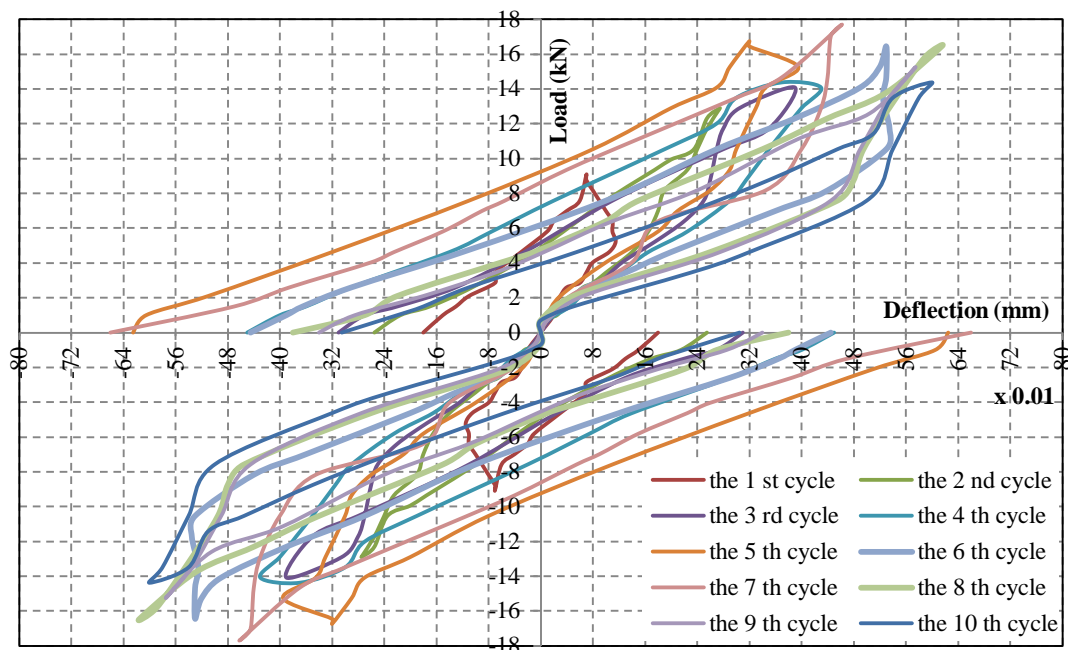
Figure 33. Load- deflection relationships of all cycles for the tested specimen- $\Delta_2$
