Seismic Risk Assessment and Rehabilitation Method of Existing RCC Structures Using Micro Concrete

2.1. Background of Research Project and Building Information

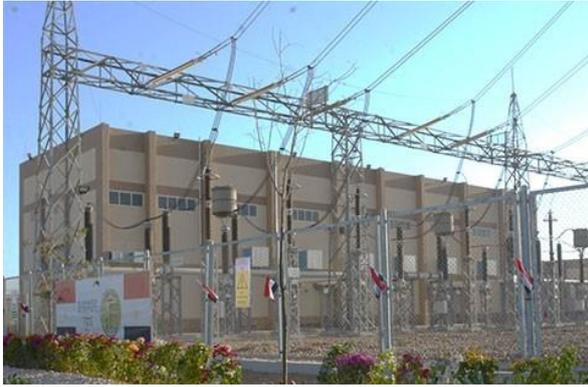
Figure 1. Exterior view of the building

Moment Resisting Frame (MRF) was discovered to be the structural system, and isolated footing foundation systems were found to be the foundation systems. Different material tests have been done to determine concrete strength and rebar strength. CSI ETABS 2016 v16.2.2 design analysis software was employed for the sufficiency and testing of structural members. In this study, the structural frame was a moment-resisting frame system. This building uses a combination of flat plate and RCC beam slabs on various floors. The following information is provided regarding this RCC structure: The building is 14.17 m in height, 23.31 m in length, and 12.80 m in width. Column sizes were 10" X20", 12" X20", and 14" X20" at the corner zone, edge zone, and middle zone, respectively. The beam size was 15" X18" and 15" X15", slab thickness was 5", and the stair waste slab thickness was 7". The foundation system has been found to be a cast in situ pile and pile-cap foundation. The main entrance area, the parking lot, and the generator portion are on the first floor. There are offices and a store room on the second floor. The other utility and equipment rooms are on the second and third floors. Figure 1 shows the image of the building, while Figure 2 shows the building's column, beam, and slab layout.

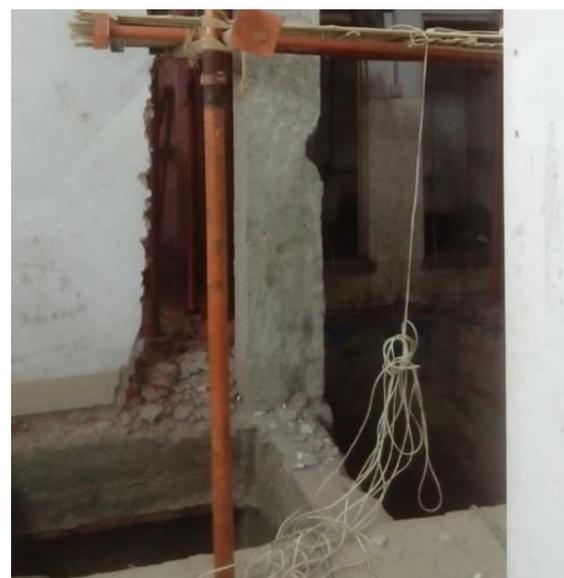
Figure 12. Chipping of the old column

Lehman et al. reconstructed moderately to severely damaged circular RC columns with recently cast concrete-headed reinforcement and mechanical couplers. They found that while the strength and flexibility were totally recovered for somewhat damaged columns, the stiffness was not. The restoration method could not restore the behavior of highly damaged specimens [33]. This study carried out retrofitting construction following the retrofitting structural design and drawing. Retrofitting structural drawings have been done as per the analysis model. The concrete column section has been increased, and additional vertical reinforcements have been inserted per the demand for column analysis and calculation. The RCC concrete cover of the column was removed, exposing all of the longitudinal bars [34]. New rebars were installed on all column faces with appropriate epoxy grout. Enough anchoring of new concrete with old concrete was provided.

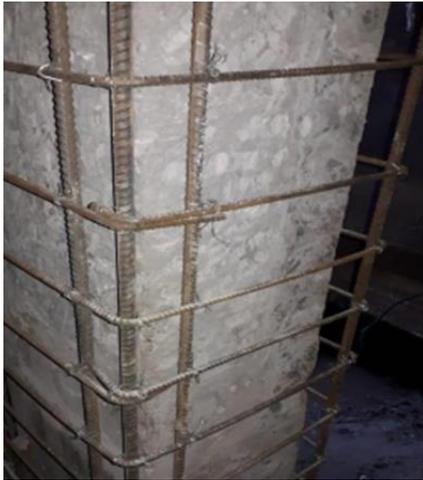
Figure 13. Insertion of vertical reinforcement

Fresh rebar was inserted into the column's corners, and welded bent bars were used to connect them to the old rebar. New bars must be installed at the corners to prevent the beams' piercing. Micro-concrete has been used for retrofitting column casting. After casting, the concrete cylinder was checked, and it was found that the definite strength value was higher than the old concrete strength. For jacketing, the concrete strength must be more than or at least equivalent to the existing columns. Figure 11 depicts the rebar configurations of the retrofitting column section. For this study, an existing building was renovated without compromising the working environment or the available space. Figure 14-15 depicts the working process for column jacketing. Figure 12 shows the chipping of the old column; Figure 13 shows the insertion of new reinforcements; Figure 14 shows the formwork and micro concrete casting; Figure 15 shows the casting completion of half-length of the column; and Figure 16 displays images taken after the retrofitting work is finished.

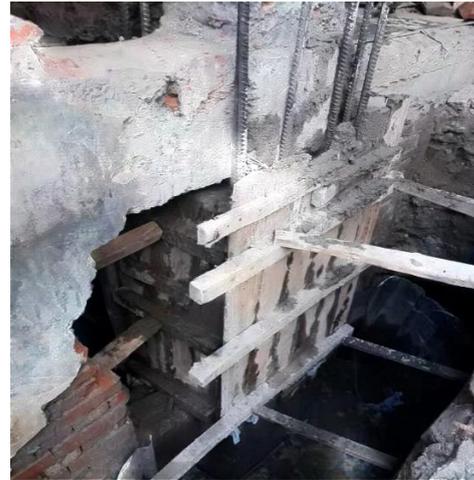
Figure 14. Formwork and micro-Concrete casting

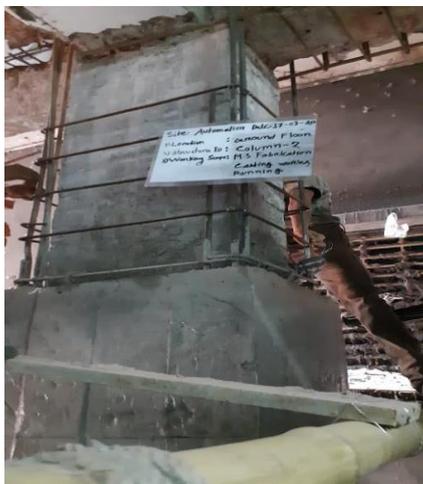
Figure 15. During concrete casting

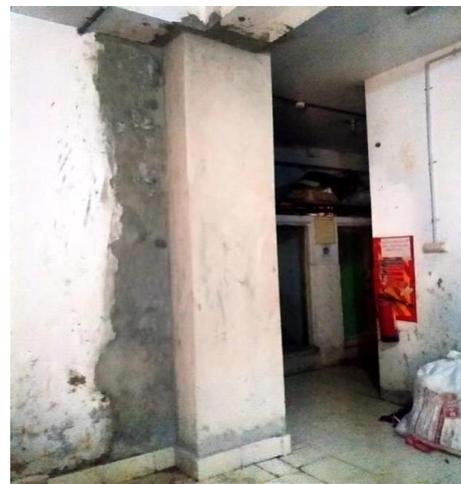
Figure 16. After completion of jacketing
