## Condition Assessment of Existing Concrete Building Using Non-Destructive Testing Methods for Effective Repair and Restoration-A Case Study

The present paper focusses on condition assessment of an existing 35 year old hospital building and the possible rehabilitation works to enhance the life span of the structure with safety. The preliminary assessment of the condition of the structure is done by visual inspection, probing of cracks and spalls to see their extent, reinforcement cover measurements etc. In the second phase possible strength measurements, carbonation measurements, reference electrode measurements are done by taking samples for laboratory testing. Finally, combining the analysis of results of various NDT methods for assessing the quality of structures has been done and the possible repair and restoration works are suggested.

#### ➤ Project considered: Government General Hospital Building, Kurnool, Andhra Pradesh, India.

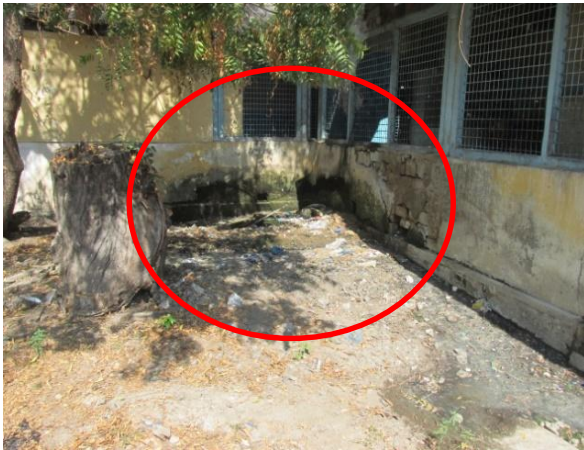
Figure 3. No Plinth Protection

- Plinth protection was observed to be damaged at some locations.
- False ceiling was observed to be damaged at many locations.
- Separation crack was observed between CRS and brick masonry.

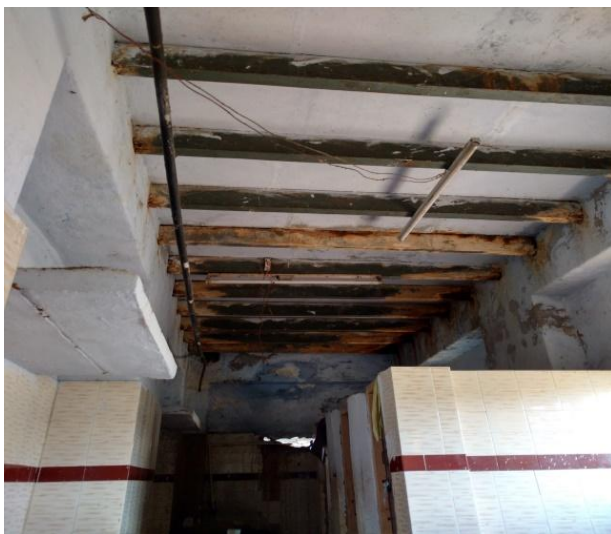
Figure 5. Distressed in wooden members

- Wooden purlins were observed to be decayed at some locations.
- Cracks were observed in the existing WPC on the terrace.
- Severe leakages & dampness was observed in the roof & walls of the newly constructed toilet block.

In corridor areas the existing AC sheets at the first floor level shall be replaced with metal sheets and the damaged wooden joists shall be removed and replaced with new wooden joists with existing dimensions.

In view of severe distress observed in the rear side corridor region of Portion -7 consisting of madras roofing system with wooden rafters, it is recommended to remove the madras roofing system. It shall be replaced with R.C precast slab panels with structural steel (ISMC) beams.

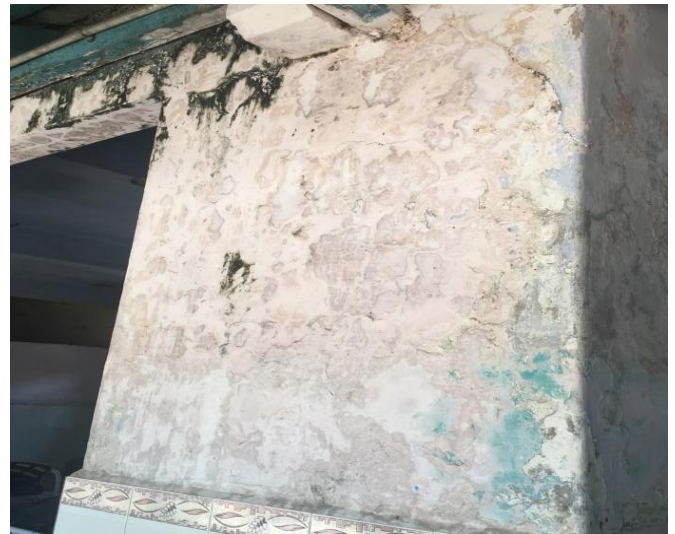
Figure 6. Dampness in columns

- Dampness was observed on walls below sill level at many locations.
- Growth of Vegetation was observed at a few locations nearer to the plinth.
- Dampness was observed on sunshades at many locations.

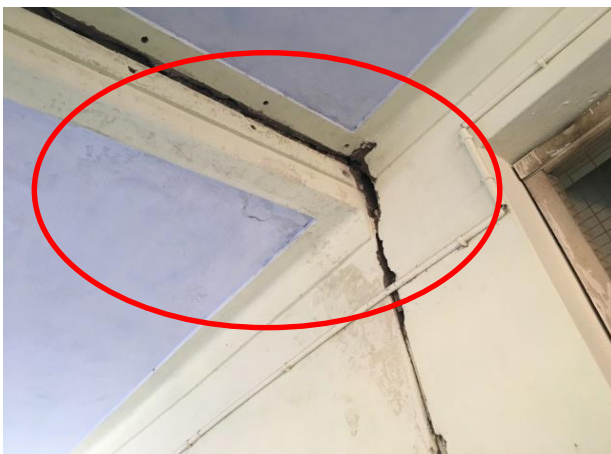
Figure 7. Cracks near Expansion Joint

- It was reported that, severe leakage was observed from the expansion joint during monsoon season.

In view of leakages from the expansion joint, it is recommended to clean the joint and fill it with Polyurethane sealant and redo the portion as per IS 5256-1992 provisions.

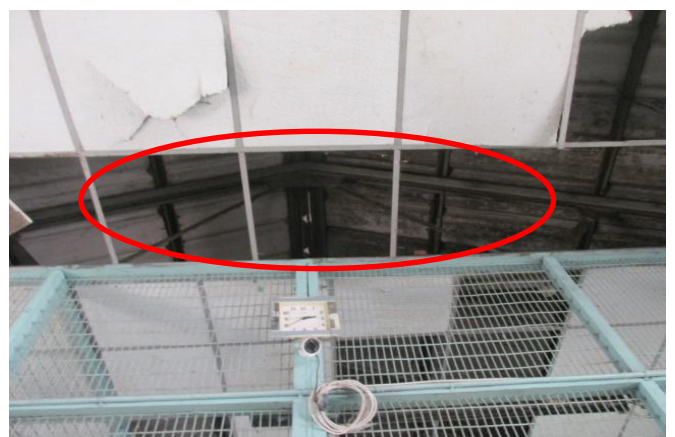
Figure 8. Damaged false roofing and Truss

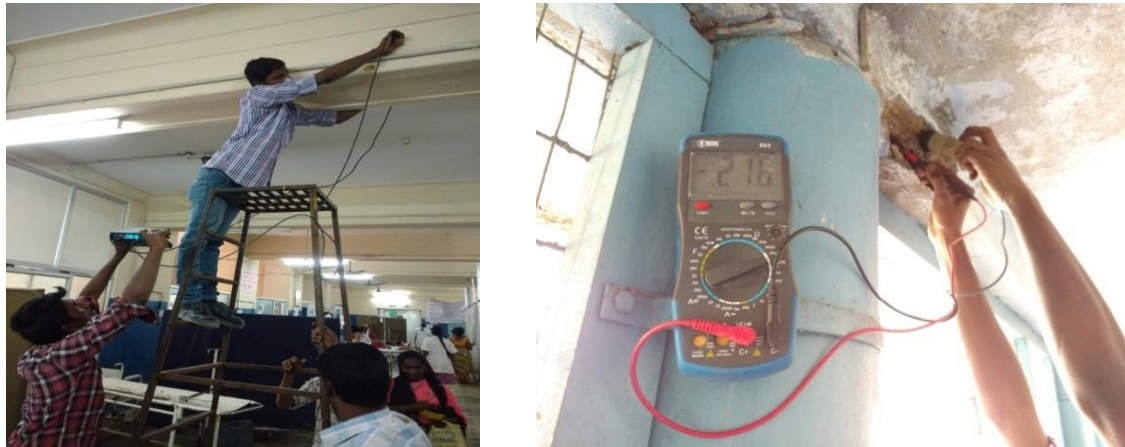
**Figure 9. In-situ Non-destructive Tests**
