## Experimental Study on Seismic Performance of Kancingan Timber Frame Infill Walls Building

This study was carried out to examine the seismic performance of *Kancingan* house walls and the behavior of their timber frames, brick infill, and anchor nails during cyclic loading tests. *Kancingan* House, a timber frame building with brick infill walls, is a cost-effective and efficient method of wall construction commonly used in houses in Merauke, Indonesia. The experimental method was used to determine the seismic performance of the walls built using buswood with a module width of 100 cm and a height of 130 cm through cyclic load testing. The result showed a maximum lateral load of 26.43 kN with a displacement of 19.08 mm under compression loading and 28.78 kN under tensile loading with 15.6 mm displacement. The initial stiffness was measured at 5.03 kN and 9.59 kN/mm for compressive and tensile loading, respectively. Furthermore, ultimate load and displacement of 21.14 kN and 23.02 kN were obtained at a displacement of 30.68 mm under compressive loading and 25.23 mm under tensile loading. The ductility values of 10.76 and 9.78 were obtained under compressive and tensile loading. In

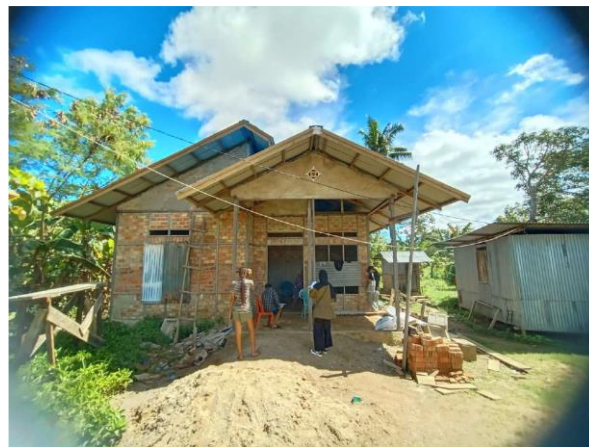
**Figure 2. Kancingan house in Merauke**

The *Kancingan* house has profound historical significance in the Merauke community, a heritage diligently preserved through the ages. According to Topan et al. [14], development led to changes in the construction process, modifying the functions of the building aspect that was once considered to be a strong structure. This was influenced by cost, materials, culture, and construction intricacy. In addition, the current model of the *Kancingan* house is shown in Figure 2.

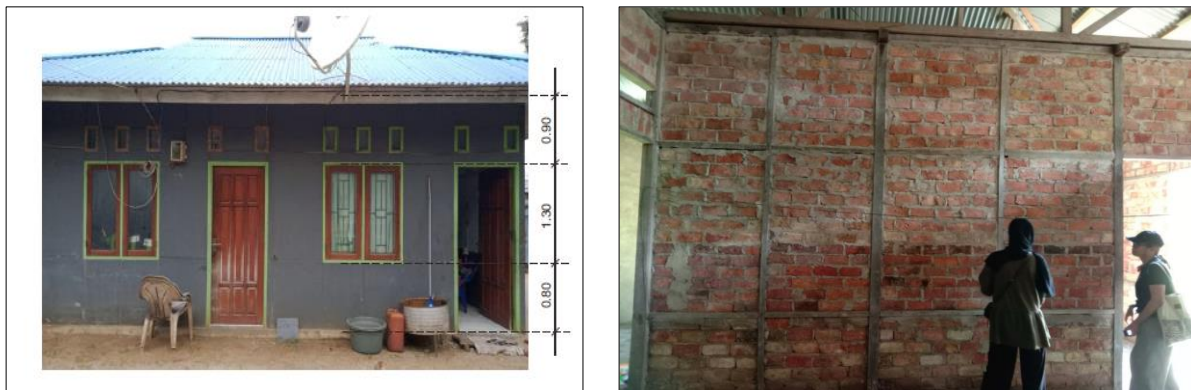
**Figure 3. (a) A pattern of windows and doors frame that often appears in *Kancingan* house, (b) Timber frame pattern on wall in *Kancingan* house**

The architectural design of the *Kancingan* House features wooden columns and a wall frame, known as a *regel*, measuring 8/8 cm in size. The design of the door and window frames significantly impacts the appearance of the walls (Figure 3-a). Additionally, these walls possessed a variety of grid patterns and module sizes characterized by the vertical spacing of the timber frames. The horizontal beams were placed in line with the heights of the door and window frames, while the vertical ones coincided with the wall length (Figure 3-b).

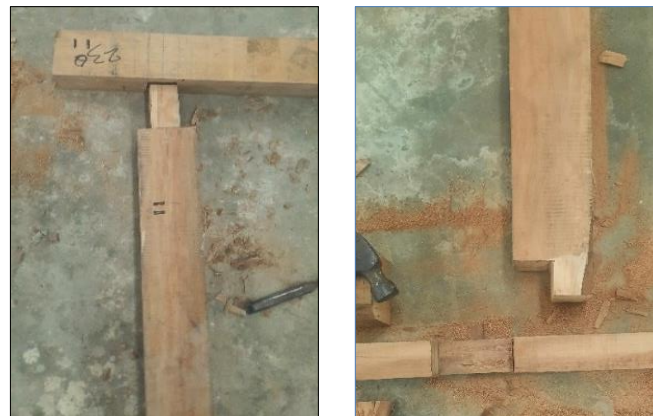
Figure 6. (a) Mortise and tenon joint. (b) Halved joint

The specimen designed for this experiment is similar to the wall construction process in a *Kancingan* house. It comprised a timber frame made of bus wood (*malelauca cajuputi*), with dimensions of 2x100 cm module width and 130 cm height. As shown in Figure 5, wood sizes 8/8 and 4/8 were used for the main column and divider beam, respectively. The type of connection implemented was the mortise and tenon joint, positioned at the top of the specimen and commonly found in traditional households, namely the Balinese house [38], as shown in Figure 6-a. Additionally, a halved-joint connection was used at the base of the sample connection, as shown in Figure 6-b.

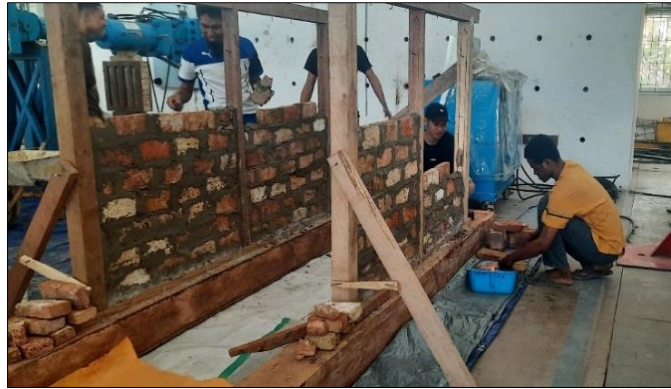
Figure 8. Process of installing a brick wall

Following the installation of the brick walls on the specimen, as shown in Figure 8, a curing process was initiated for one week to ensure proper hydration of the cement before plastering. The plastering process was performed with a mortar composed of one part cement and four parts sand on both sides of the wall, resulting in plaster and final thicknesses of brick infill approximately 1.5 cm and 8 cm, respectively. Subsequently, the walls were covered with wall filler or putty to facilitate the placement of 5 × 5 cm grid lines, which aided in detecting cracking during the test. The specimens were cured for 28 days to ensure the cement was well-hydrated and deemed ready for the lateral-load test.

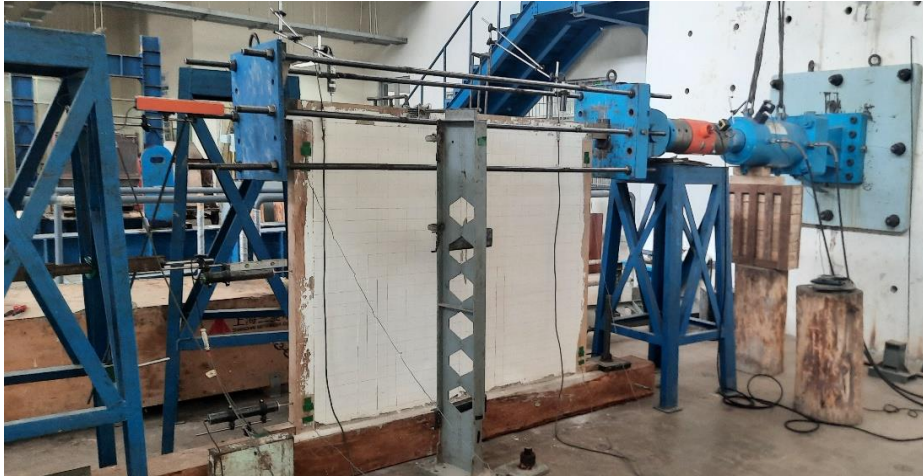
Figure 11. Set up tools and test objects

The specimens ready to be tested were placed on the device according to the arrangement shown in Figure 11.

The LVDT and strain gauge were installed on the specimen at a specified location and connected to a data logger and computer to measure the load and displacement during the test. Data were collected intermittently from the logger and computer throughout the test duration. Visual observations, such as identifying the first crack, the patterns, and breadth, were documented directly on the specimen during the test. Finally, the behavior of the walls was assessed based on these observations and measurements.

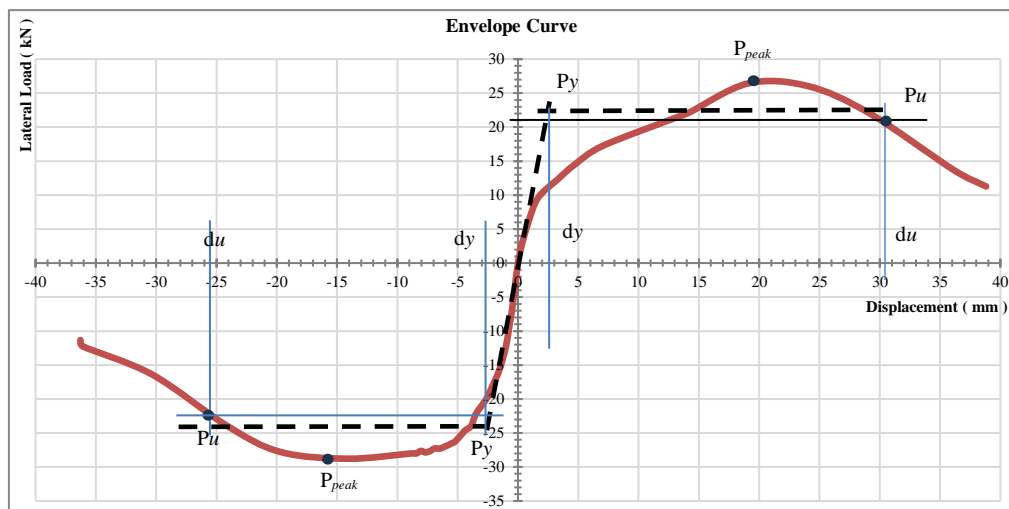
Figure 13. Envelope curve

The envelope curve in Figure 13 shows the maximum load experienced in each cycle. This representation is accompanied by a bilinear curve based on the equivalent energy elastic–plastic (EEEP) method, as described in ASTM E 2126. The variables along the curve, such as the elastic stiffness ( $K_e$ ), Yield Load ( $P_y$ ), Peak Load ( $P_{peak}$ ), ultimate load ( $P_u$ ), and ductility of the specimen, provide invaluable information regarding the performance of the material during cyclic testing, as shown in Figure 13.

Next, the seismic parameters shown in envelope curve:

- ASTM Standard 2126-11 was used to determine the load under the yield condition using the elastic-plastic equivalent energy (EEEP) method. The findings showed that in the compressive loading direction, the yield load ( $P_y$ ) and displacement ( $D_y$ ) of the test object was 22.47 kN and 2.85 mm, respectively. Additionally, in the tensile loading direction,  $P_y$  and  $D_y$  were 22.46 kN, and 2.58 mm.

- The ultimate load,  $P_u$ , is generally defined as the load achieved at 80% of the peak load. In the compressive loading direction, the ultimate load is 21.14 kN at displacements of 30.68 mm. However, in the tensile loading direction, the ultimate load is 23.02 kN and displacements of 25.23 mm.

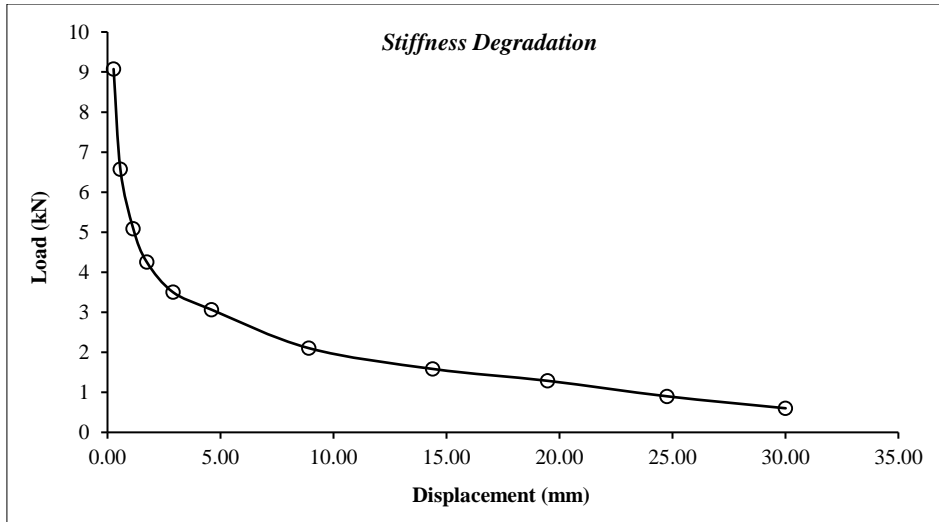
Figure 16. Stiffness degradation of the wall

The average stiffness of both compressive and tensile loading at each cycle was used to calculate the sample stiffness at a certain transfer rate. The resulting stiffness degradation curve in Figure 16 shows a consistent decrease in stiffness as displacement from lateral loads increases. At the beginning, there was a slight decrease in stiffness degradation, however, from the sixth cycle onwards, the stiffness decreased steadily until the final cycle. This decrease was mainly caused by damage to the wooden joints at the nail connections. As the load was applied, the raised nails formed holes in the timber surface. The displacement should be as large as the raised nail distance for the next cycle to ensure the wall can withstand lateral loads. Additionally, the stiffness capacity is significantly influenced by the timber joints, and the presence of the infill wall [11, 51, 52].
