The Effect of Fiberglass Paint Coating on the Shear and Flexural Strength of Concrete Blocks

Eka Juliafad ^{1*}, Lisyana Junelin Restu ¹, Fajri Yusmar ¹, Nevy Sandra ¹,
Rusnardi Rahmat Putra ¹

¹ Department of Civil Engineering, Universitas Negeri Padang, Sumatera Barat 25131, Indonesia.

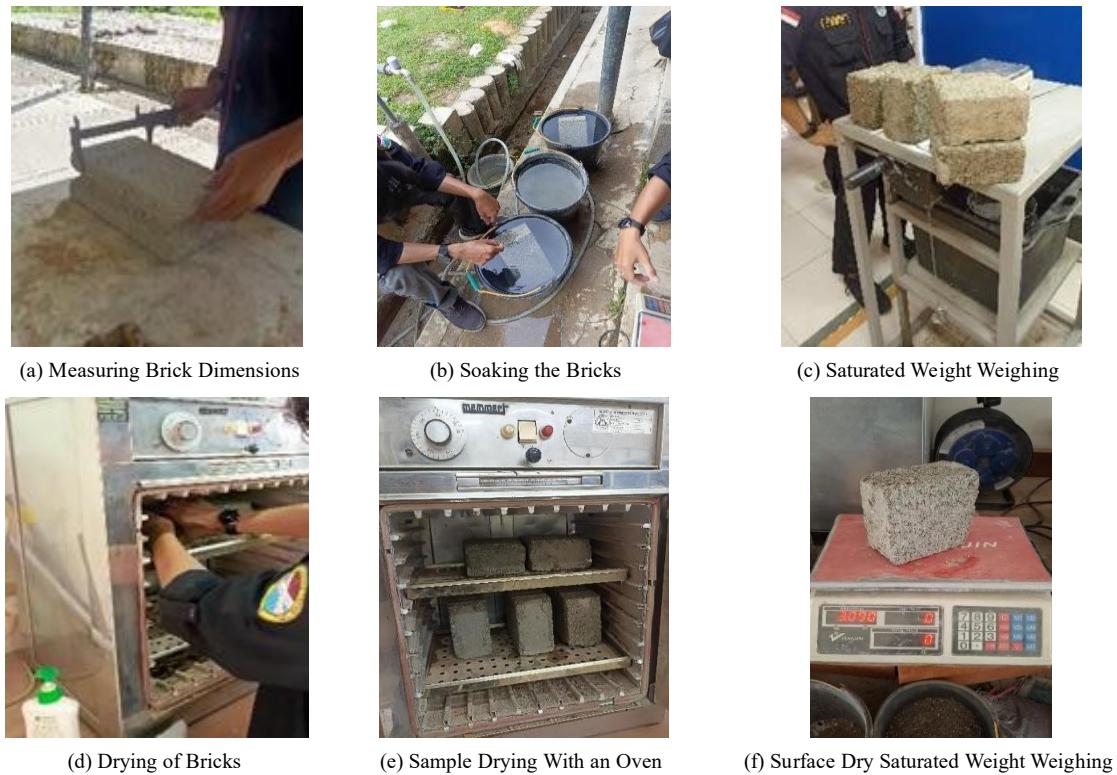
Figure 2. Concrete Block characteristics inspection process

Furthermore, it is essential to verify the specific gravity of the bricks as stipulated by SNI 15-2094-2000; the specific gravity of red brick masonry is 1700 kg/m³. This brick testing will adhere to the SNI 15-2094-2000 standard due to the absence of a defined standard for the specific gravity of bricks [5, 30]. Figure 2 presents the process of testing the characteristics of Concrete Blocks.

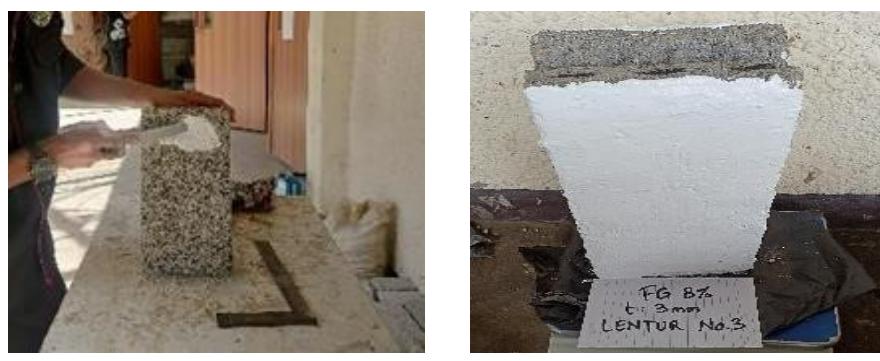
Figure 5. Flexural Strength Samples Production Process

Flexural test specimens were fabricated by coating entire concrete blocks' upper and lower surfaces. Figure 5 illustrates the sample fabrication procedure for flexural testing. The design of the flexural samples is presented in Figures 6 and 7.

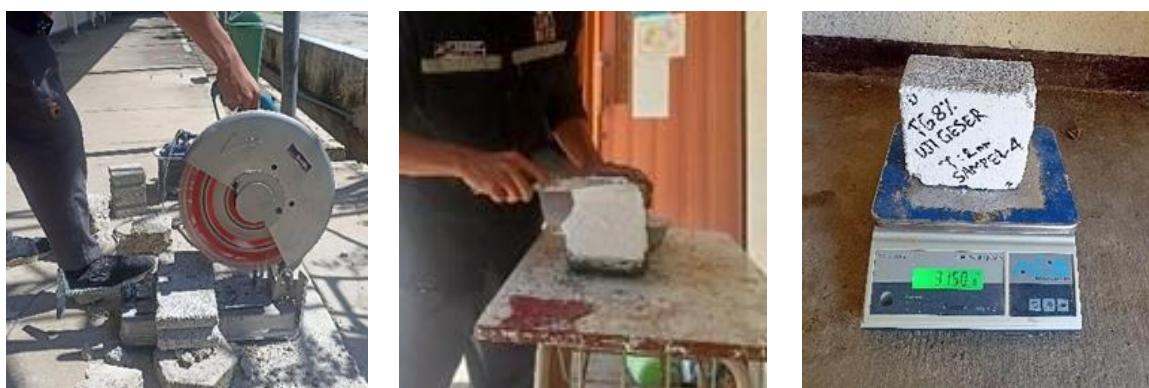
Figure 8. Shear Strength Samples Production Process

Shear test specimens were created by dividing a concrete block and applying a coating to the upper and lower surfaces. Figure 8 displays the sample manufacturing procedure for shear testing. Shear photographs are presented in Figures 9 and 10.

(a) Sample cutting

(b) Coating Samples with Fiber Paint

(c) Dry Samples Ready to Test

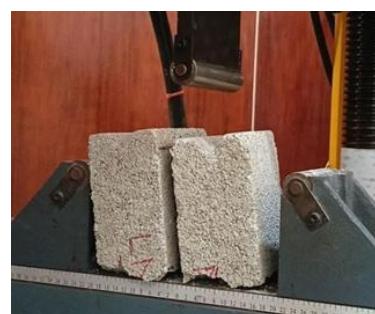
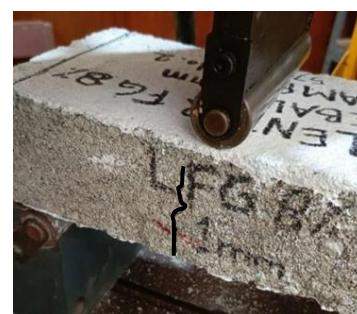
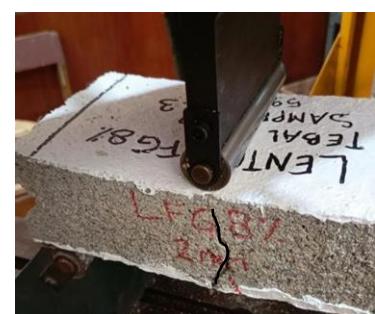
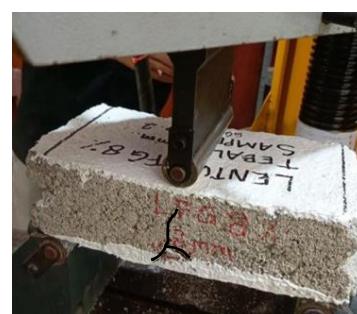
Figure 27. Samples Flexural Damage Pattern

Following the flexural strength testing of concrete blocks incorporating an 8% fiberglass paint layer, the results indicated a flexural strength of 1.93 kN/cm² for a 1 mm thick fiber paint, 2.17 kN/cm² for a 2 mm thickness, and 2.74 kN/cm² for a 3 mm thickness. Upon examining the damage pattern on the blocks, a layer of fiberglass paint comprising 8% was applied, which had undergone testing for flexural strength (Figure 27). The test results indicate that the thickness of the fiberpaint layer has a significant influence on the crack patterns of concrete blocks under flexural testing. In uncoated specimen Figure 27-a, experienced a vertical tensile crack that initiated at the mid-span on the tension side and propagated upward, leading to flexural failure of the concrete block specimen. The application of a 1 mm fiberpaint layer (Figure 27-b) began to show improvements, where cracks became finer and more controlled, although still clearly visible. With a thickness of 2 mm in Figure 27-c, the cracks were fewer, thinner, and did not propagate completely, indicating enhanced flexural resistance and better ductility. Meanwhile, the 3 mm fiberpaint layer (Figure 27-d) provided the best performance, as evidenced by the presence of very fine tensile cracks limited to the mid-span area without extensive propagation. This demonstrates that fiberpaint is capable of restraining crack propagation and distributing tensile stresses more evenly, thereby improving the flexural performance and crack resistance of concrete blocks.

(a) The control sample can be seen as collapsed in the middle of the image.

(b) The sample of 1 mm thick fiberglass painted Concrete Block cracked in the middle.

(c) The sample of 2 mm-thick fiberglass-painted Concrete Block cracked in the middle.

(d) A sample of 3 mm thick fiberglass painted Concrete Block appears to have cracks in the middle.

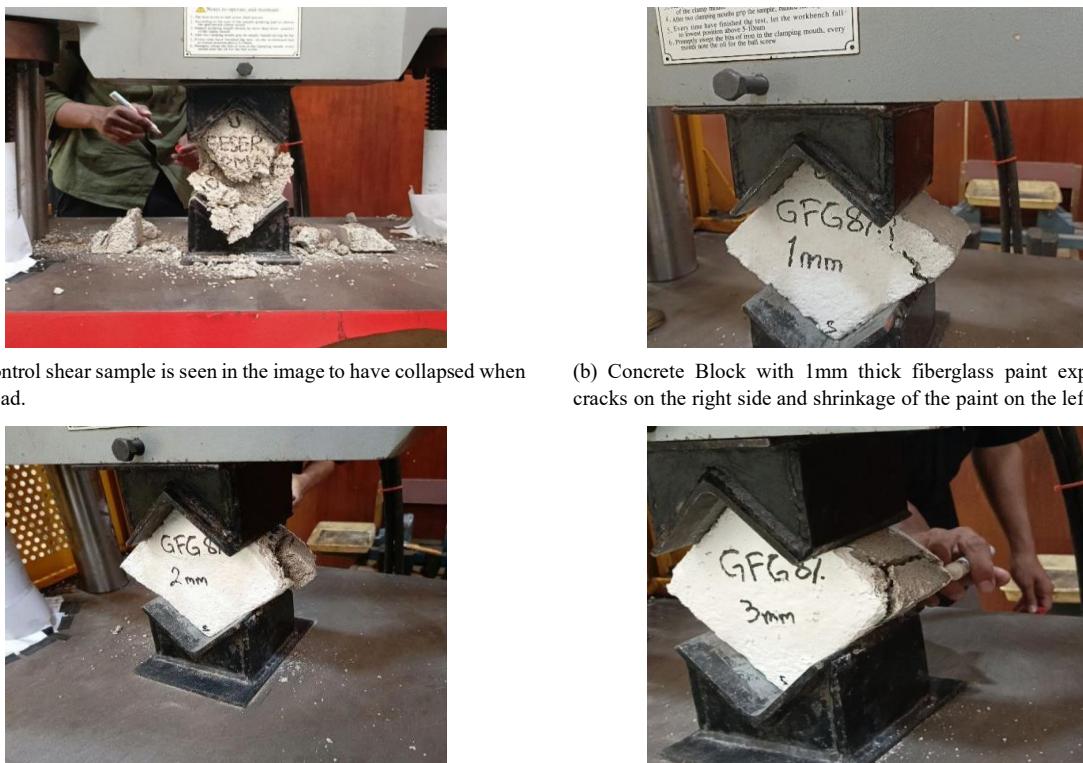
Figure 28. Samples Shear Damage Pattern

Shear strength tests on concrete blocks with an 8% fiberglass paint layer yielded results of 10.88 kN/cm^2 for a 1 mm thickness, 13.42 kN/cm^2 for a 2 mm thickness, and 15.79 kN/cm^2 for a 3 mm thickness. The damage pattern observed on concrete blocks, resulting from applying a fiberglass paint layer mixed at 8%, which was evaluated for shear strength, is illustrated in Figure 28. In the shear test, the application of fiberpaint coatings was found to significantly influence the crack patterns of the concrete blocks. In the control specimen without fiberpaint coating (Figure 28-a), the concrete block experienced complete failure after being subjected to shear loading, characterized by major cracks leading to overall collapse. In contrast, the concrete block coated with 1 mm fiberpaint (Figure 28-b) exhibited cracks only along the sides of the specimen, while the fiberpaint layer effectively restrained the formation of larger cracks. For the specimen with a 2 mm coating (Figure 28-c), the damage was primarily observed in the uncoated areas, whereas the coated regions showed only fine cracks. A similar trend was observed in the specimen with a 3 mm coating (Figure 28-d), where no cracks appeared in the fiberpaint layer, and the damage was confined to the uncoated portions of the block. These findings indicate that the application of fiberpaint enhances the shear resistance of concrete blocks by restricting crack propagation and reducing the extent of structural damage.
