Evaluation and Restoration of Corrosion-Damaged Post-Tensioned Concrete Structures

The adopted case study herein examines a two-story building due to notable signs of structural deterioration. The building has provided over 24 years of service, comprising halls and offices across its ground and first floors. Recent inspections have revealed concerning signs of delamination and spalling observed on the roof slab soffits. These conditions suggest a probable degradation of the structure's PT tendons, evidenced by the exposure and corrosion of the tendons, alongside cracking. Such deterioration is frequently attributed to the critical issue of reinforcement corrosion. The implications of this case study are significant, highlighting the structural challenges aging structures face in corrosive environments. The findings underscore the importance of practical maintenance and the strategic implementation of repair methodologies to ensure the ongoing safety and functionality of the building users. This study used multiple techniques for nondestructive and semi-destructive tests. For decades, those techniques have shown effectiveness and reliability in assessing concrete structures' durabi

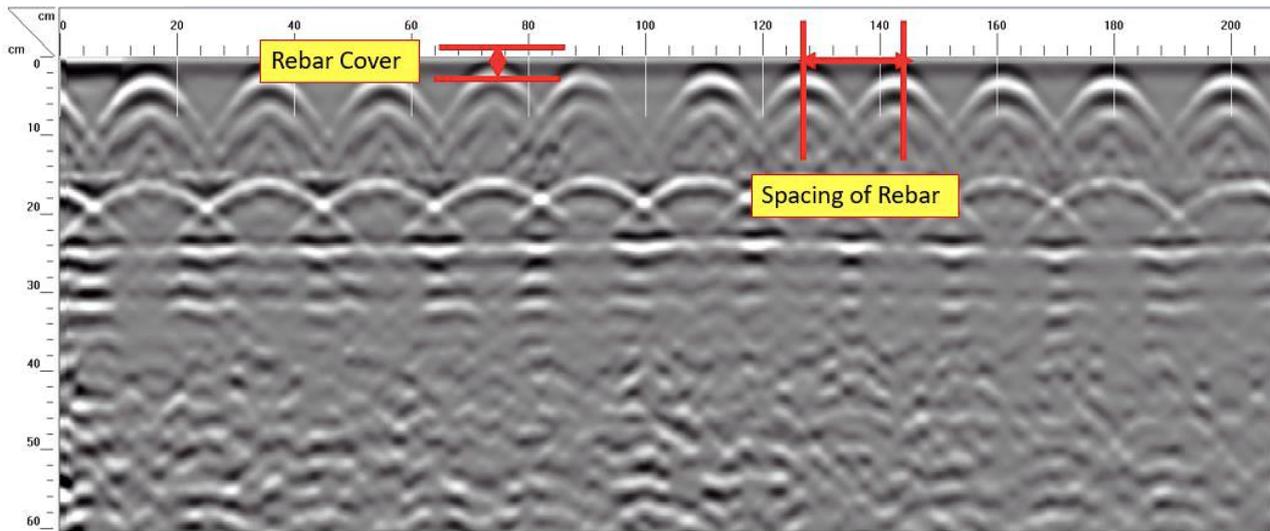
Figure 6. Typical radar data from the cover survey showing the steel reinforcement (FF Beam at Grid A/14-15)

In contrast, the depth of the steel reinforcement corresponds to just below the maxima, where the signal density is greatest (black). The below Table 1 summarizes these results. The concrete cover ranges from 20 to 50 mm for the roof slab. The first-floor slab concrete cover ranges from 50 to 60 mm. Ground and first floor column concrete cover ranges from 25–35 mm to 20–44 mm, respectively. The first-floor beam concrete cover measured 20 mm, and the roof beam concrete cover ranged from 22 to 25 mm.

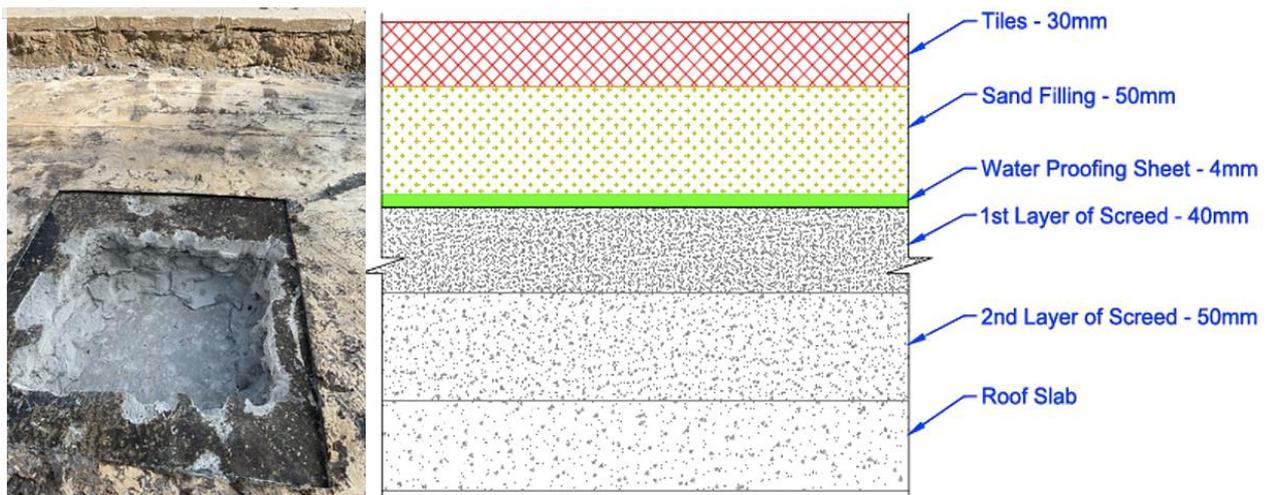
The roof slab top is covered with several protective layers, including tiles, sand filling, waterproofing, and screed, which prevent complete visual inspection or sounding of the roof slab surface. Waterproofing was removed at one location to check the condition of waterproofing and concrete, while the top layer was covered with tiles. Below, the tiles are covered with 50 mm of sand filling. Underneath, a 4 mm waterproofing sheet was removed. The concrete slab was covered with two layers of screed, 40 mm and 50 mm, respectively. Figure 8 presents the different layers of the waterproofing system found on the roof.

Figure 8. Roof protection system as found at the location with a section showing different layers of protection

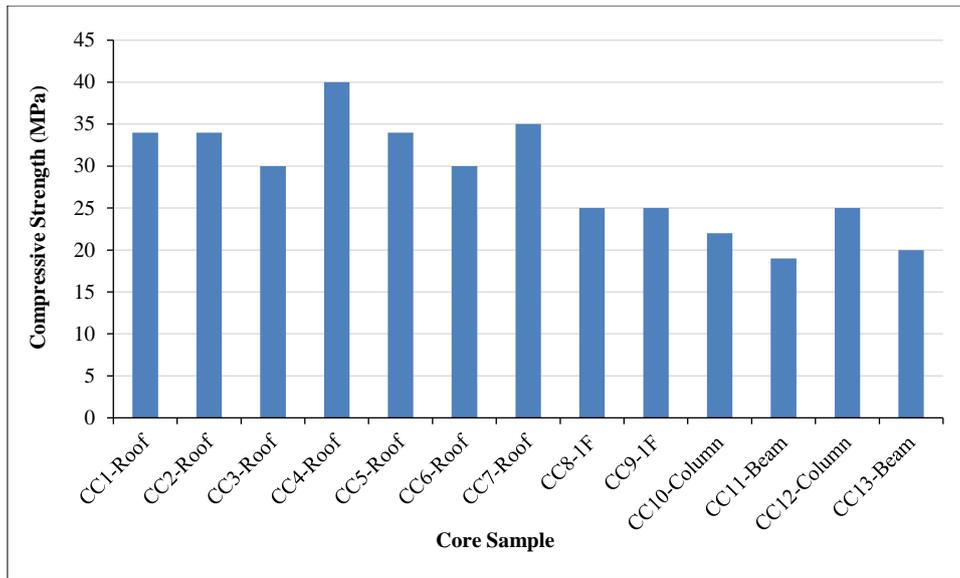
Thirteen concrete core samples were subjected to compressive strength tests as per the guidelines of BS EN 12504:1 2009 [40], which pertains to the testing of concrete within structures, explicitly addressing the extraction, examination, and compression testing of core specimens. The results of these tests are concisely summarized in Figure 9. The range of compressive strengths observed in the samples varied from 19.3 MPa to 40.0 MPa. Notably, the specified design strength for the concrete was 40 MPa cylinder compressive strength (f'_{cu}). Only one of the core samples tested met the designated design strength value. The remaining samples exhibited compressive strengths below the expected threshold. A detailed examination of the testing locations and the concrete cores yielded no evident factors that could account for these lower strength values. Consequently, it is inferred that the concrete compressive strength at most tested locations did not meet the original design specifications.

Figure 9. Summary of compressive strength of all elements

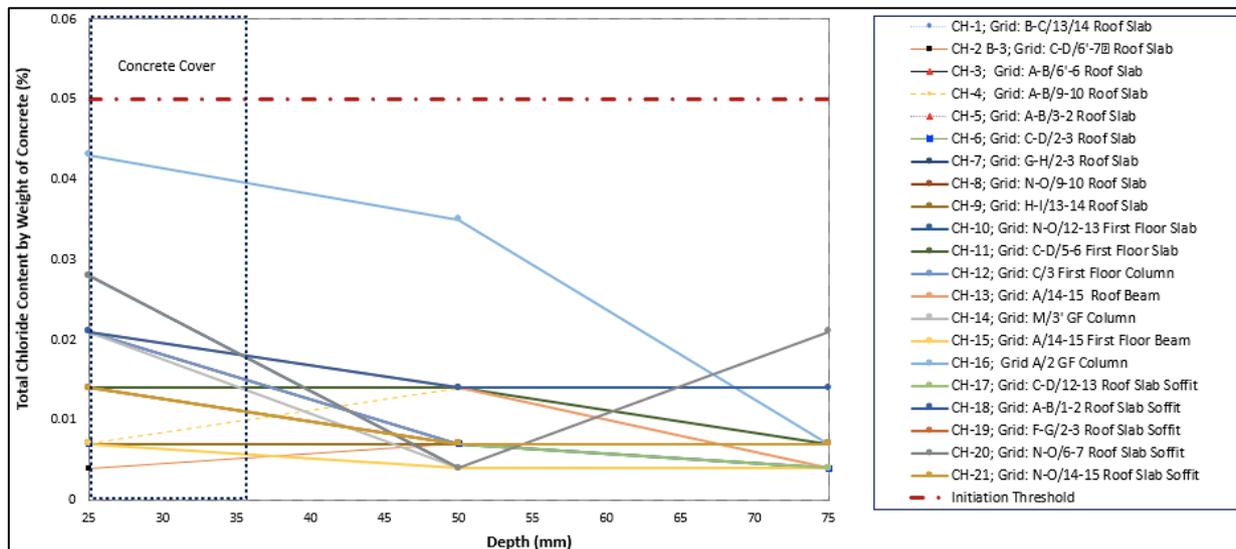
The chloride content was determined following a procedure adapted from BS 1881-124 [41]. The contamination was evaluated by measuring the total chloride content at various depth increments. The generally accepted threshold is between 0.2% and 0.4% of Chloride per weight of cement. A threshold value of 0.3% of Chloride per sample weight is used for analysis during this study. This can be calculated into a threshold per sample weight, with assumptions as follows: weight of cement (kg/m³) = 380, average unit weight of concrete (kg/m³) = 2256, cement/concrete ratio = 0.168. The threshold per weight of sample = threshold per weight of cement × 0.168 = 0.30 × 0.168 = 0.05%. The data obtained for chloride contamination is presented in Figure 10. The chloride levels for all tested samples were determined to be below the threshold initiating corrosion. However, it should be noted that chloride content in all tested samples can be explained by the chloride-contaminated water used in the concrete mixing, which was reported later on.

Figure 10. Chloride profile for all elements
