Rehabilitation of Partially Corrosion-Damaged Post-Tensioned Concrete Structures Using Carbon Fiber Reinforced Polymer

Hadif Alsuwaidi ¹, Ahed Habib ^{2*}, Zaid A. Al-Sadoon ¹, Mohamed Maalej ¹,
Salah Altoubat ¹, Samer Barakat ¹, M. Talha Junaid ¹

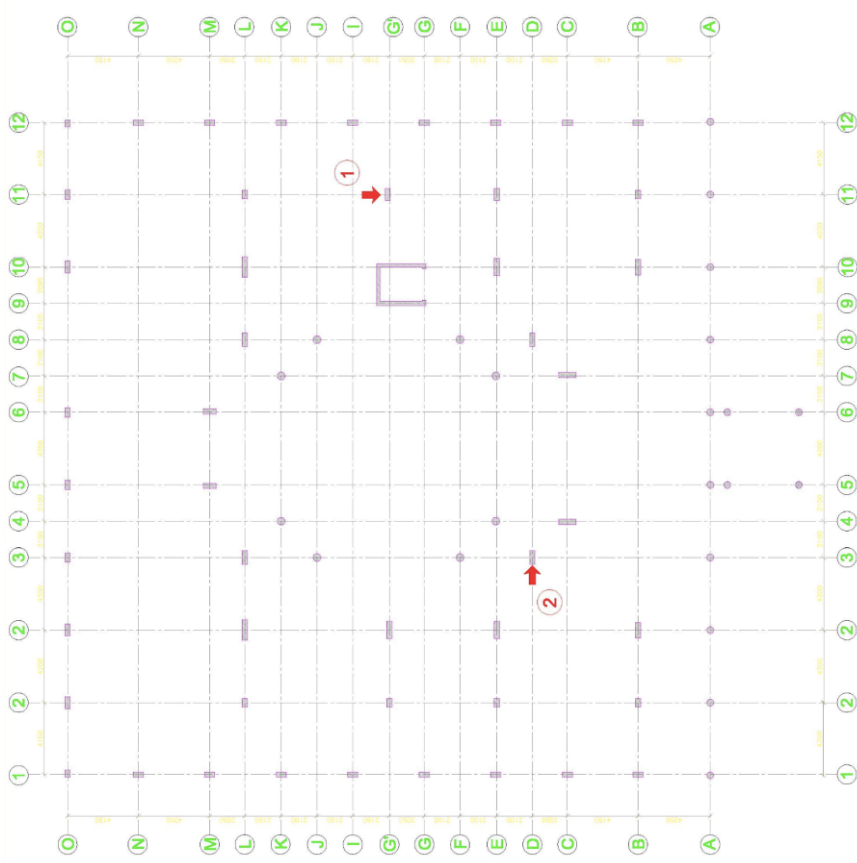
Figure 2. Ground floor test locations

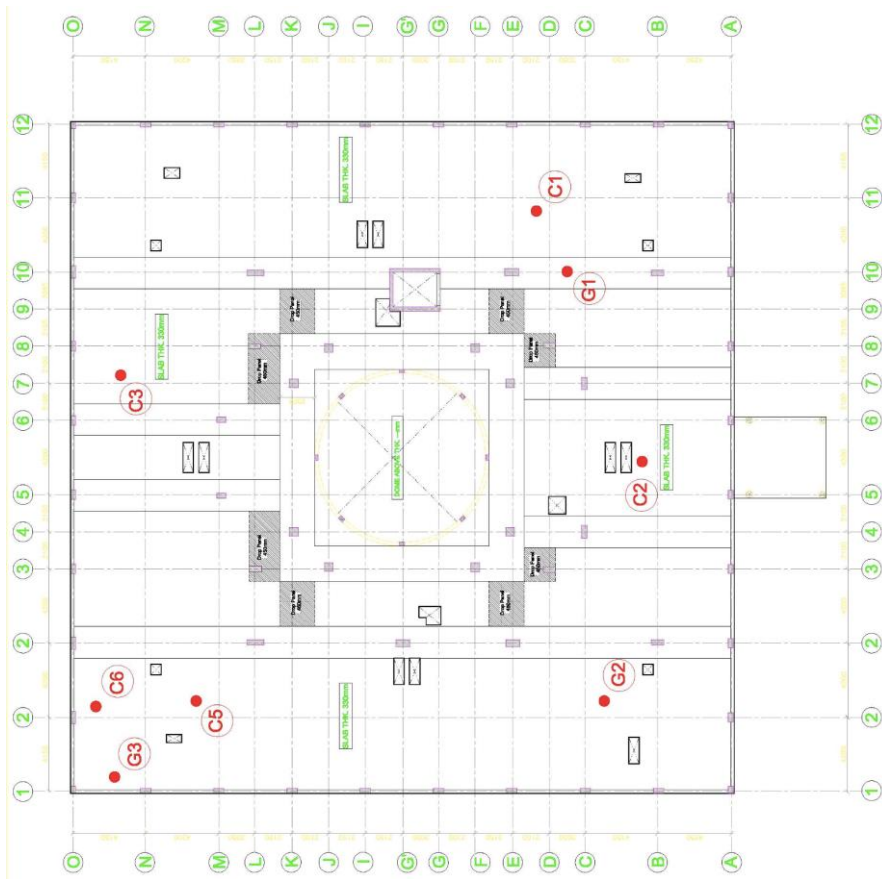
Figure 5. Roof slab soffit test locations

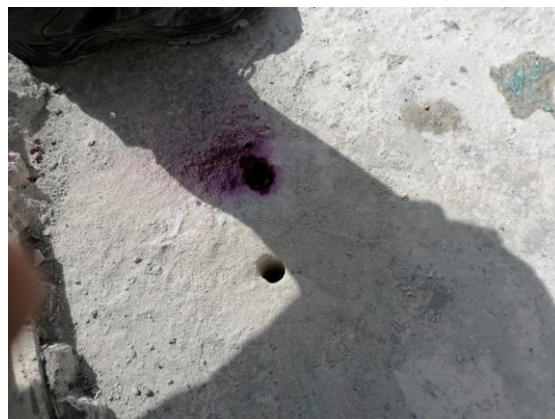
The outer carbonated layer retained its natural color upon testing, while the uncarbonated portion appeared pink. Since atmospheric carbon dioxide reacts with exposed surfaces immediately, tests were conducted on freshly exposed concrete. To maintain accuracy, care was taken to prevent contamination by dust from uncarbonated concrete. Figure 13 illustrates the carbonation depth testing process, while Table 3 presents the measured depths at the tested locations. The results indicate that the maximum carbonation depth remains below the concrete cover, suggesting minimal risk of corrosion due to carbonation.

Figure 13. Carbonation test process

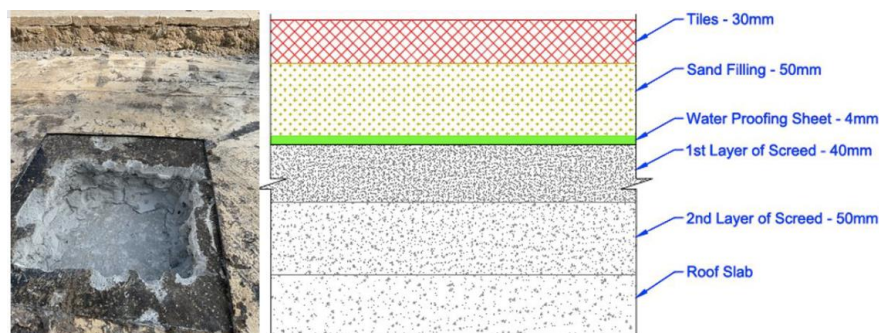
The roof slab is protected by multiple layers, including tiles, sand filling, waterproofing, and screed, which obstruct direct visual inspection or acoustic assessment. A section was removed at a selected location to evaluate the condition of the waterproofing system and underlying concrete. The uppermost layer consists of tiles and a 50 mm sand filling. Beneath this, a 4 mm waterproofing sheet was removed to expose the concrete slab, which is coated with two screed layers of 40 mm and 50 mm thickness, respectively. Figure 18 illustrates these layers within the waterproofing system.

Figure 18. Roof protection system as found at the location with a section showing different layers of protection
