Civil Engineering Journal

Vol. 4, No. 12, December, 2018

Study on Seismic Dynamic Response of Shallow-Buried Subway Station Structure and Ancillary Facilities

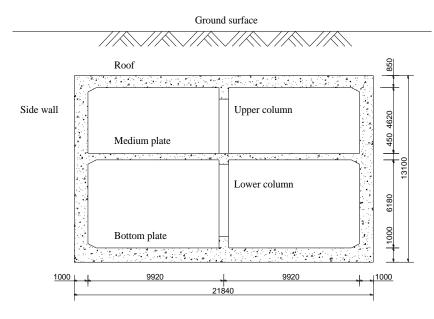
Figure 1. Representative cross-section (unit: mm)

2. Project Background

A numerical analysis model of soil-structure dynamic interaction was established by using finite element software ABAQUS. According to the plane strain problem analysis, the size of the structure is determined according to the axis of the standard cross section shown in Figure 1. According to the "Code for Seismic Design of Urban Rail Transit Structures" (GB50909-2014) and the "Code for Seismic Design of Buildings" (GB50011-2010), the distance between the side boundary of the model and the bottom boundary to the underground structure is not less than 3 times of the width and vertical effective height of the underground structure. In this paper, the width of one side of the soil is taken to the top of the bedrock, which is 60 m. The dimensions meet the design specifications mentioned above.

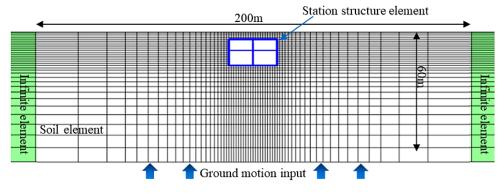
The numerical model is shown in Figure 2.

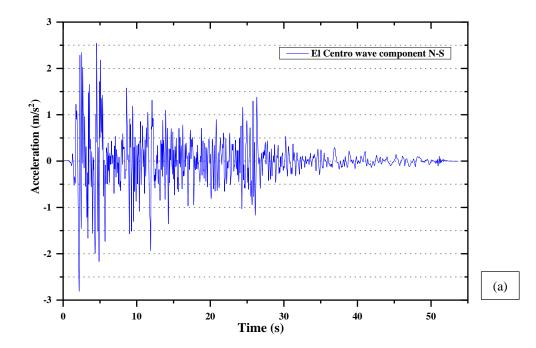
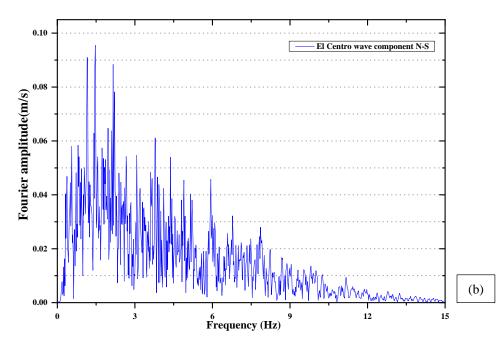
Figure 3. N-S component of El Centro ground motion: (a) Acceleration-time history (b) Fourier amplitude spectrum

The selected earthquake input at the bottom (i.e., the top of the bedrock) of the numerical model is the N-S component of El Centro ground motion, with its acceleration time history and Fourier amplitude spectrum shown in Figure 3. In order to investigate the acceleration response characteristics of the subway station structure under different seismic intensities, the peak ground accelerations at the bottom of the model are adjusted to 0.1, 0.2, 0.3, 0.4, 0.5, and 0.6 g separately.

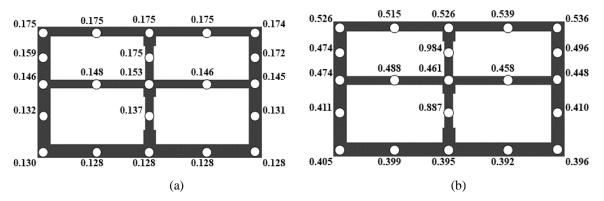
Figure 4. Peak acceleration responses at different locations of the structure: (a) 0.1g (b) 0.6g

Figure 4 shows the distribution of peak acceleration responses at different locations of the subway station structure, as the peak input accelerations at the base are 0.1 and 0.6 g. It is seen in Figure 4(a) that when the ground motion intensity is low, the distribution of accelerations inside the subway station structure generally shows a gradually increasing trend from bottom to top, and the peak acceleration responses at the same height are practically the same. The locations corresponding to the maximum and minimum peak acceleration responses occur at the top and bottom plates, respectively. It is observed in Figure 4(b) that when the ground motion intensity is high the accelerations inside the subway station structure, in general, increase from bottom to top, with the location corresponding to the minimum peak acceleration response at the structural bottom plate, while the maximum peak acceleration response occurs at the upper-story central column.

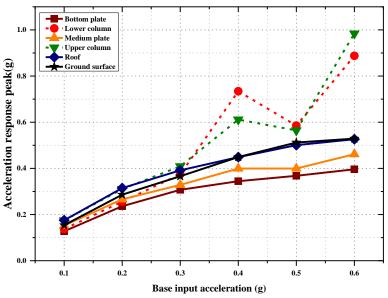
Figure 5. Peak acceleration responses with different base input accelerations

Figure 5 shows the variations of peak acceleration responses of the bottom plate, middle plate, top plate, upper- and lower-story central columns, and ground surface as the peak of bedrock input acceleration changes. When the bedrock input accelerations are small (0.1 and 0.2 g), the accelerations inside the structure are close to the peak ground acceleration response due to the shallow-buried depth of the station. For the case of 0.1 g input, the amplification factors of peak accelerations at the bottom plate, lower central column, middle plate, upper central column, top plate, and ground surface relative to bedrock are 1.28, 1.37, 1.46, 1.75, 1.75, and 1.54, respectively. However, when the bedrock input acceleration is large (the cases of 0.3–0.6 g), the acceleration responses at the bottom, middle, and top plates are either less than or close to the peak ground acceleration response, and the peak acceleration responses of both upper and lower central columns significantly exceed the peak ground acceleration response. Specifically, for the case of 0.6 g, the amplification factors of peak accelerations at the bottom plate, lower central column, middle plate, upper central column, top plate, and ground surface relative to bedrock are 0.66, 1.48, 0.77, 1.64, 0.88, and 0.88, respectively. These results suggest that, because the dynamic response of the subway station structure is controlled by the deformation of the

surrounding soil, the overall distribution of peak interior acceleration responses of the subway station structure is similar to the pattern of acceleration propagation in soil, demonstrating the amplification effect under small earthquakes and the attenuation effects under large earthquakes. The reason why the acceleration response of the central column is significantly larger under large earthquakes is discussed in detail below.

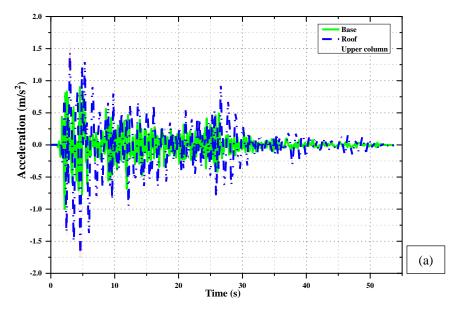
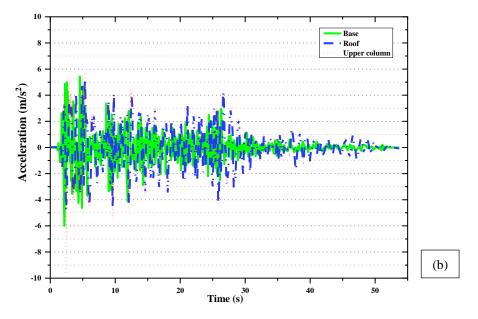
Figure 6. Comparison of acceleration-time histories for different locations: (a) 0.1 g, (b) 0.6 g

Figure 6 and 7 compare the acceleration-time histories and Fourier amplitude spectra, respectively, of the structural top plate and upper central column as well as the bedrock. It can be seen in Figure 6(a) that, when the peak input acceleration of the bedrock is 0.1 g, the accelerations of the top plate and the upper central column relative to that of bedrock are magnified, and the acceleration-time-history curves associated with these two locations are highly correlated, with corresponding peaks almost coinciding with each other. However, it is observed in Figure 6(b) that, when the peak input acceleration of the bedrock is 0.6 g, the acceleration-response-time history of the top plate is significantly smaller than that of bedrock, while the acceleration-response-time histories of the upper central column and the bedrock are very similar, with the peak acceleration of the central column more pronounced. Such phenomena are also observed by comparing the Fourier amplitude spectra in Figure 7. Figure 7(a) and 7(b) show that the acceleration Fourier amplitudes of the top plate and the upper central column are both magnified in the frequency range 0-3 Hz and attenuated in the frequency range 3–6 Hz. The differences between the two sets of acceleration Fourier amplitudes are as follows. For frequencies higher than 6 Hz, when the bedrock input acceleration is 0.1 g, the two sets of acceleration Fourier amplitudes are almost zero. In comparison, when the bedrock input acceleration is 0.6 g, the acceleration Fourier amplitudes of the top plate are also almost attenuated to zero while the acceleration Fourier amplitudes of the upper central column are still non-zero. Therefore, the higher-than-6-Hz frequency component is responsible for the high acceleration response of the central column compared to that of the top plate.

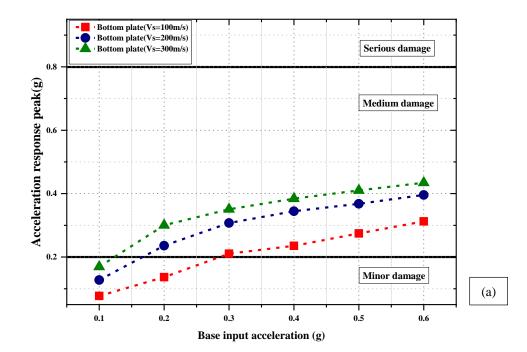
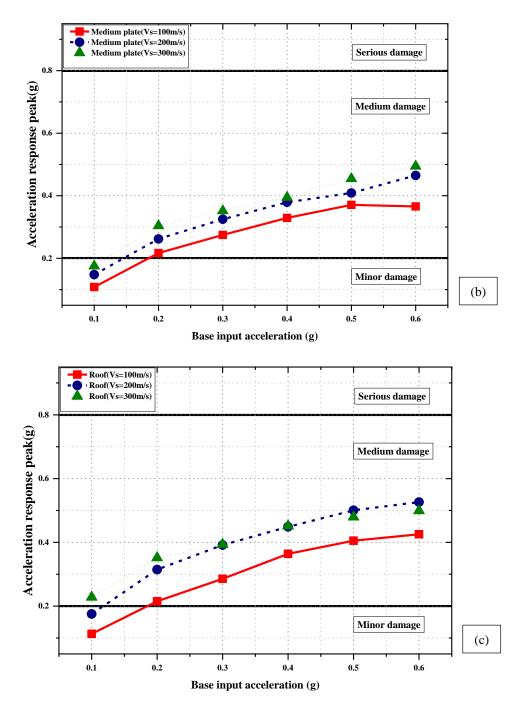
Figure 8. Peak acceleration responses at: (a) bottom (b) medium (c) roof

Because the nonstructural facilities are usually attached to horizontal structural members, such as floor plates, vertical structural members such as the central column are not considered when evaluating the damage to nonstructural members. Figure 8 shows the variation of peak acceleration responses of the structural bottom, middle, and top plates as the bedrock input acceleration changes. To investigate the effects of soil-layer stiffness on the acceleration of the subway station structure, two additional soil-layer shear-wave velocities (100 and 300 m/s) of the soil layer are considered in the calculation, and the results along with those calculated earlier with 200 m/s are plotted in Figure 8. It can be seen that, as the peak input acceleration of the bedrock increases, the peak acceleration response of the structural bottom, middle, and top plates increase. In addition, as the soil-layer stiffness increases, the acceleration response of the structure also increases. This observation indicates that the higher the soil-layer stiffness of the site is, the larger the acceleration response of the subway station structure becomes, possibly causing more severe damage to nonstructural facilities.

The relationship between structural acceleration response and nonstructural damage, according to that available in the literature [14], states that the nonstructural facilities are slightly damaged, moderately damaged, and severely damaged when the corresponding acceleration response is less than 0.2 g, in the range 0.2–0.8 g, and in the range 0.8–1.25 g, respectively. The nonstructural facilities are considered completely destroyed when their acceleration response is greater than 1.25 g. It can be seen in Figure 8 that the nonstructural facilities are slightly damaged and moderately damaged when the bedrock input accelerations are 0.1 g and in the range 0.2–0.6 g, respectively.
