Civil Engineering Journal

Flexural Behavior of Repaired Reinforced Concrete Beams Due to Corrosion of Steel Reinforcement Using Grouting and FRP Sheet Strengthening

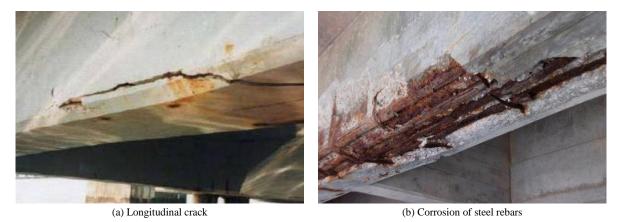
Figure 2. Deterioration of Reinforced Concrete beams due to corrosion of steel rebars

Reinforced concrete structures in coastal areas have a very high risk of damage due to the aggressive marine environment. Although concrete is a relatively durable construction material, it is not enough to guarantee the durability of the construction as a system if the steel reinforcement as a structural component experiences corrosion. The marine environment, which contains elements of salt, can seep through the pores of the concrete and penetrate the concrete reinforcement [4]. As a result, the steel reinforcement in the concrete may experience corrosion and loss due to the infiltration of chloride ions in the seawater environment. The chloride ion is corrosive and can attack the calcium silicate binding system [5–7]. Figure 2 shows a photo of a steel-reinforced concrete beam experiencing corrosion on the reinforcement. The corroded reinforcement may expand and cause longitudinal cracks and spalling in the reinforced concrete cover, which results in a decrease in the strength and service life of the structures. Beams that have been corroded on the steel reinforcement due to the influence of chloride attacks from the marine environment or due to the carbonation process will expand and cause longitudinal cracks around the concrete cover, resulting in spalling, as illustrated in Figure 3. This causes a decrease in the nominal moment capacity of reinforced concrete beams [8–11].

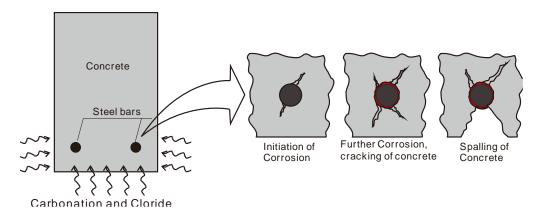
Figure 3. Corrosion propagation due to Carbonation and Chloride attack

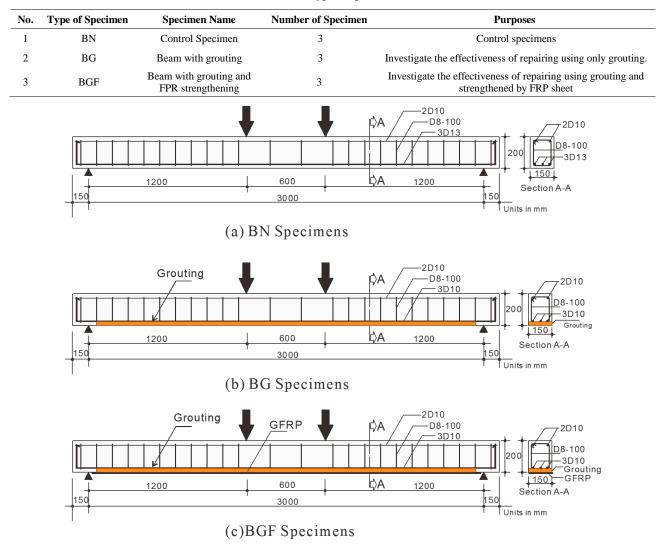
Figure 6. Detail of Specimens

The dimensions of reinforced concrete beams for laboratory testing were 150×200 mm with a length (L) of 3300 mm. Two types of beam specimens were prepared, which are BG and BGF. The BG was a repaired beam without FRP reinforcement (only grouting concrete), and the BGF was a repaired beam with FRP sheet strengthening, respectively. In addition, BN specimens were also prepared as a control beam. Table 1 shows the variations of the specimens, and Figure 6 shows the details of the beam specimens. The specimens for control beams (BN) were designed to use 3D13 mm (three bars of 13 mm diameter) as tensile reinforcement with a concrete strength of f'c = 25 MPa. The control beams were designed to have a theoretical moment capacity of 15 kNm. For beam specimens of BG and BGF, steel reinforcements of 3D10 were used as tensile reinforcement with the same arrangement and configuration as the BN beams. A smaller diameter of tensile reinforcement on BG and BGF was used to simulate a mass loss due to the corrosion of tensile reinforcement. In this case, it was assumed that the initial cross-section of steel reinforcement with a diameter of 13 mm (D13) decreased to 10 mm (D10), or 40% of its original cross-section. Details of the specimens are shown in Figure 6.

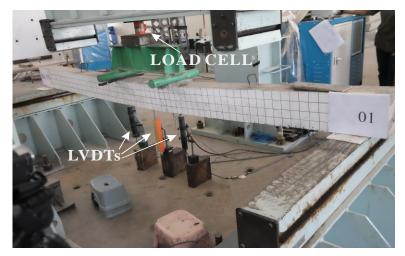
Figure 8 shows the test setup for beam specimens. The specimens were loaded under flexural loading with a fourpoint loading system monotonically using static test equipment with a capacity of 150 tons. Prior to testing, the horizontal and vertical lines with a spacing of 50 mm were drawn at one side of the beam specimens for cracking observation.

Figure 8. Test Setup

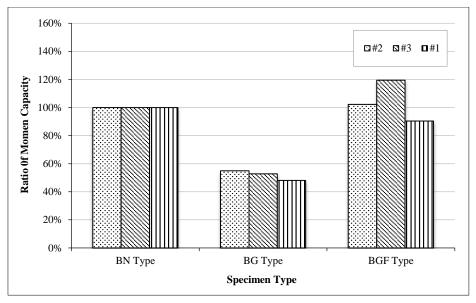
Figure 9. Ratio of Flexural Capacity Compared to Control Beam (BN)

Further observation, the BGF specimen showed that the flexural capacity of repaired beams (grooving and strengthening with GFRP) was still not significantly increased compared to the control specimen (BN). In estimating the flexural capacity of each type, it was designed that the specimens of BGF type had a flexural capacity of 35% above the control specimens. However, the flexural capacity between BGF and BN was relatively the same, or there was only a relatively small increase of 4%. Figure 9 shows the flexural capacity ratio compared to the BN-type specimens. Due to the longitudinal cracks that occurred on the interface between existing concrete and grouting concrete, the flexural action tended to behave as a non-bond. This may be illustrated in Figure 10. The failure of bonding interaction caused a decrease in the performance of the FRP sheet to strengthen the beam. The separation of the grouting layer and existing concrete, which was indicated by horizontal cracks, caused the FRP sheet to not fully interact with the compression concrete.

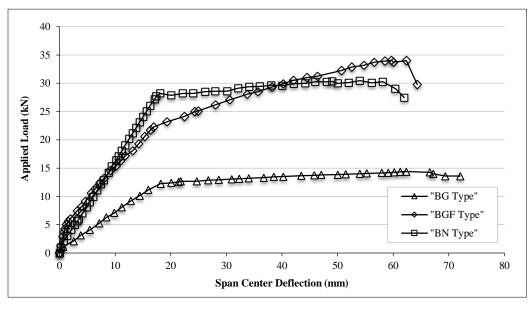
Figure 11 shows the load and deflection relationship at the mid-span of beams. Typical of the behavior of reinforced concrete beams, cracks occurred at relatively low applied loads when the ultimate stress of concrete had been reached. On the BG beam, the initial cracks occurred earlier than in the BN and BGF specimens. This occurred because the steel strain in the BG beam was relatively higher than that in the BN and BGF beams. It should be noted that the cross-section of the reinforcement in BG type was smaller to simulate a reduction of the steel reinforcement cross-section due to corrosion. In the BGF beam, although it used the same cross section of tensile reinforcement as the BG type, this specimen was strengthened with GFRP sheet, which contributed to delaying the achievement of the rupture stress in the concrete. The occurrence of initial cracks in the beam caused a decrease in beam stiffness. The BN beam experienced a change in initial stiffness from 3.88 kN/mm to 1.54 kN/mm. The BG beam experienced a change in initial stiffness from 4.65 kN/mm to 1.10 kN/mm. The biggest change in stiffness occurred in the BGF-type beam. This was due to the smaller GFRP modulus of elasticity (95 GPa) compared to steel reinforcement (200 GPa). After the steel strain reached the yield strain and entered the plastic phase, a change in the stiffness of the beam occurred again. The BN beam experienced a change in stiffness to 0.099 kN/mm.

Figure 11. Load-Deflection Curve

The BG beam experienced a change in stiffness to 0.047 kN/mm, and the BGF beam experienced a change in stiffness to 0.282 kN/mm. As it can be observed, after the steel reinforcement was yielded, the change in stiffness of the BGF beam was relatively smaller compared to the other beams. This is because the BGF beam was still strengthened using the GFRP sheet.

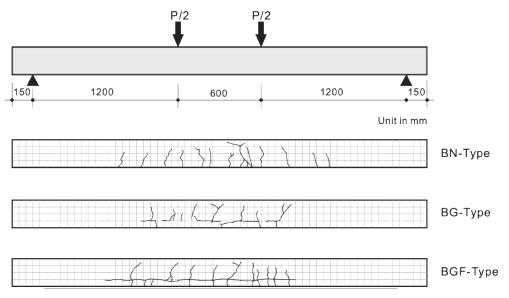
Figure 12 shows the crack pattern of all specimens. In general, the first cracks occurred on the tension side of the beam (the bottom side of the beam) when the stress exceeded the concrete rupture strength. Cracks propagated from the tension side to the compression side as the applied load increased. For BN beams, the crack propagated to the compression section as on regular reinforced concrete beams. However, for BG and BGF beams, a layer of grouted concrete on the bottom side of the beam with a thickness of about 50mm showed a different crack pattern. At the beginning of loading, the vertical cracks appeared in a similar case with regular reinforced concrete beams. As the load increased, the vertical cracks continued to propagate, but they were also followed by the appearance of horizontal cracks. These horizontal cracks disrupted the bending interaction between the reinforcement on the tension side and the concrete on the compression side. This caused a reduction in the moment capacity. For BGF beams, a similar phenomenon also occurred. With the appearance of horizontal cracks, the GFRP sheets as reinforcement cannot interact effectively

anymore in resisting moments. This caused a decrease in momentary capacity. It can also be observed from Figure 12 that the repaired concrete beams (BG and BGF beams) had a smaller crack density in the span of the loading point (zero shear span) compared to the BN specimens. The crack density (number of cracks per unit length) of the BN type is 1.2 per meter. Meanwhile, the BG and BGF beams were 0.83 per meter and 0.65 per meter, respectively.

Figure 12. Crack Pattern of all beams

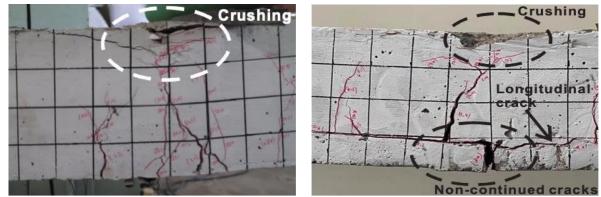
Figure 13 shows the modes of failure that occur on specimens. For the BN specimen, the mode of failure that occurred was similar to the general failure mode of regular reinforced concrete beams. The ultimate load was determined by the crushing of the concrete on the compression side after yielding the steel reinforcement on the tension side. Following the elongation of the tensile reinforcement due to the increased tensile force as an interaction with the compressive force, the number and length of cracks also increased. This mechanism continued until the concrete reached its crushing strength.

(a) Failure of BN Type

For BG and BGF type beams, a 50-mm grouted concrete layer on the tension side showed a different failure mechanism. For BG-type beams, cracks begin to occur in the grouted concrete when the stress exceeds the rupture stress of the grouted concrete. As the load increased, the cracks increased in both number and length. When the cracks reached the interface between grouted concrete and normal concrete, the horizontal cracks appeared. The appearance of longitudinal cracks indicates that the bonding stress or shear stress between the grouted concrete and the normal concrete was unable to maintain the monolith integration for longer. This caused the beam to tend to behave as a non-bonded sandwich beam. This phenomenon was indicated by the appearance of non-continued cracks in the beam, as may be observed in Figure 13.
