Experimental Study on the Effect of Flow Velocity and Slope on Stream Bank Stability (Part II)

Abstract

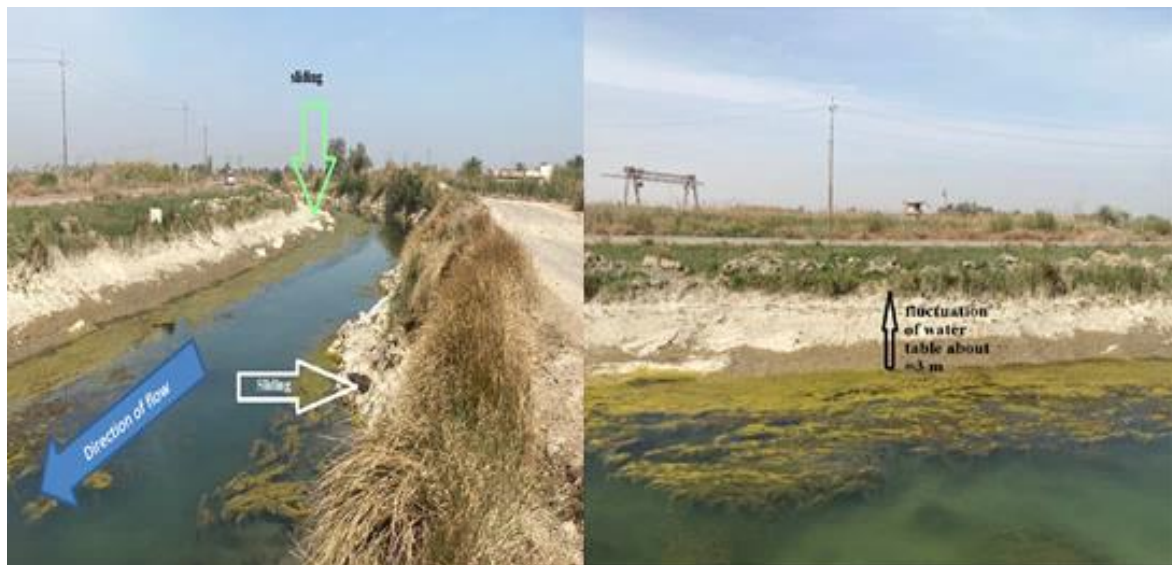
Figure 3. Slope instability of the channel bank during dropping period

This study aims to investigate the state of the Al Muwahada channel and determine the factors that contribute to the instability and erosion of its banks. The Al Mowahada Channel, a substantial irrigation channel situated to the west of Baghdad, Iraq, it receives water from the Euphrates River upstream of the al-Fallujah barrage. The Al Mowahada Channel is used as the case study for this paper. The case is to be studied in the laboratory by simulating the channel's dimensions and the flow state. The geometric feature of the channel is characterized by a maximum water depth of 5 meters, a minimum water depth of 1.35 meters, a bottom width of approximately 20 meters, and a top width of 40 meters (Figure 2). The maximum and minimum discharge rates are 140 and $35 \text{ m}^3/\text{s}$, respectively. The water table frequently fluctuates between 1.35 and 5 m as a result of the functional mechanism of the channel, increasing to 5 m for five days and then descending to 1.35 m for an additional five days [18]. The phase of dropping is illustrated in Figure 3.

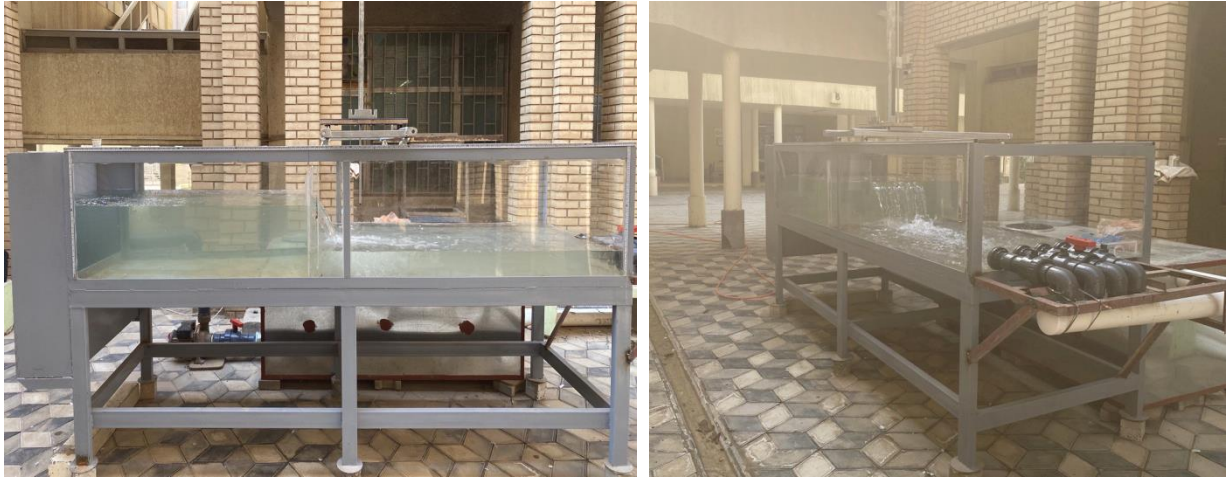
Figure 4. Laboratory flume

The experimental investigations were conducted using a laboratory flume. The flume was being manufactured to create a physical model that more closely resembles the natural channel under controlled conditions. The main structure of the flume is a steel frame with dimensions of 3 m in length, 1 m in width, and 0.6 m in height. It also periodically connects to quieting containers that are 1 m wide, 1.5 m high, and 0.4 m thick to dissipate the high flow velocity. The sidewalls of the flume are constructed from Plexiglas that is 4 mm thick. A water storage tank of 1800 liters was also incorporated into the system of flume to conserve flow water. The pumping apparatus was connected to the flume using a four-inch diameter pipe. Water is pumped into a flowmeter (Rotameter type) by a three-horsepower pump, which then measures the discharge inputs to the quieting tank (Figure 4). The dimensions of the flume are determined by modeling the actual dimensions of the original channel (prototype). The geometric similarity entails that the ratios of the prototype characteristic lengths to the model lengths are L_r equal to $1/45$. The Froude number of the prototype must be equivalent to the Froude number of the model to confirm the validity of the modeling [19].

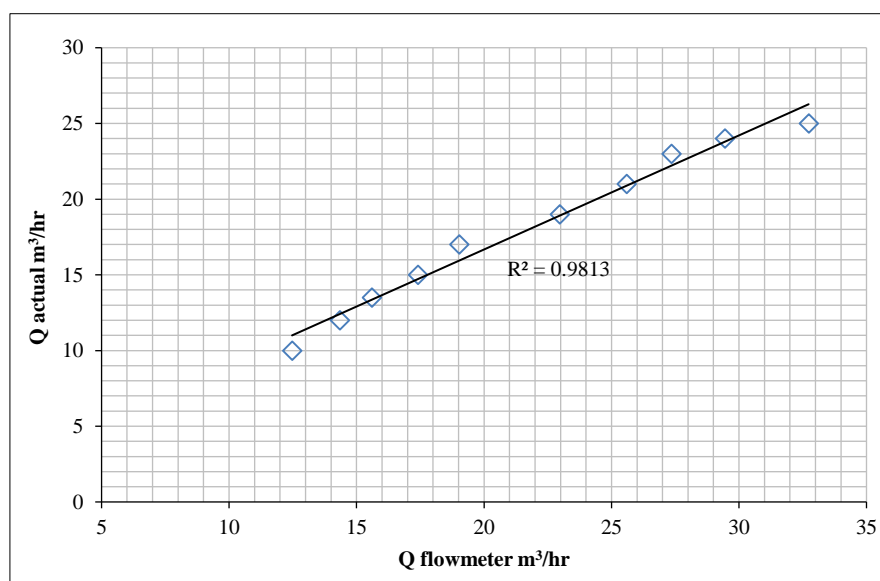
Figure 6. Calibration curve of the flow meter

The rectangular, fully contracted, sharp-crested weir, as illustrated in Figure 5, was used to conduct the calibration procedure for the flow meter device [20]. By simultaneously operating the weir and the flow meter and recording 10 readings for each. The actual discharge of the flow meter ($Q_{\text{flow meter}}$) was then plotted, and the regression equation that follows is the result of the calibration illustrated in Figure 6.

$$Q_{\text{actual}} = 0.7535 Q_{\text{flow meter}} + 1.6032 \quad (1)$$

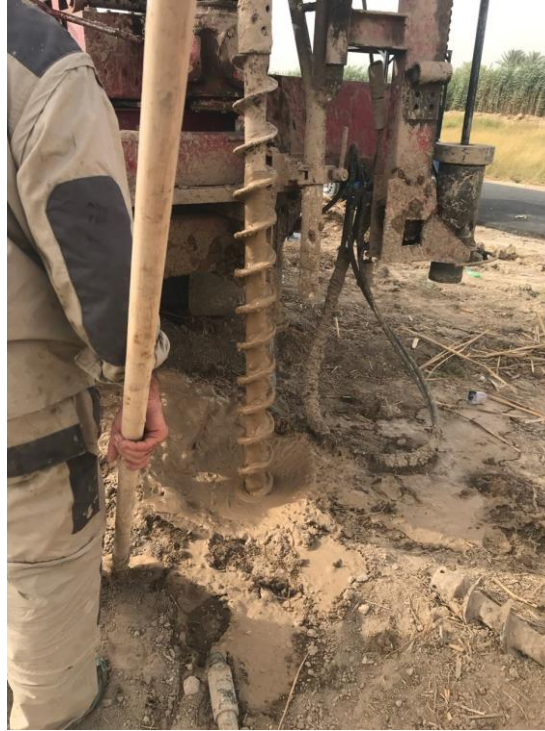
Figure 7. Soil investigation of the embankment

The flume model was designed to accurately replicate field conditions and parameters in a laboratory environment. To construct the riverbank in a laboratory environment, the original bank soil of the Al-Mowahada channel is being used, with the essential soil properties, embankment geometry, and water table within the embankment factors considered. A borehole was excavated at a depth of 12 meters to investigate sediments along the riverbank, as illustrated in Figure 7. Both the flow rate and the water depth in the laboratory flume were under control. The investigation involves the simulation of a model in a flume to conduct laboratory tests, as partially illustrated above. Finally, construct riverbanks with a slope angle of 45° and 60° , as illustrated in Figures 8 and 9. The water content, dry unit weight, and specific gravity of the soil are all taken into consideration.

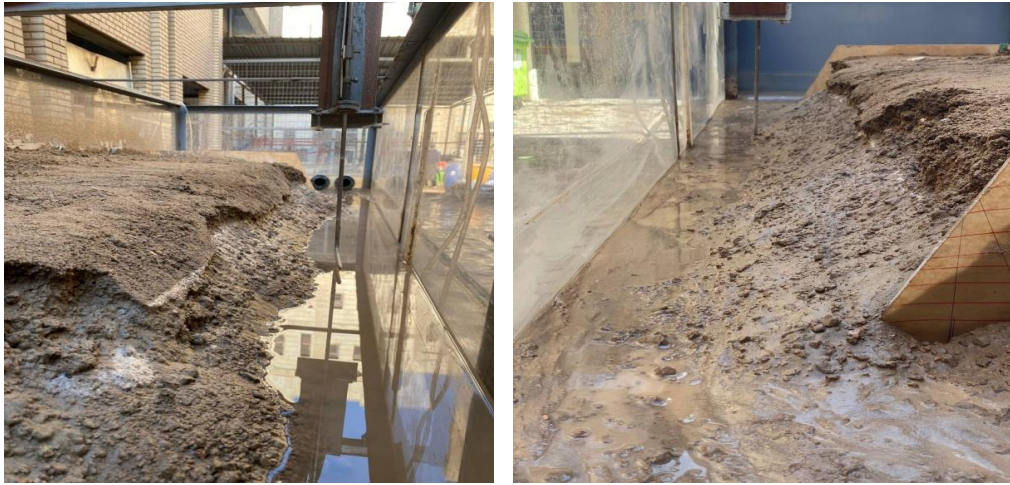
Figure 12. Erosion of the channel bank with slop angle of 60°

The sedimentation area at the toe of the bank recedes when the flow velocity increases to 0.116 m/s, and the quantity of erosion increases directly (Figure 12). The tipping point between erosion and sedimentation exceeded the previous point and approached a depth of 6.25 m from the bottom of the channel (see Table 9 and Figure 11-b).

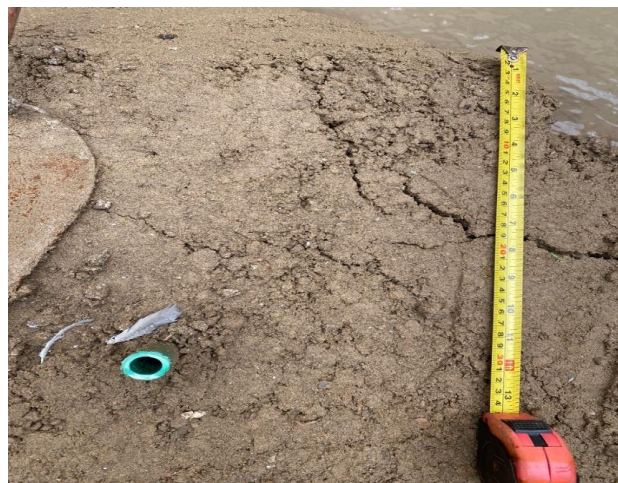
Figure 13. Tension crack phenomenon

Table 10 and Figure 11-c illustrate the behavior of the bank, which was subjected to a flow velocity of 0.12 m/s. The deformation of the channel bank produces a new angle that is more stable than the present bank angle and approaches the 45° angle. The collapse occurs because of tension cracks that develop on the surface of the bank as a result of the shoulder's prolonged exposure to flow, as illustrated in Figure 13.
